# Annexure C

Murray Bridge Technical College

C1-Project Green- Visual tree Assessment

# VISUAL TREE ASSESSMENT

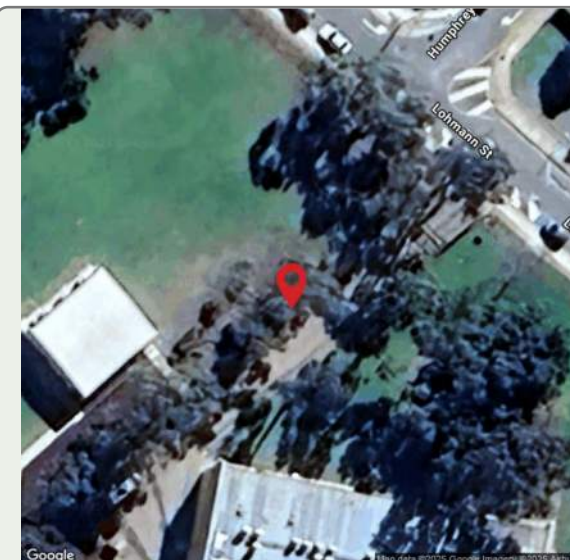
| PG Number | PGSA00009617 |

Recommend grinding stump of removed callistemon.  
Potential mower impact.

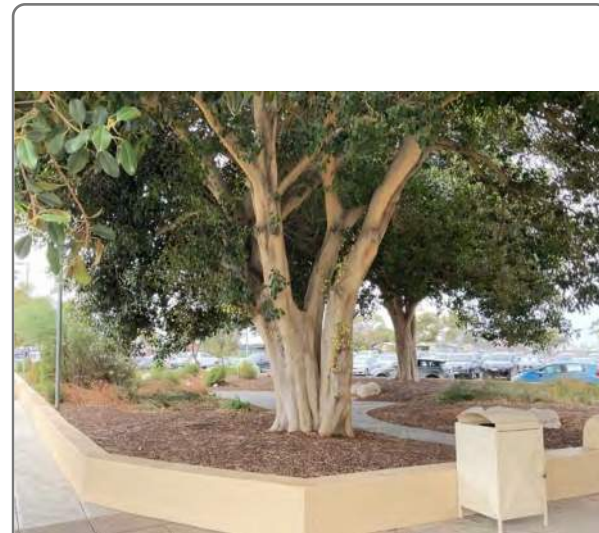
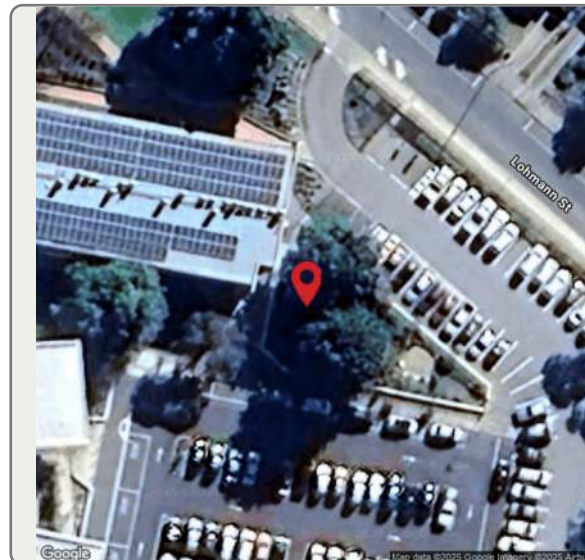
| PG Number | PGSA00009626 |

Recommend pruning ficus to remove failed limbs above path and building entrance. Clear security light to parking bays.

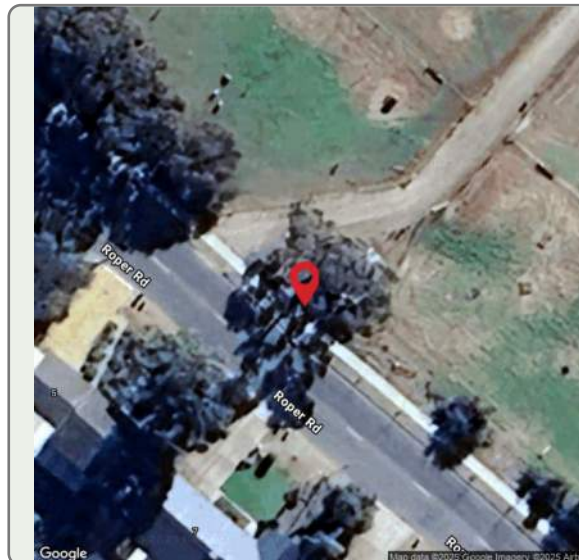
| PG Number | PGSA00009633 |

Recommend pruning to reduce lateral over water tank by 15%.  
Tree exhibits good crown health. Shows wounds from past pruning reductions and good occlusion.

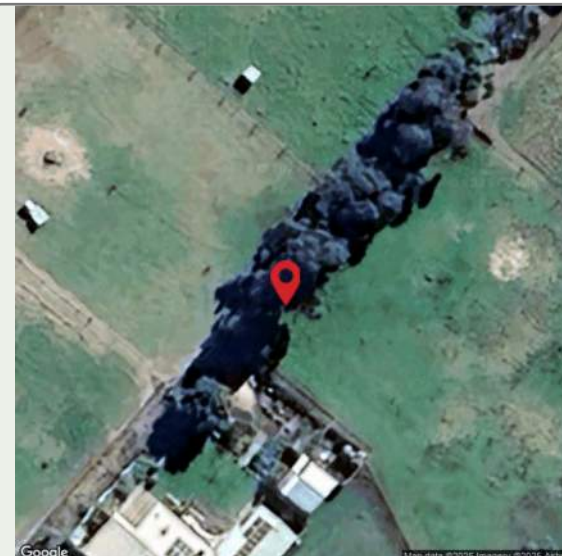
| PG Number | PGSA00009636 |

Recommend removal of dead Sa blue gum. Tree ring barked by animals. No potential to improve. Remove tree leaving stump at 1m for animal rubbing post.

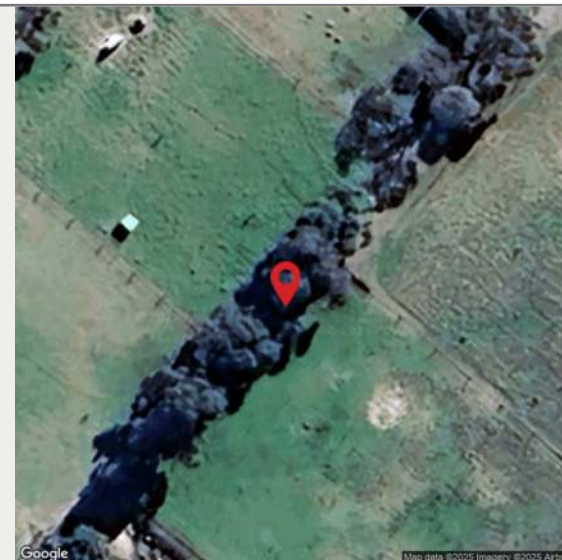
| PG Number | PGSA00009637 |

Recommend pruning dead limbs from crown over animal pen. Remove failed limb in melaleuca. Tree exhibits good crown health. Ring barking to approximately 50% of trunk cambium.

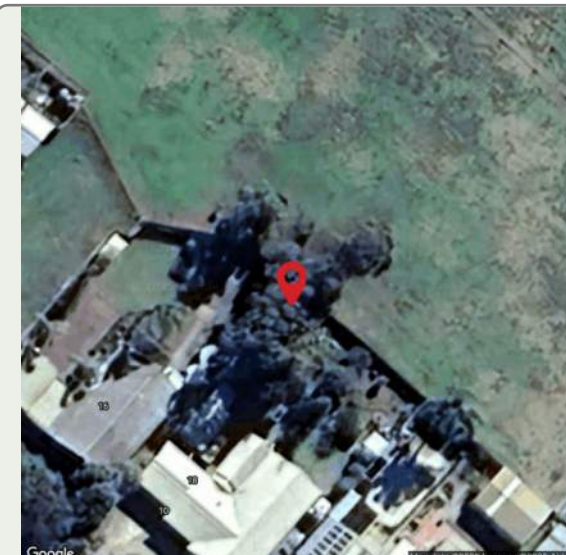
| PG Number | PGSA00009660 |

Mature Sa blue gum on property boundary. Exhibits good crown health. Crown encroachment over neighbouring property.  
Recommend pruning to reduce the western leader by half back to lower upright.

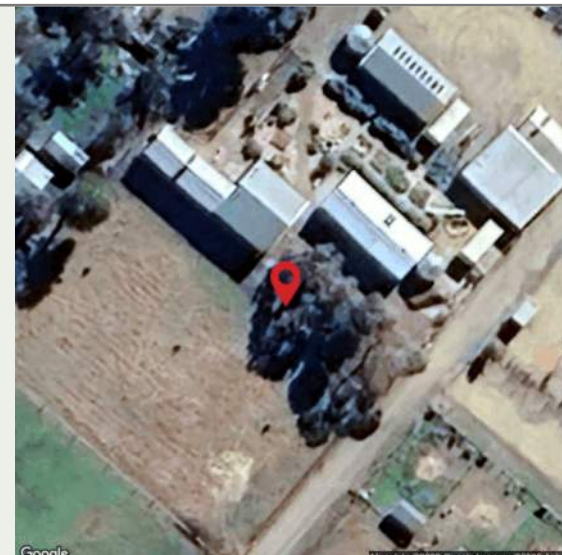
| PG Number | PGSA00009661 |

Recommend pruning tree to remove lateral over front of shed to collar.  
Presents good crown health. Co dominant stems from ground.

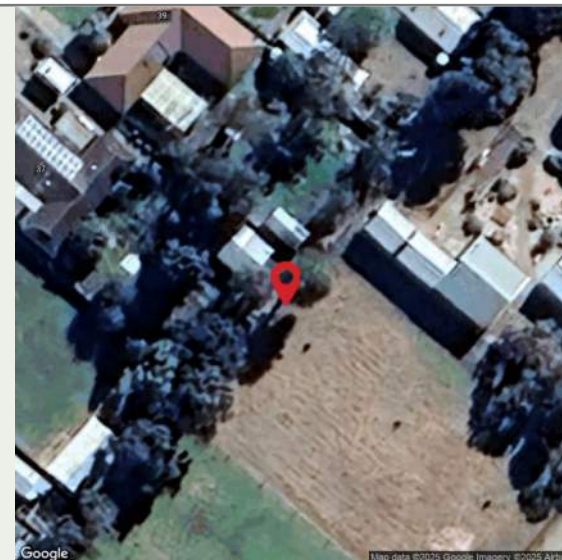
| PG Number | PGSA00009672 |

Trunk retained from removal with no Regrowth or sign of live cambium.  
Recommend remove to ground.

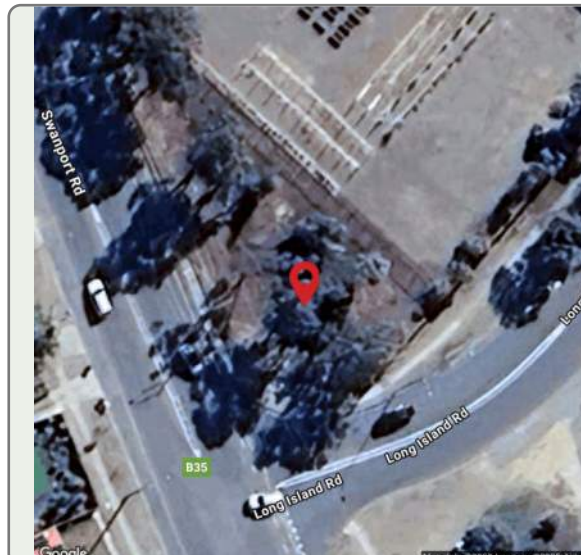
| PG Number | PGSA00009677 |

Recommend removal of the remaining co dominant stem. Stem is starting to fail from base and leaning into neighbouring trees. Splitting at bifurcation. Lower epicormic growth could be retained due to low use area.

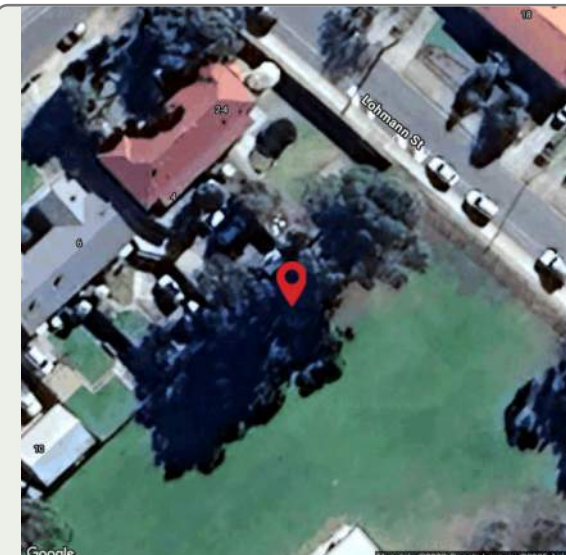
| PG Number | PGSA00009743 |

Recommend pruning tree to reduce the western lateral by 15%. Remove failed limb from crown and mulch larger failed limb by tree. Epicormic growth developing from reduction point of the reduced co dominant stem.

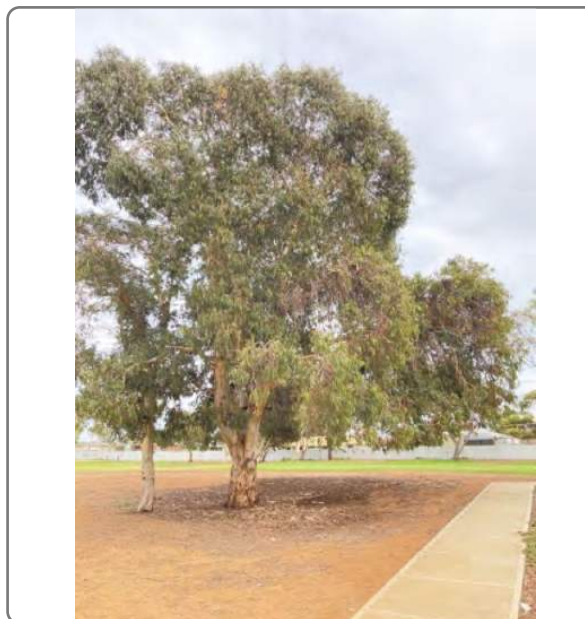
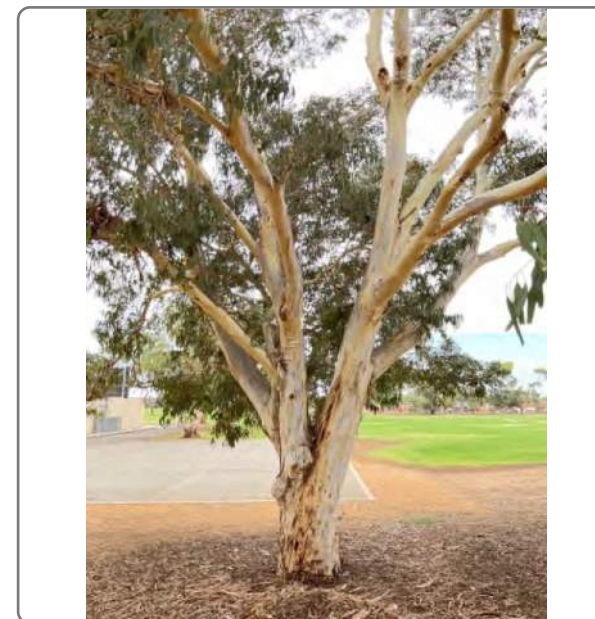
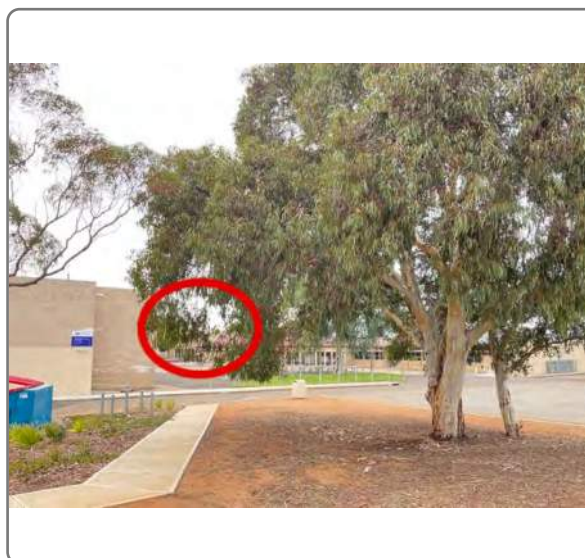
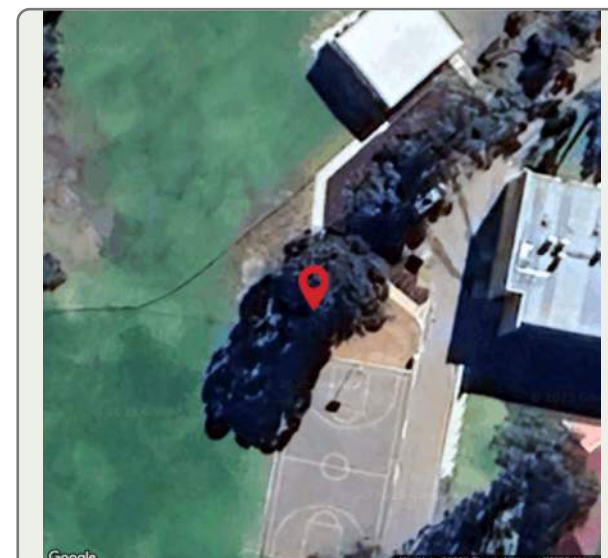
| PG Number | PGSA00009761 |

Recommend pruning tree to lift the lower crown over path. Tree exhibits good crown health. Bird damage noted to several unions through tree.

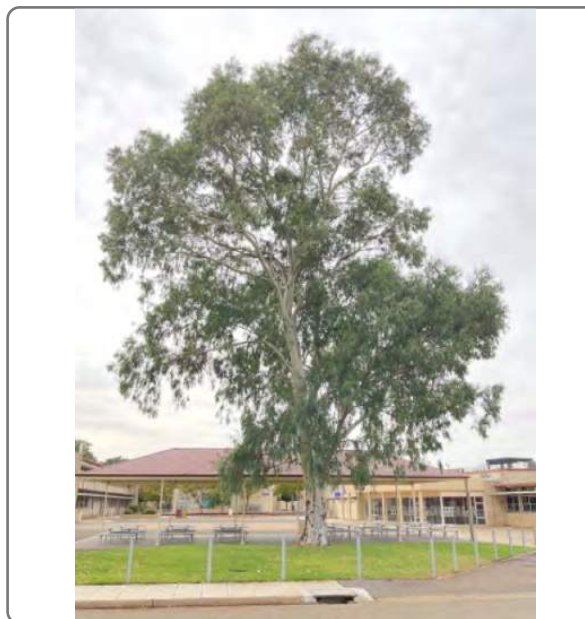
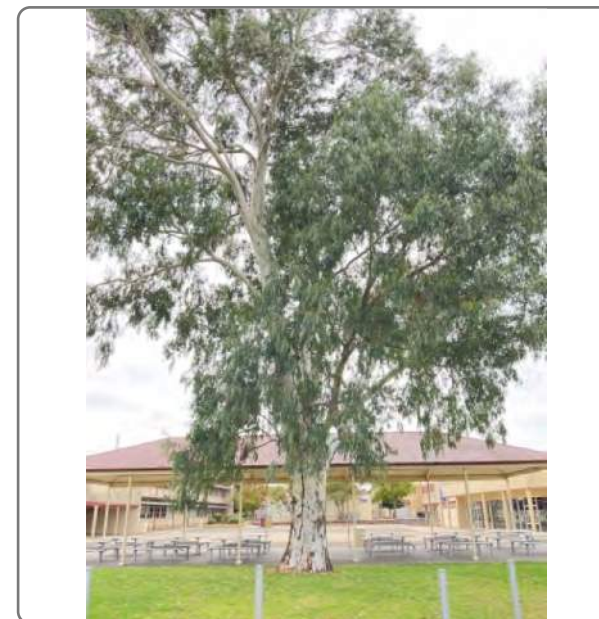
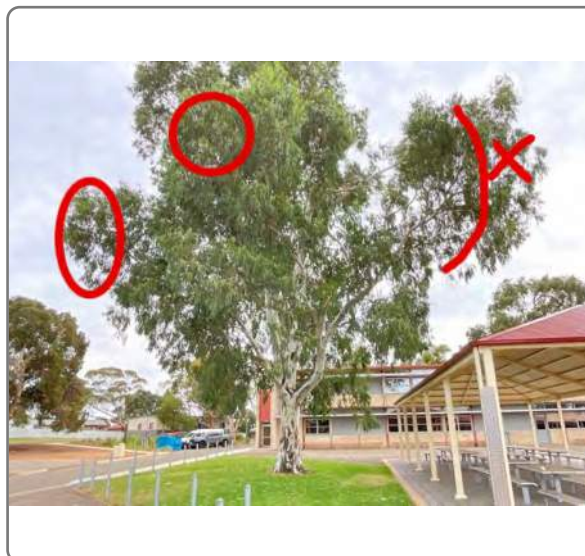
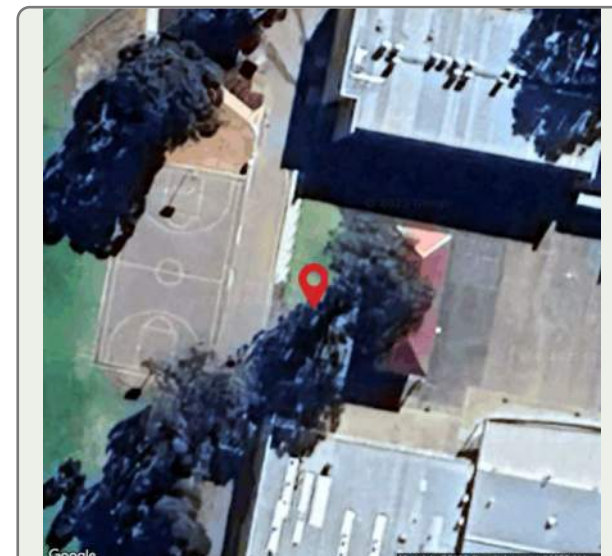
| PG Number | PGSA00009770 |

Recommend pruning to reduce the southern crown on lower leader over shelter shed. Reduce the western and northern extending limbs by 15% to lower growth points. Recent limb fail of the southern upper crown. Failures removed. Epicormic growth developing.

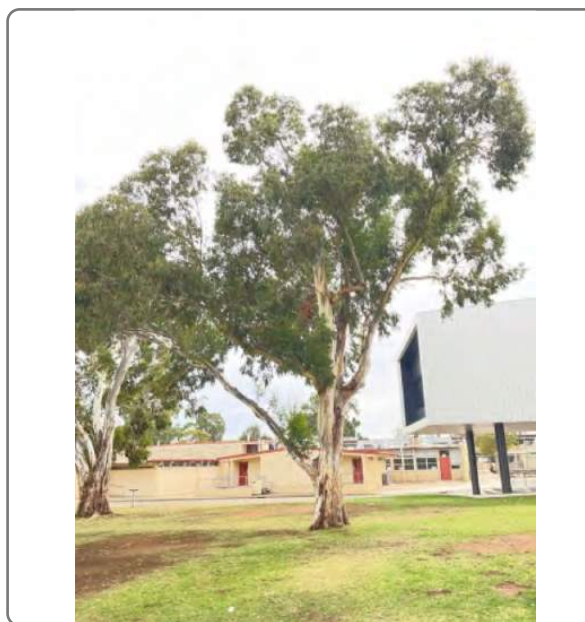
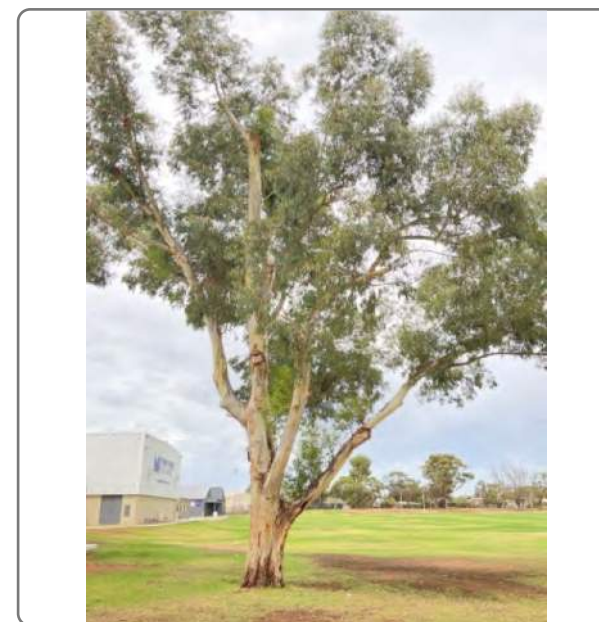
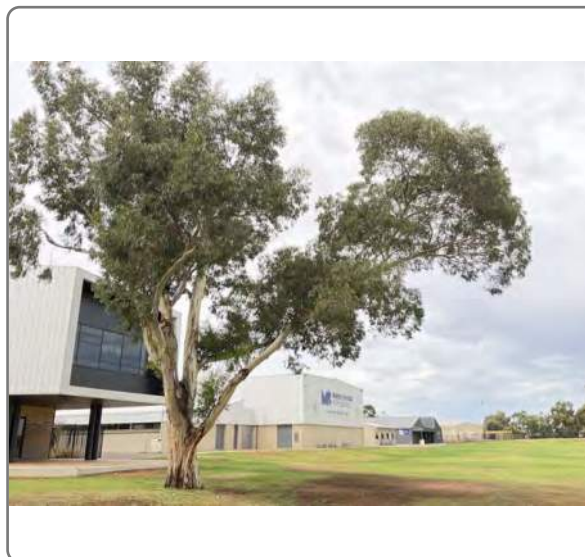
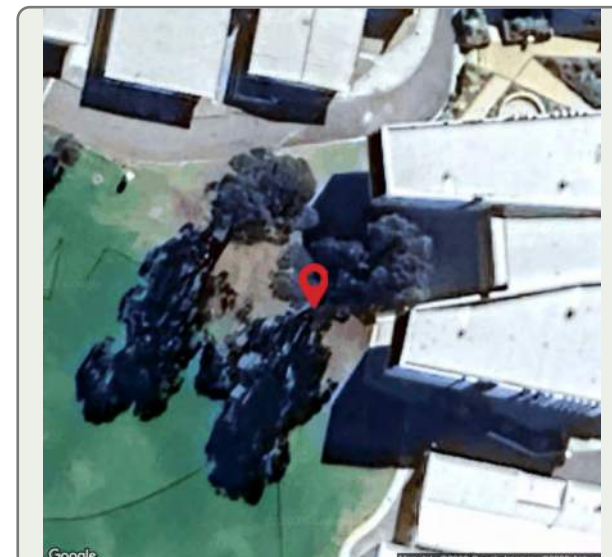
| PG Number | PGSA00009792 |

Recommend pruning tree to reduce crown on the northern scaffold limb by 15%.  
Limb not reduced in line with crown reduction and holds fair end weight.  
Southern laterals reduced adequately. Responding well to major crown reduction.

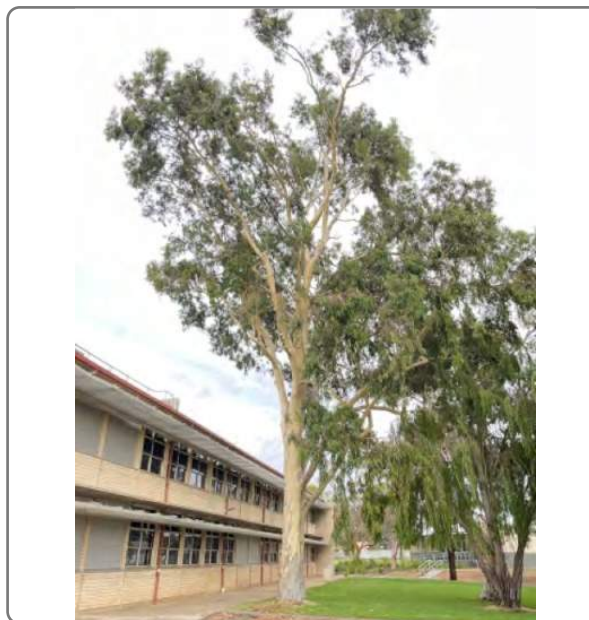
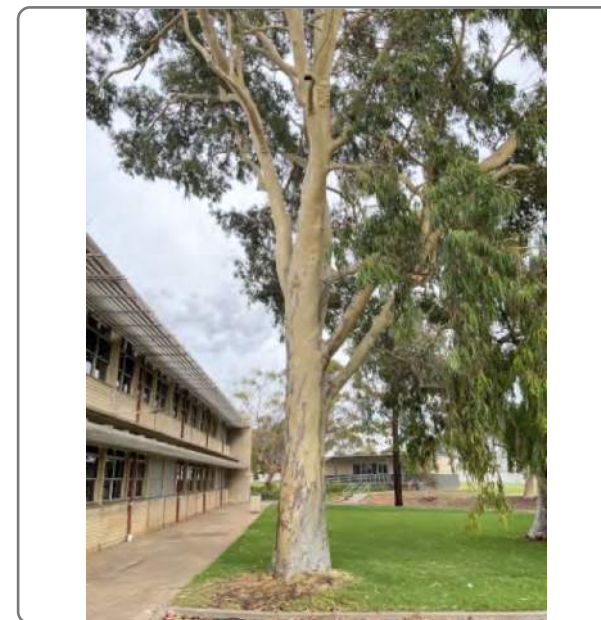
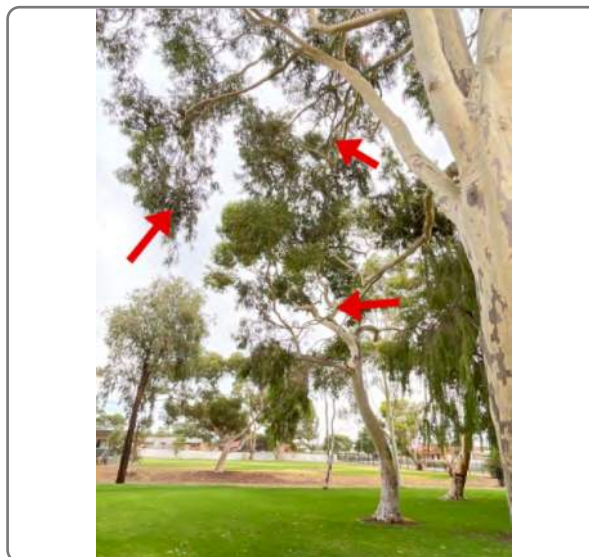
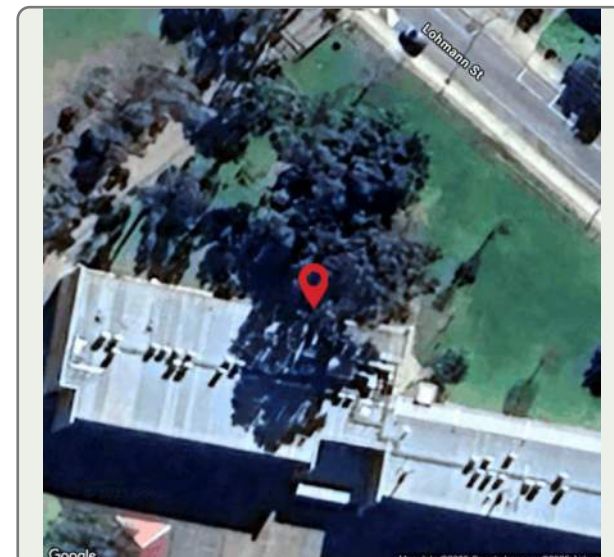
| PG Number | PGSA00009804 |

Large mature spotted gum by front building. Tree exhibits good crown health. Damage and failed limbs through upper crown from storm damage. Failures removed . Epicormic growth developing. Recommend pruning to reduce end weight from laterals to north over and resting in sugar gum.

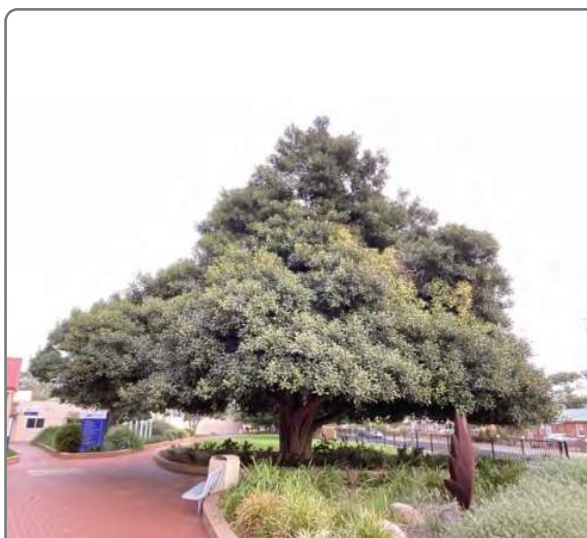
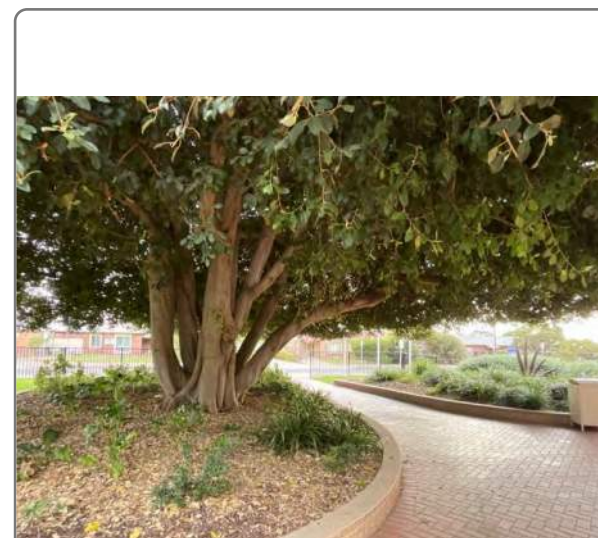
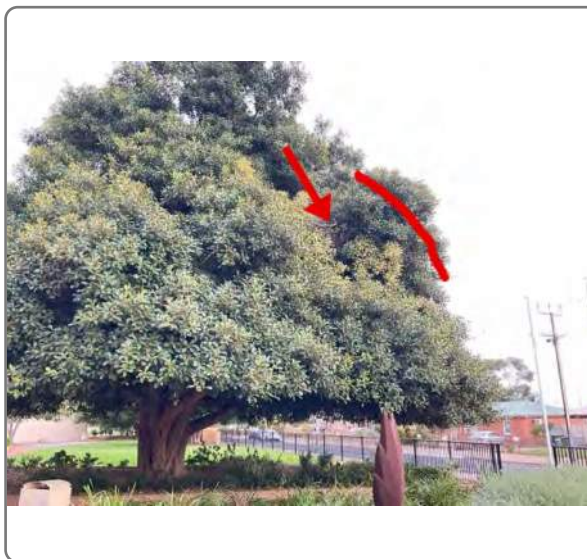
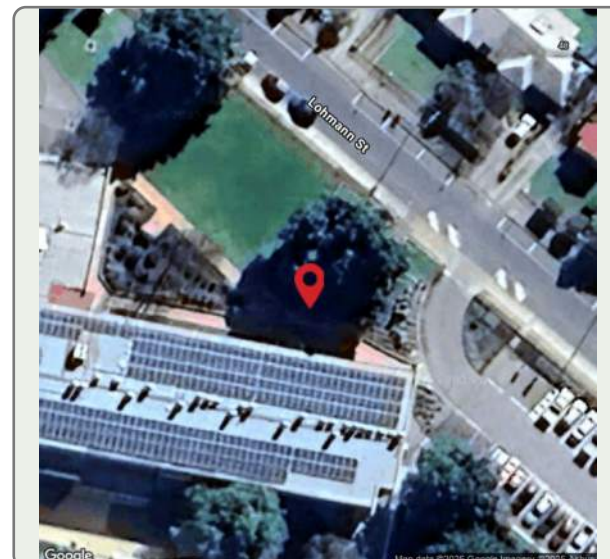
| PG Number | PGSA00014168 |

Mature fig tree front of administration building. Exhibits good crown health. Raised well over entrance and path ways. Several limb fails in mid to upper crown. Recommend pruning to remove all failed limbs in crown. Reduce crown weight from the eastern stem over gate entrance to administration by 15% and remove the larger failed section.
