# Arboricultural Impact Assessment and Development Impact Report

Site: Stirling Golf Club, 35 Golflinks Road, Stirling

Date: Tuesday, 6 December 2022

ATS6360-035GoIRdDIR R1

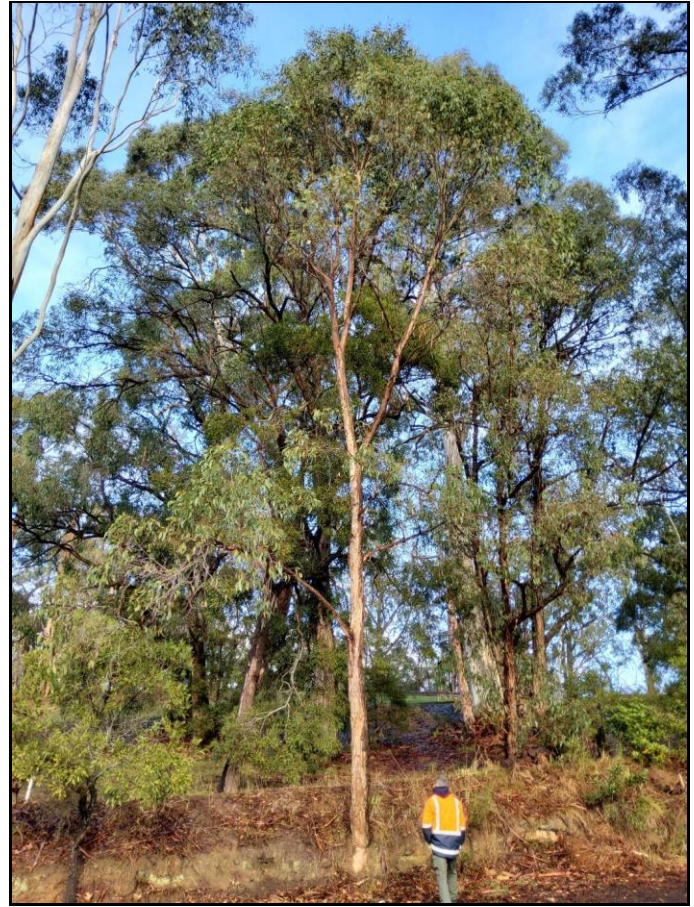
The health and structure of this tree indicate it is in good overall condition and has adapted to its local environment.

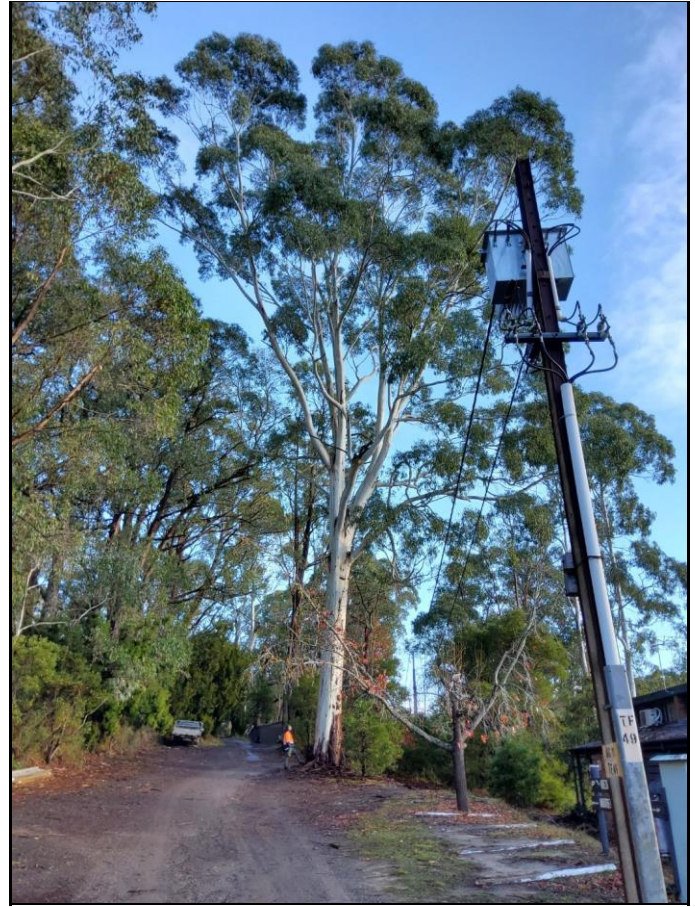
The health and structure of this tree indicate it is in good overall condition and has adapted to its local environment. This tree has a moderate history of small diameter branch failure.

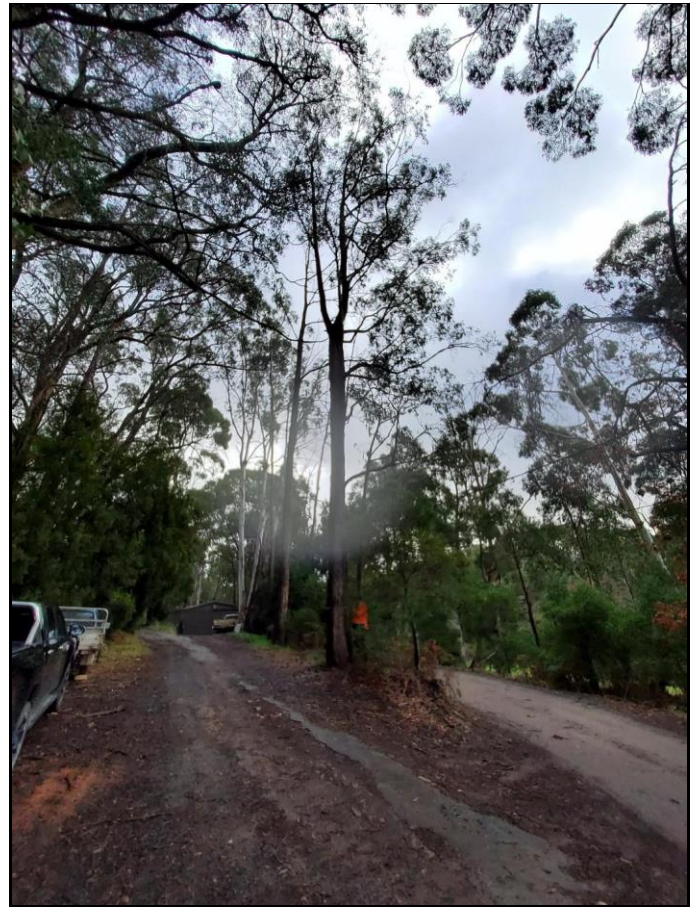
This tree is in poor overall condition as evidenced by the substantial volume of deadwood and the presence of stable included bark in the primary structure.

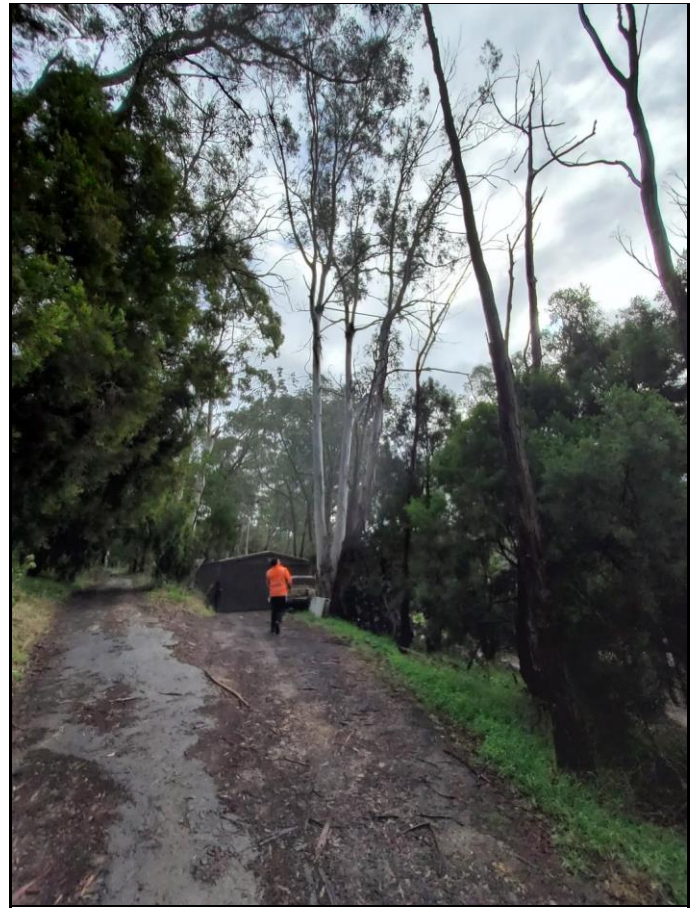
This tree is considered to be in poor overall condition due to the considerably reduced foliage density, with high levels of dieback and deadwood throughout the crown. There are a number of relatively poorly installed cables in the mid-crown of this tree between the codominant stems, these are restricting sap flow and may be a factor in the reduced crown condition.

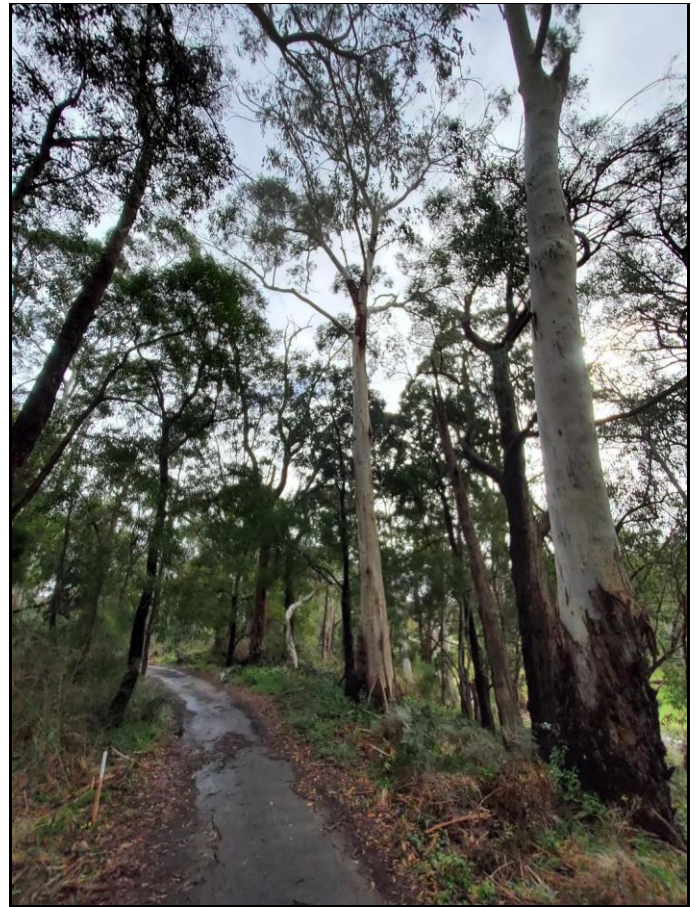
This tree is in poor overall condition as evidenced by the substantial levels of deadwood, branch failure and decay throughout the tree. There is a significant level of decay in the primary trunk union.
