Appendix P3 –  
Recommended Road  
Safety Policies and  
Practices – CASR

## Recommended road safety policies and practices for Kangaroo Island Plantation Timbers

Photos Showing Very High Risk (P1) and  
Selected High Risk (P2) Sites

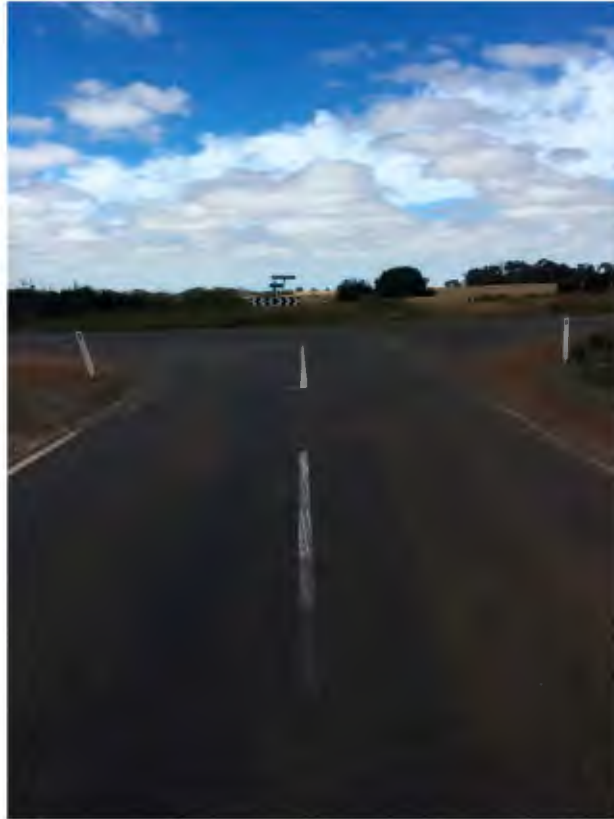
**Photo No. 1 – Item 1, junction of Playford Highway and Stokes Bay Road.**

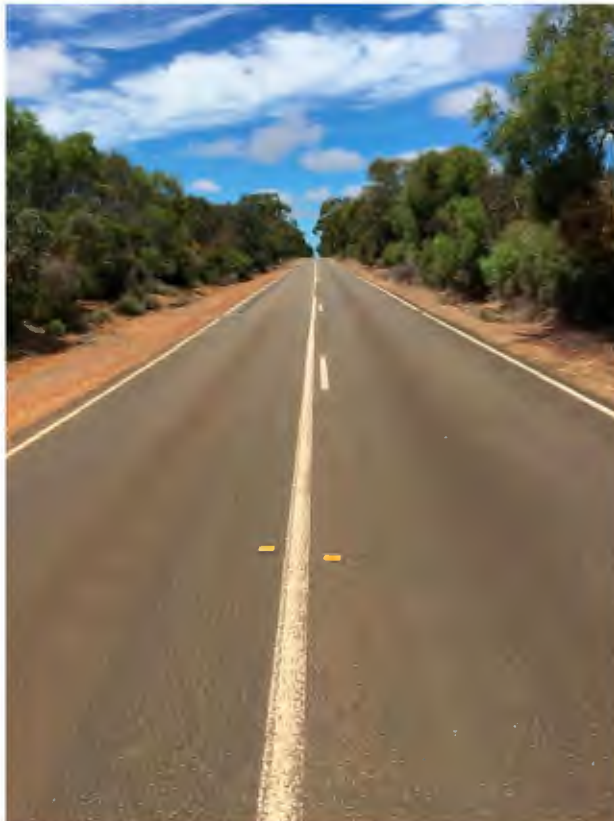
Item	Audit Findings	Risk Assessment	Recommendations	Cost/ Residual Risk
2.	<p>Table 3 in the PBS Guidelines indicates that for a L2 vehicle on a road with an AADT of between 150 and 500 vehicles (Stokes Bay Road has an AADT of 150 vehicles), 2.8m lanes are required and 1.0m shoulders for straight sections. The shoulder width requirement includes sealed and unsealed portions. It is strongly recommended that a 0.5m sealed shoulder is provided in line with Austroads guidelines.</p> <p>There is a short section along Stokes Bay Road from Ch 0.0 to 1.5 where the seal width is between 6.4m and 6.3m. This is below the required 6.6m.</p> <p>Along the rest of the road, the required seal width is met but the lane widths are generally 3m plus, meaning insufficient sealed shoulder is provided.</p> <p>See Photo No. 2.</p>	<p><b>Possibility</b> Unusual but Possible</p> <p><b>Exposure</b> Frequent</p> <p><b>Consequences</b> Very Serious</p> <p><b>Risk Score</b> P2</p>	<p>Shoulder sealing is required for the initial 1.5km section of road to bring the width up to the required seal.</p> <p>Consideration should be given to re-linemarking the reminder of the road to provide consistent lane width and shoulder widths.</p>	<p>\$25,000</p> <p>Residual Risk P4</p> <p>0.2m x 1.5km = 300m<sup>2</sup> shoulder sealing</p>

**Photo No. 2 – Item 2, typical cross-section of Stokes Bay Road.**

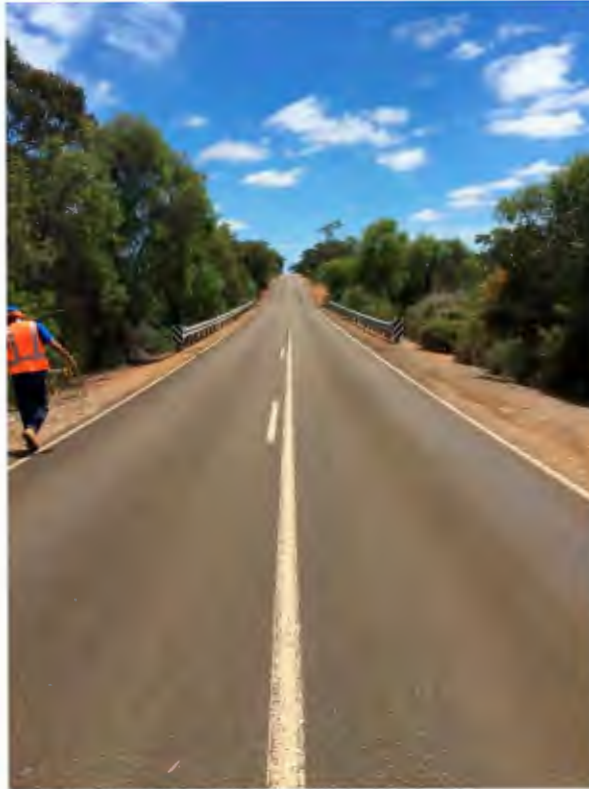
**Photo No. 3 – Item 3, guardfence protecting culverts on Stokes Bay Road.**

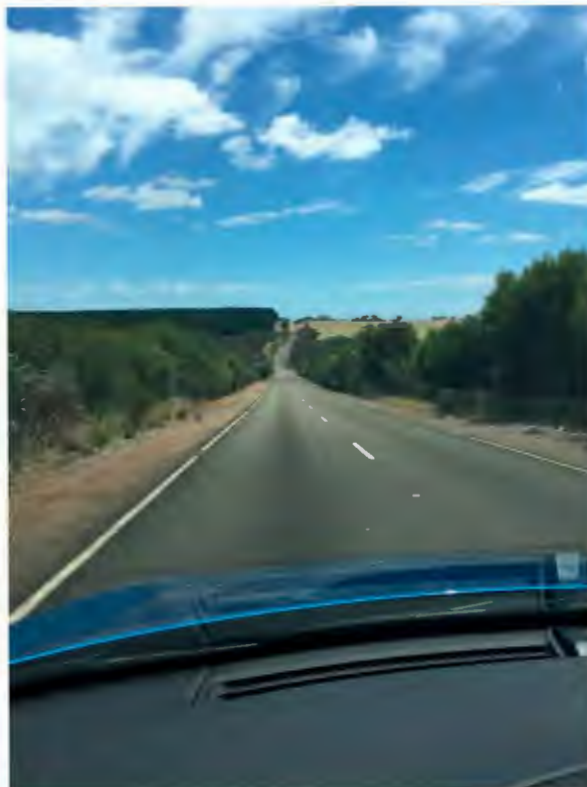
Item	Audit Findings	Risk Assessment	Recommendations	Cost/ Residual Risk
4.	<p>Ch 5.1 there is a large slope and tight vertical curve. There is warning signs and the slope is posted at 6%. The downhill section is approximately 400m long. There is a culvert at the bottom with only 8m between the guardfence. The culvert is 3m deep and there are steep batters either side of the culvert.</p> <p>The vertical curve is very tight and it is unclear if PBS L2B vehicles will be able to undertake the curve at speed.</p> <p>See Photo No. 4 and 5.</p>	<p><b>Possibility</b> Likely <b>Exposure</b> Rare <b>Consequences</b> Fatality <b>Risk Score</b> P2</p>	<p>Consideration should be given to improving the vertical alignment of this section of road. The gradient should be lowered or additional lanes added to allow for heavy vehicles to use low gears.</p> <p>A trial run may be required to see if the vertical curve at the bottom can handle PBS Level 2B vehicles.</p>	<p>\$250,000 Residual Risk P3</p>

**Photo No. 4 – Item 4, steep down grade on Stokes Bay Road.**

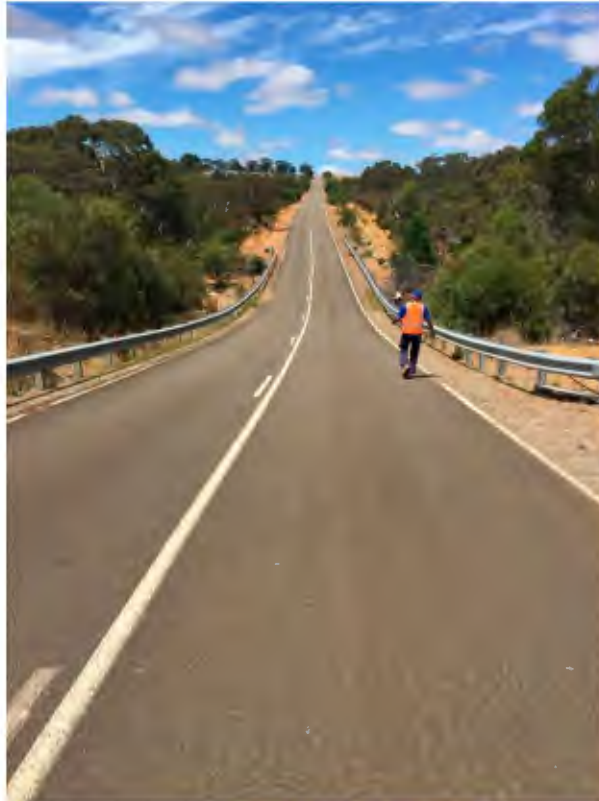
**Photo No. 5 – Item 4, guardfence protecting the culvert, the dip is very tight.**

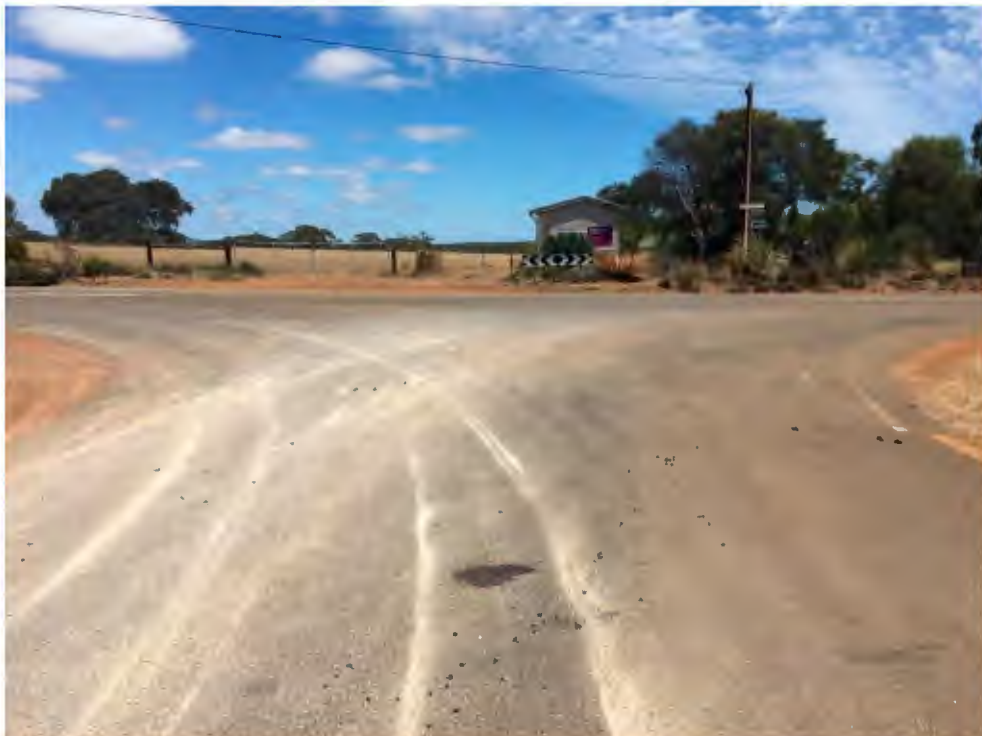
**Photo No. 6 – Item 10, junction of Stokes Bay Road and Bark Hut Road.**

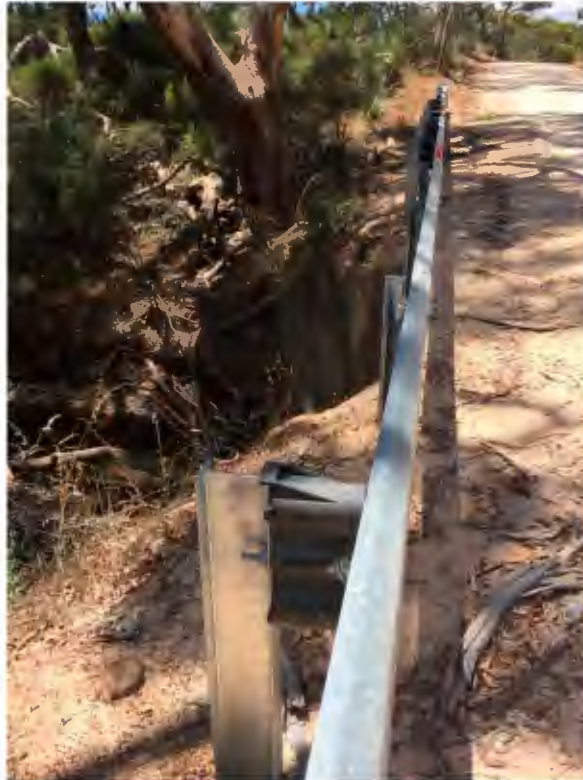
Item	Audit Findings	Risk Assessment	Recommendations	Cost/ Residual Risk
12.	At Ch 0.6 there is a steep gradient downhill to a culvert, where there is 8.6m between the guardfence protecting the culvert. The guardfence is low and the 4m deep culvert headwall is located just behind it. See Photo No. 7.	<b>Possibility</b> Likely <b>Exposure</b> Frequent <b>Consequences</b> Serious <b>Risk Score</b> P2	The culvert should be extended so the headwalls are outside of the clear zone.  If this is not to be improved, the height of the guardfence should be checked for standard vehicles.	\$50,000  Residual Risk P3

**Photo No. 7 – Item 12, guardfence protecting a deep culvert close to the carriageway.**

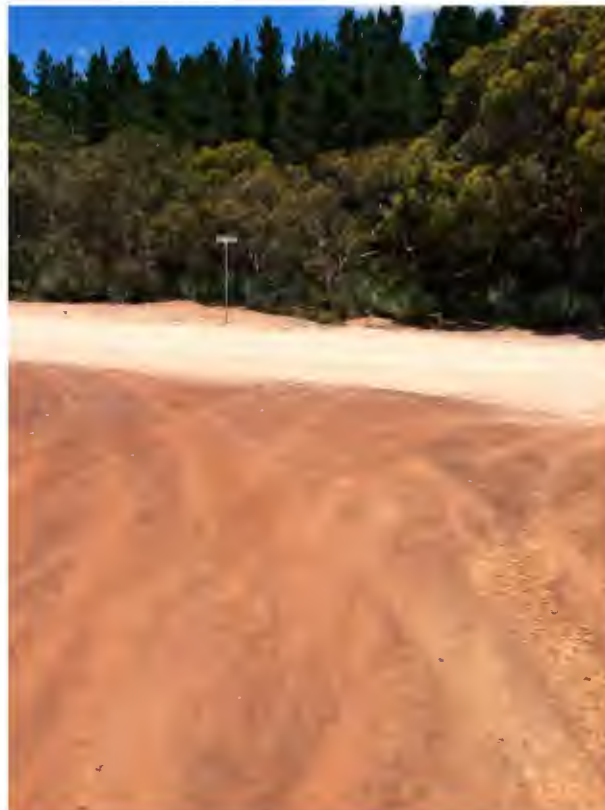
**Photo No. 8 – Item 19, junction of Bark Hut Road and McBrides Road.**

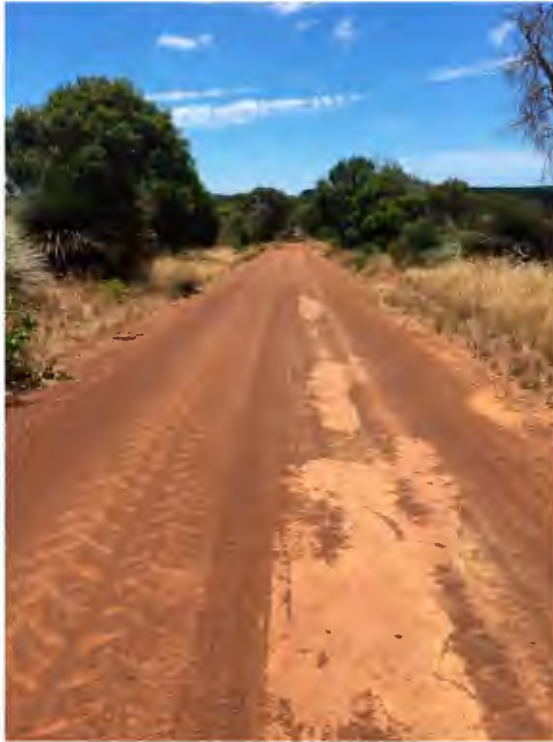
**Photo No. 9 – Item 20, typical cross-section of McBrides Road.**

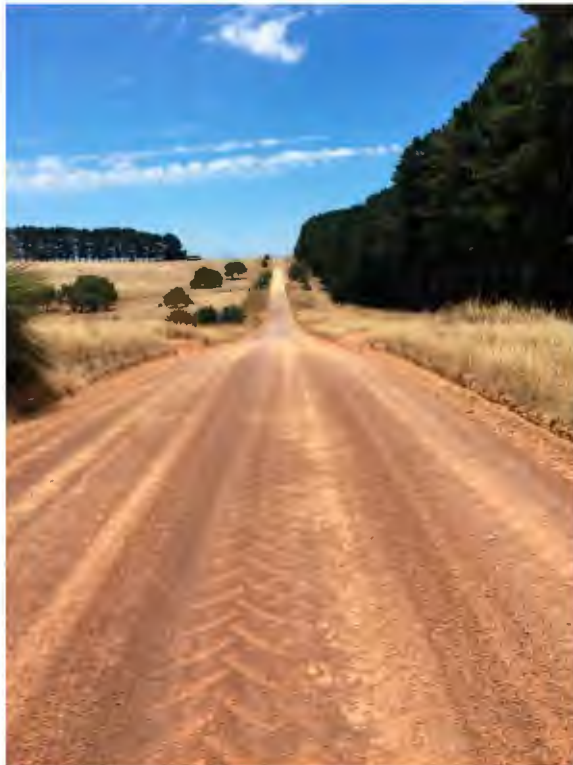
**Photo No. 10 – Item 22, vertical alignment on McBrides Road.**

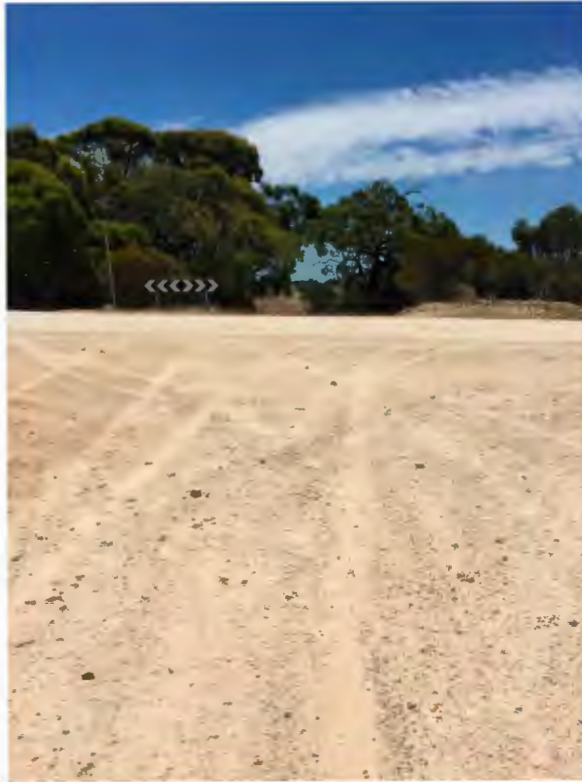
**Photo No. 11 – Item 27, junction of McBrides Road and North Coast Road.**

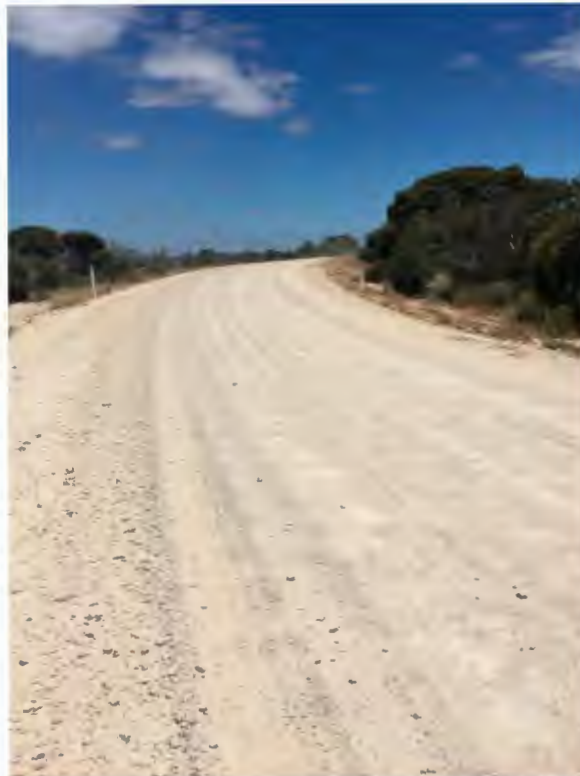
**Photo No. 12 – Item 28, typical cross-section of North Coast Road.**

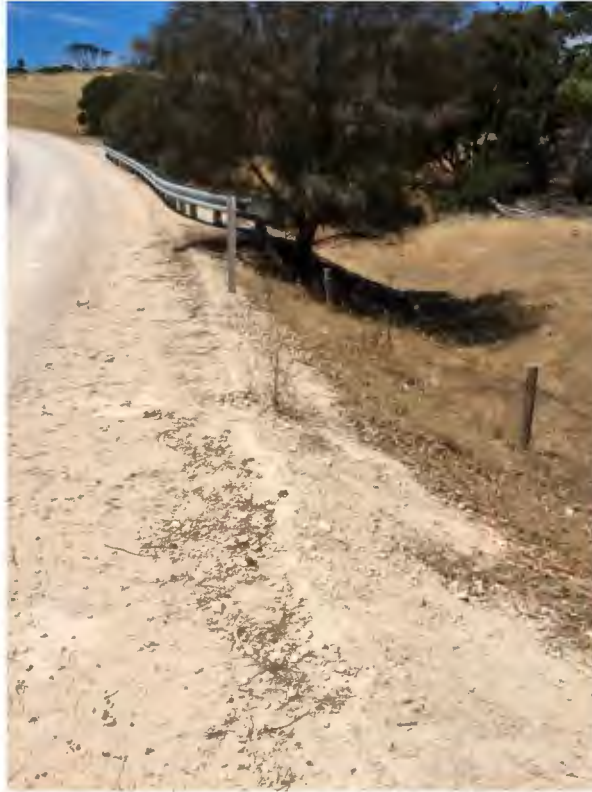
**Photo No. 13 – Item 43, guardfence protecting a culvert, batter slope not covered.**

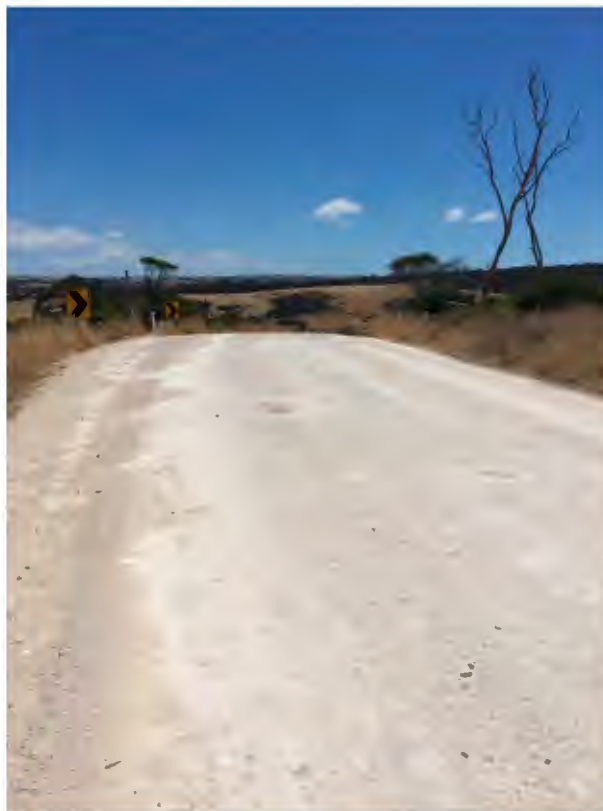
**Photo No. 14 – Item 44, tight horizontal curve on North Coast Road.**

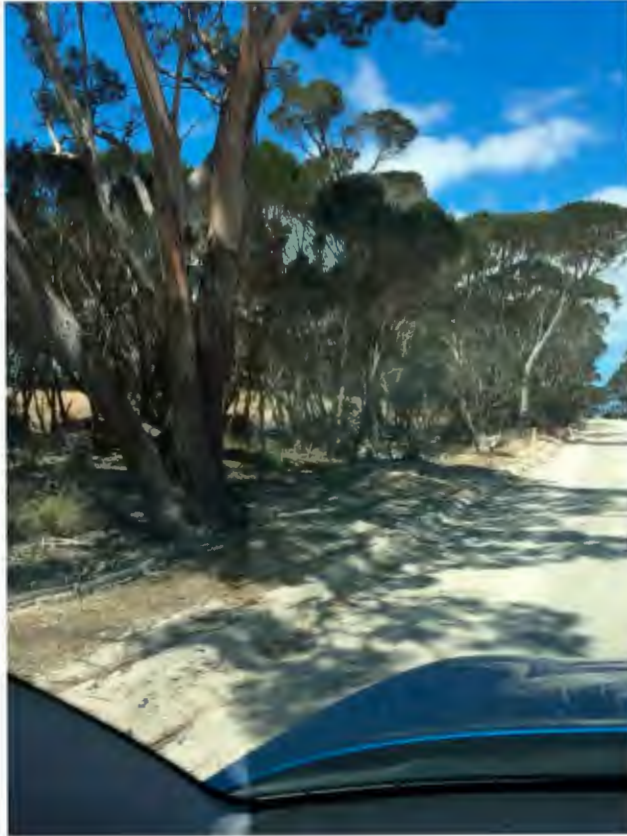
**Photo No. 15 – Item 51, large tree located on the edge of North Coast Road.**

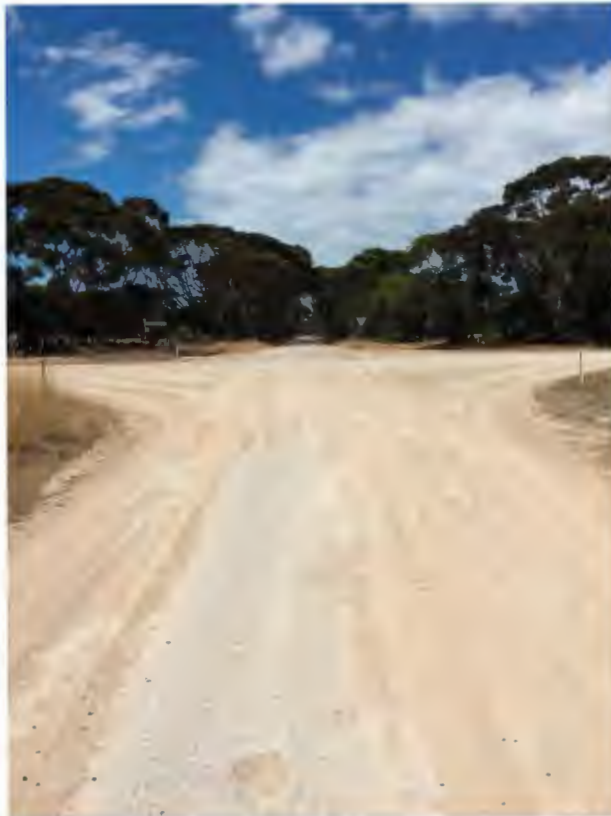
**Photo No. 16 – Item 54, Junction North Coast Road and Gap Road.**

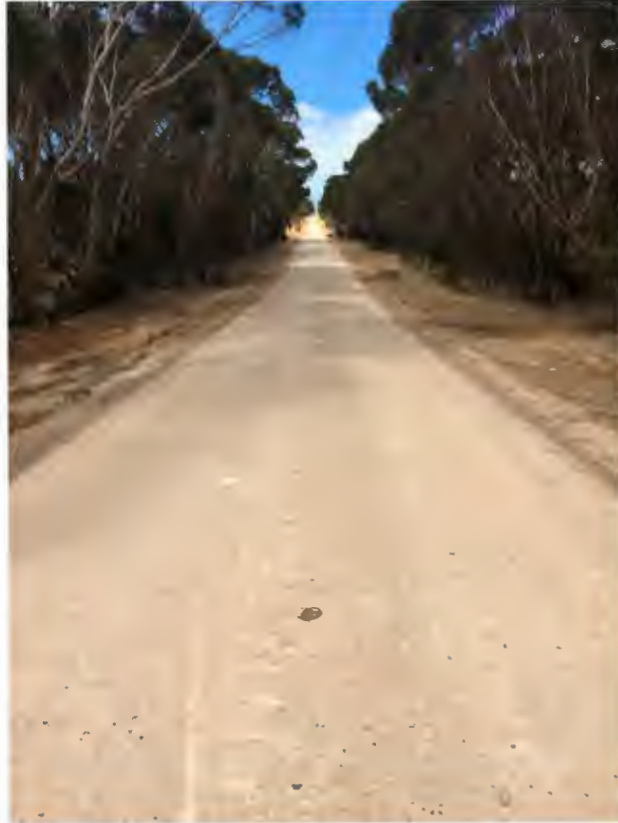
**Photo No. 17 – Item 55, insufficient road with on Gap Road.**

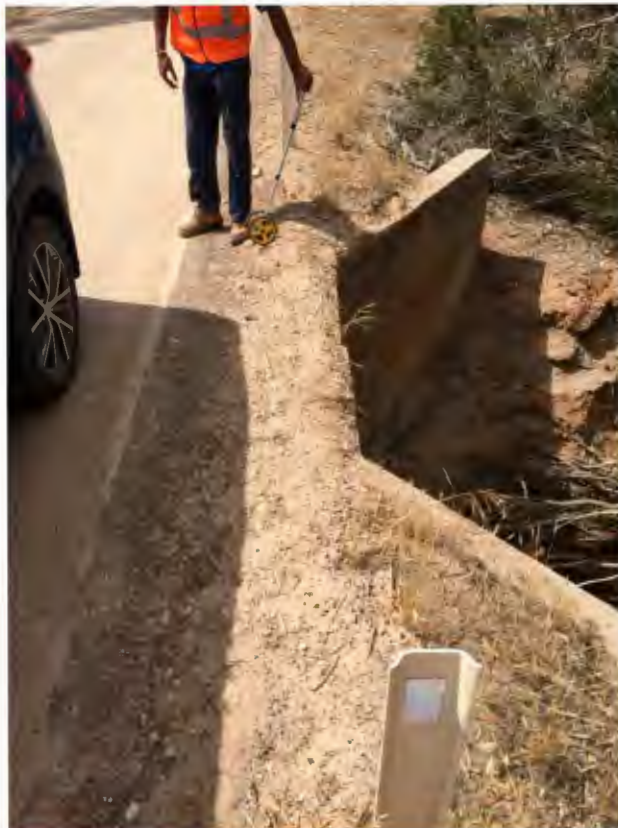
**Photo No. 18 – Item 59, culvert on Gap Road.**

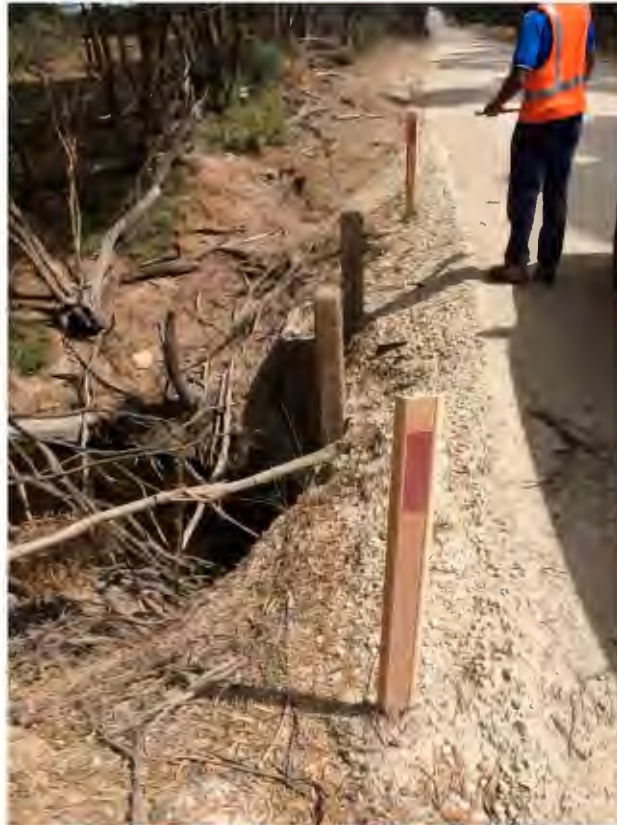
**Photo No. 19 – Item 61, large culvert on Gap Road.**

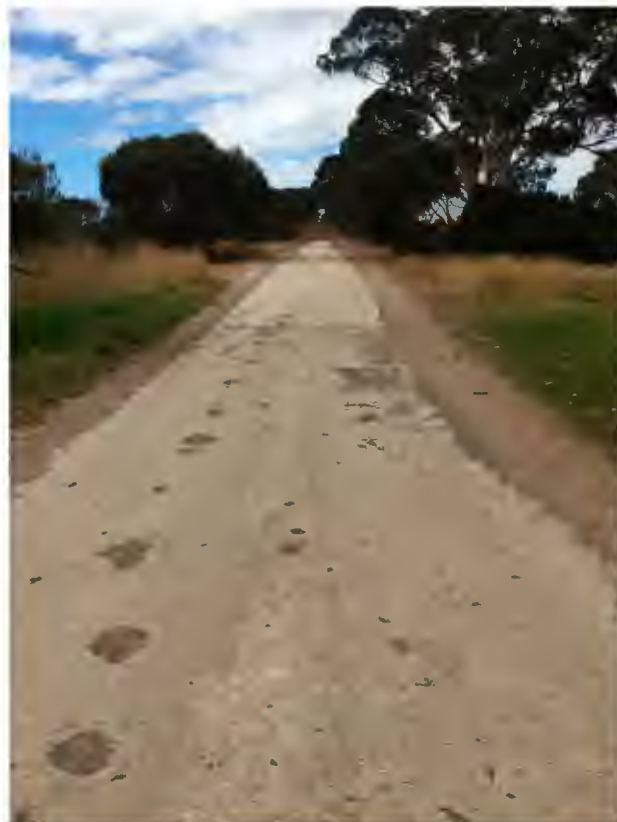
**Photo No. 20 – Item 68, insufficient road width on Ropers Road.**

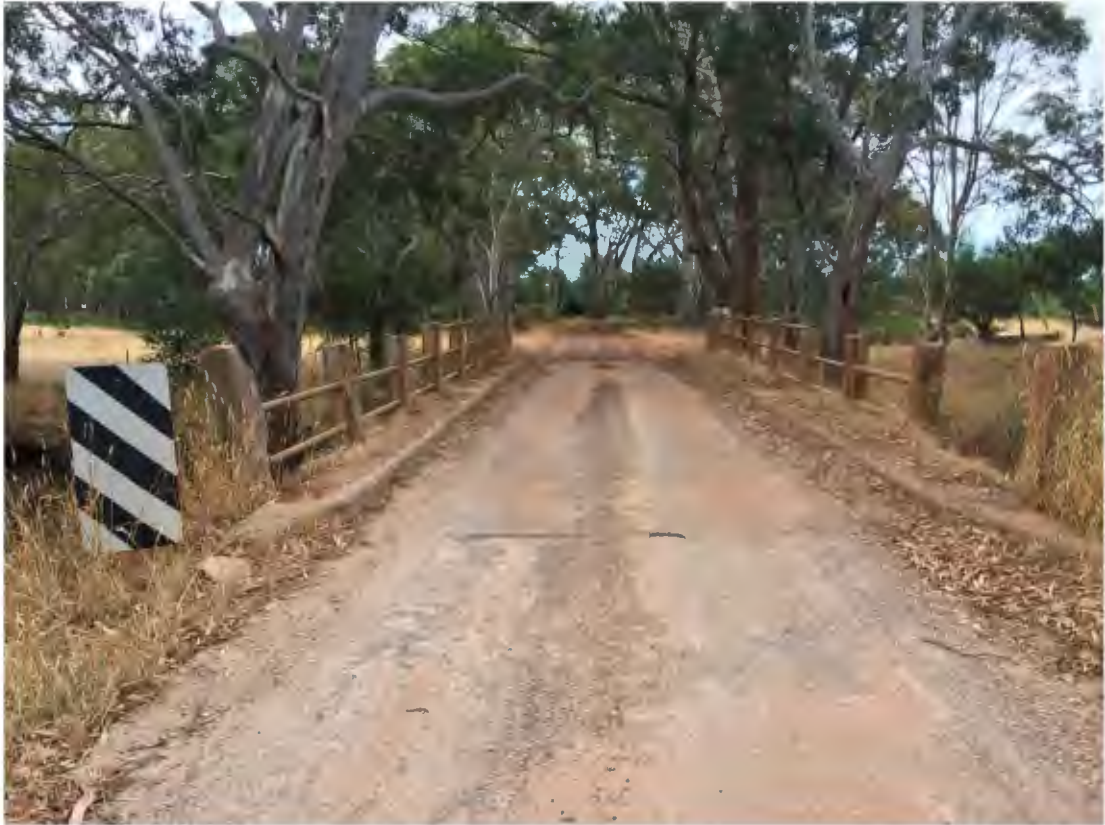
**Photo No. 21 – Item 69, single lane bridge on Ropers Road.**

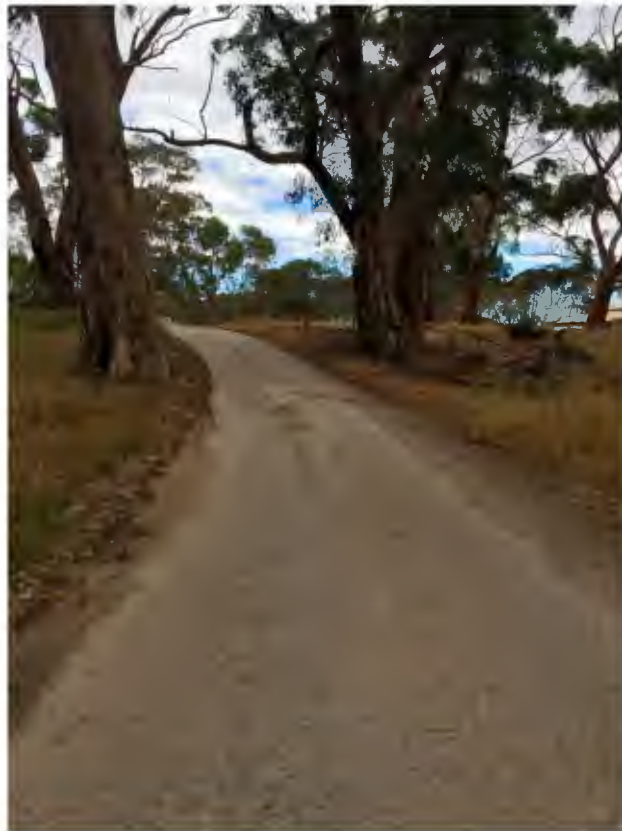
**Photo No. 22 – Item 70 and 72, tight curve and close trees on Ropers Road.**

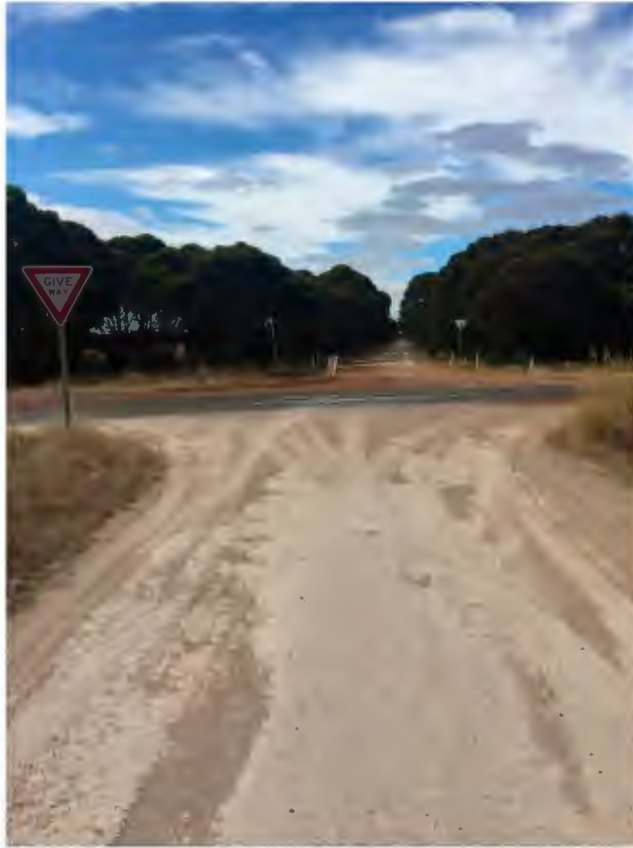
**Photo No. 23 – Item 74, junction of Playford Highway and Ropers Road.**

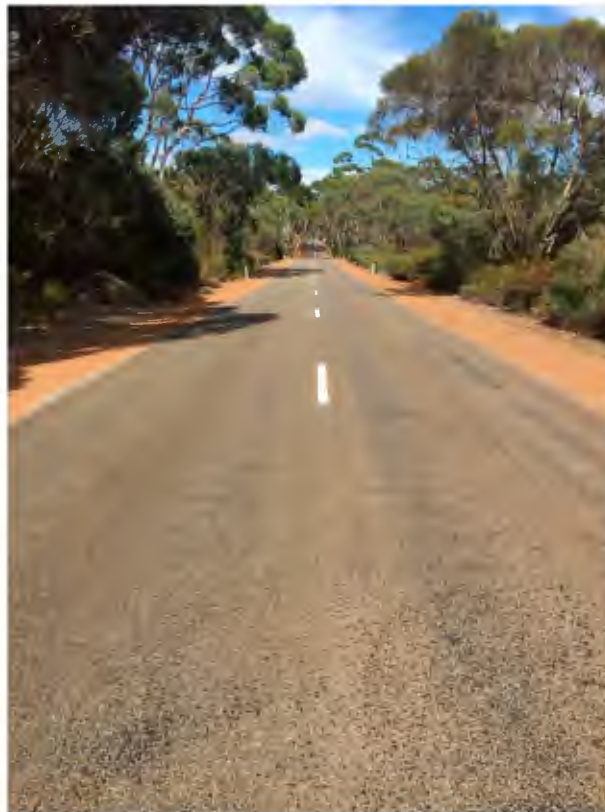
**Photo No. 24 – Item 75, Playford Highway typical cross-section.**

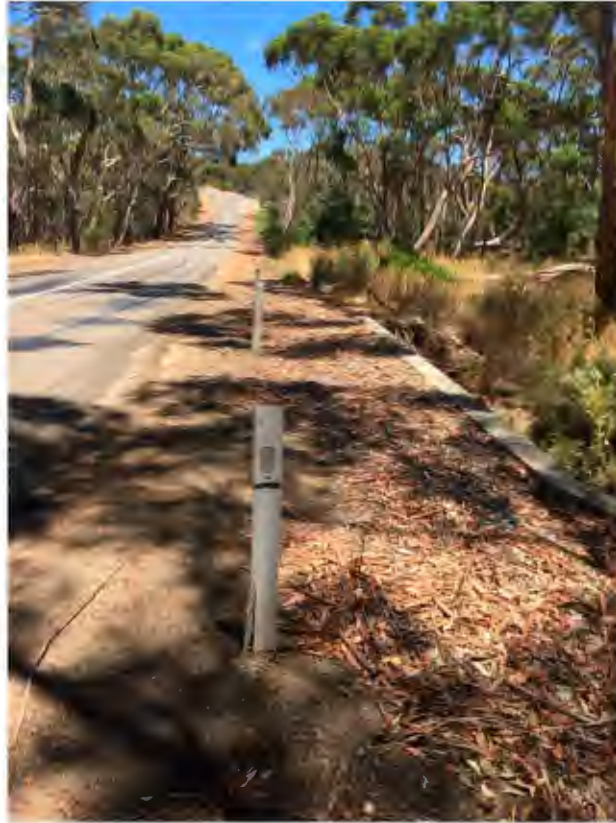
**Photo No. 25 – Item 77, large culvert at the bottom of the downgrade on Playford Highway.**

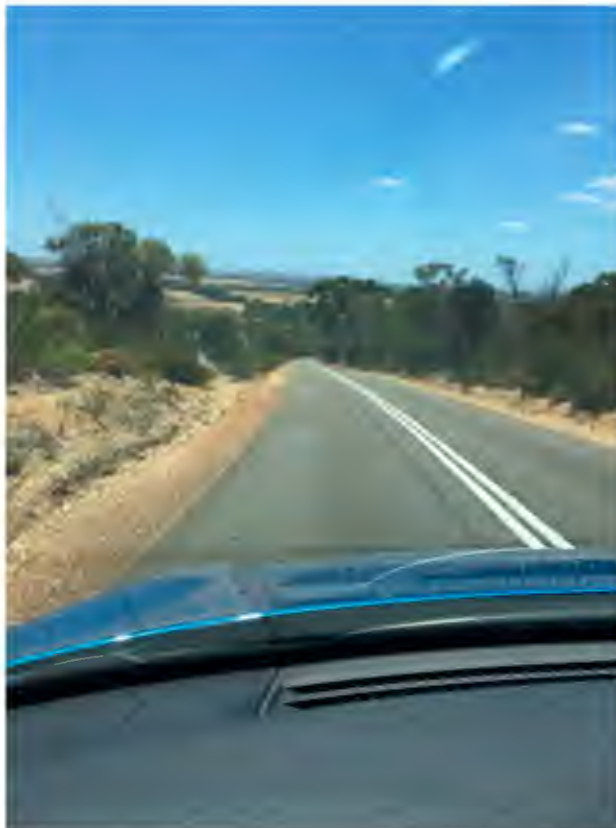
**Photo No. 26 – Item 78, steep downgrade on Playford Highway.**

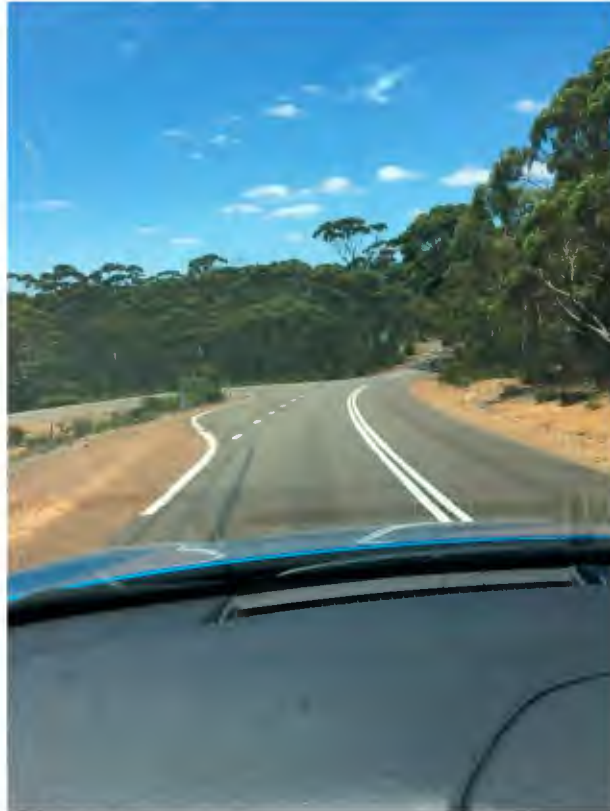
**Photo No. 27 – Item 78, the junction and horizontal curve on the downgrade.**

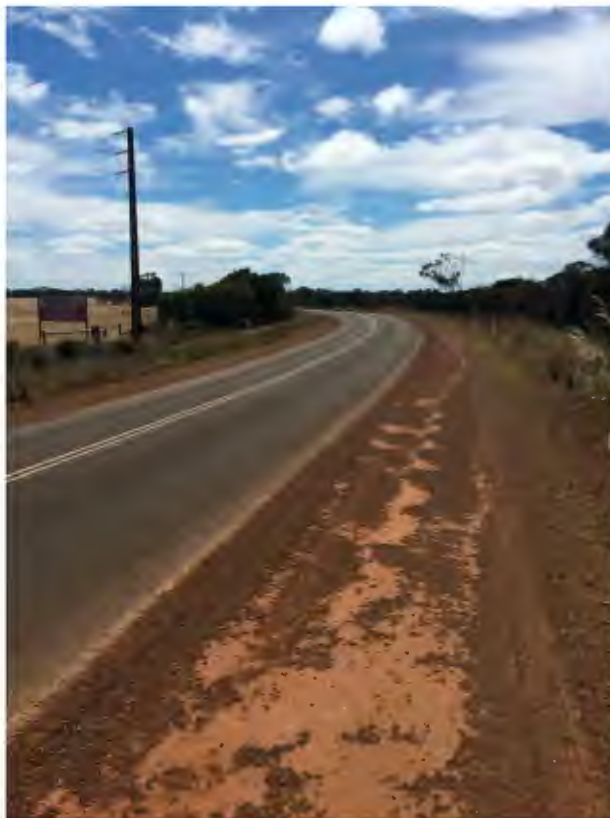
**Photo No. 28 – Item 86, typical cross-section of Playford Highway.**

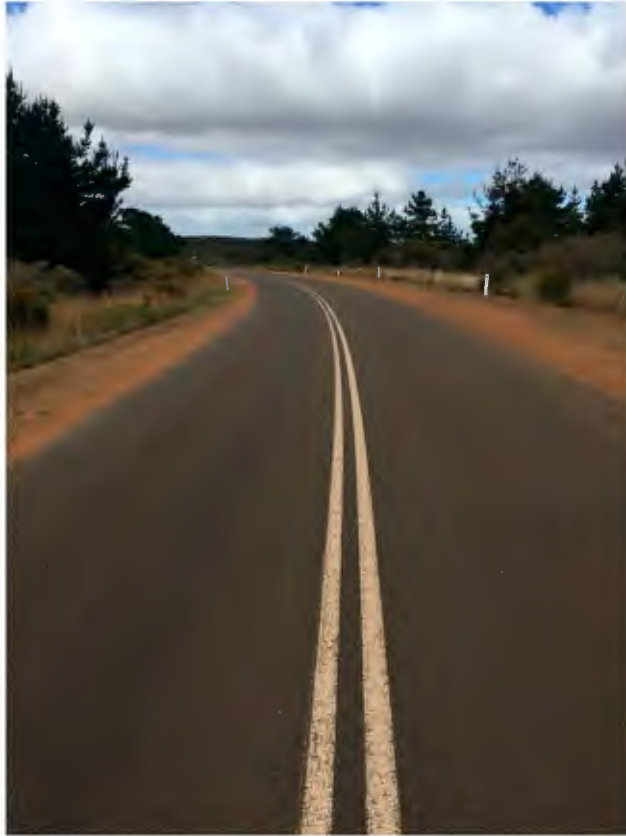
**Photo No. 29 – Item 90, typical cross-section on Playford Highway.**

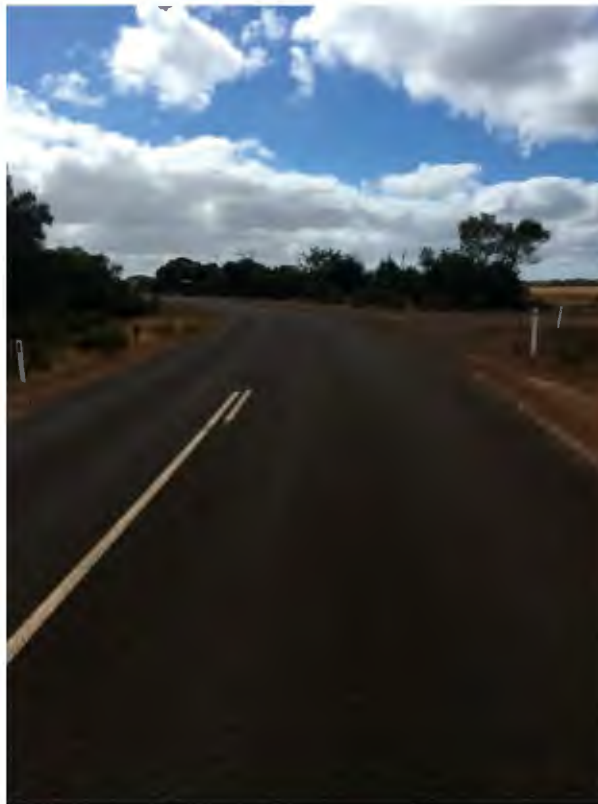
**Photo No. 30 – Item 100, junction of Playford Highway and Mount Taylor Road.**

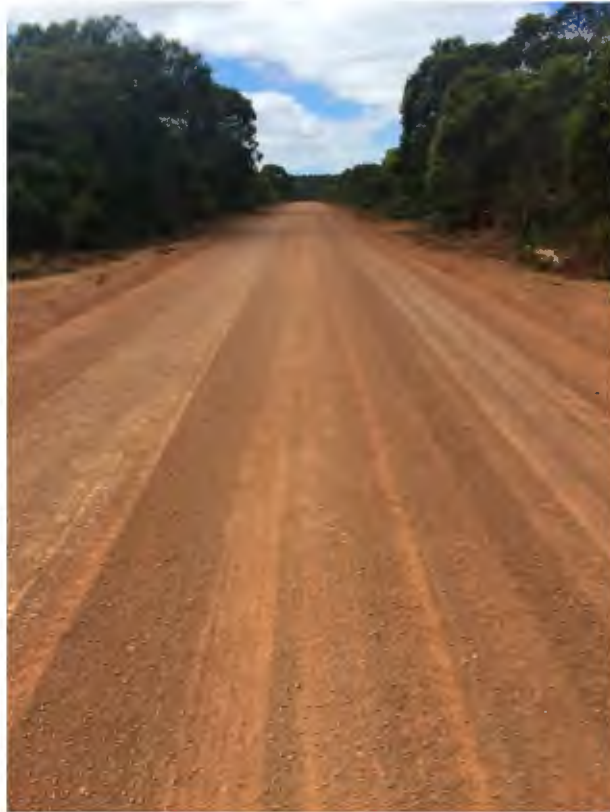
**Photo No. 31 – Item 101, typical cross-section on Mount Taylor Road.**

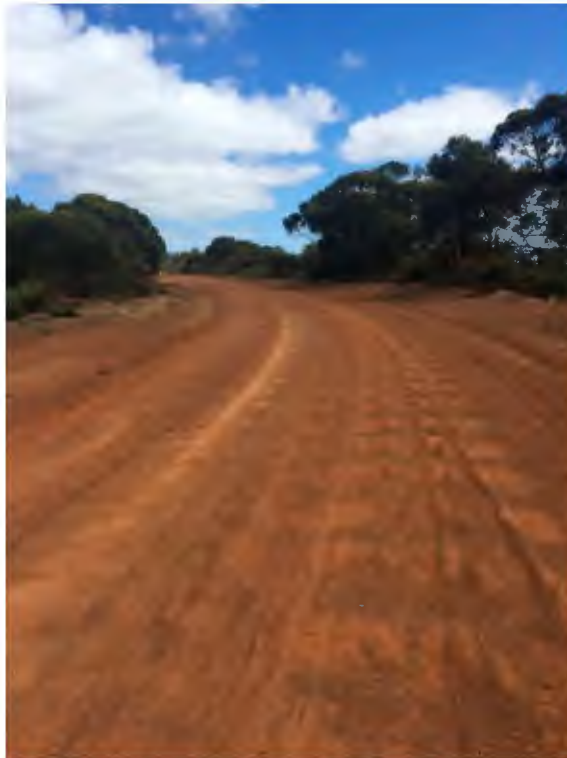
**Photo No. 32 – Item 104, corrugations and tight horizontal curve.**

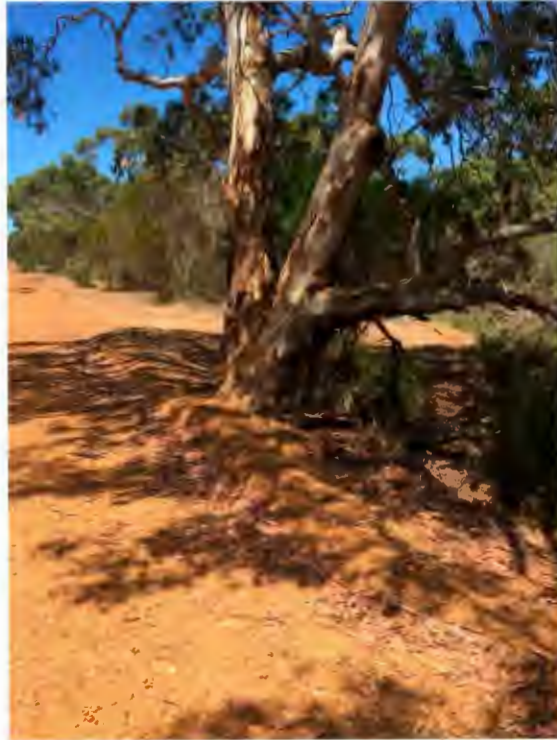
**Photo No. 32 – Item 107, tree on the edge of the carriageway.**
