Preliminary Site Investigation

Lot 104 and Lot 105 Port Elliot Road, South Australia

PROJECT NAME: Preliminary Site Investigation – Middleton SA

DOCUMENT CONTROL NUMBER 0237_LEW_RPT001A

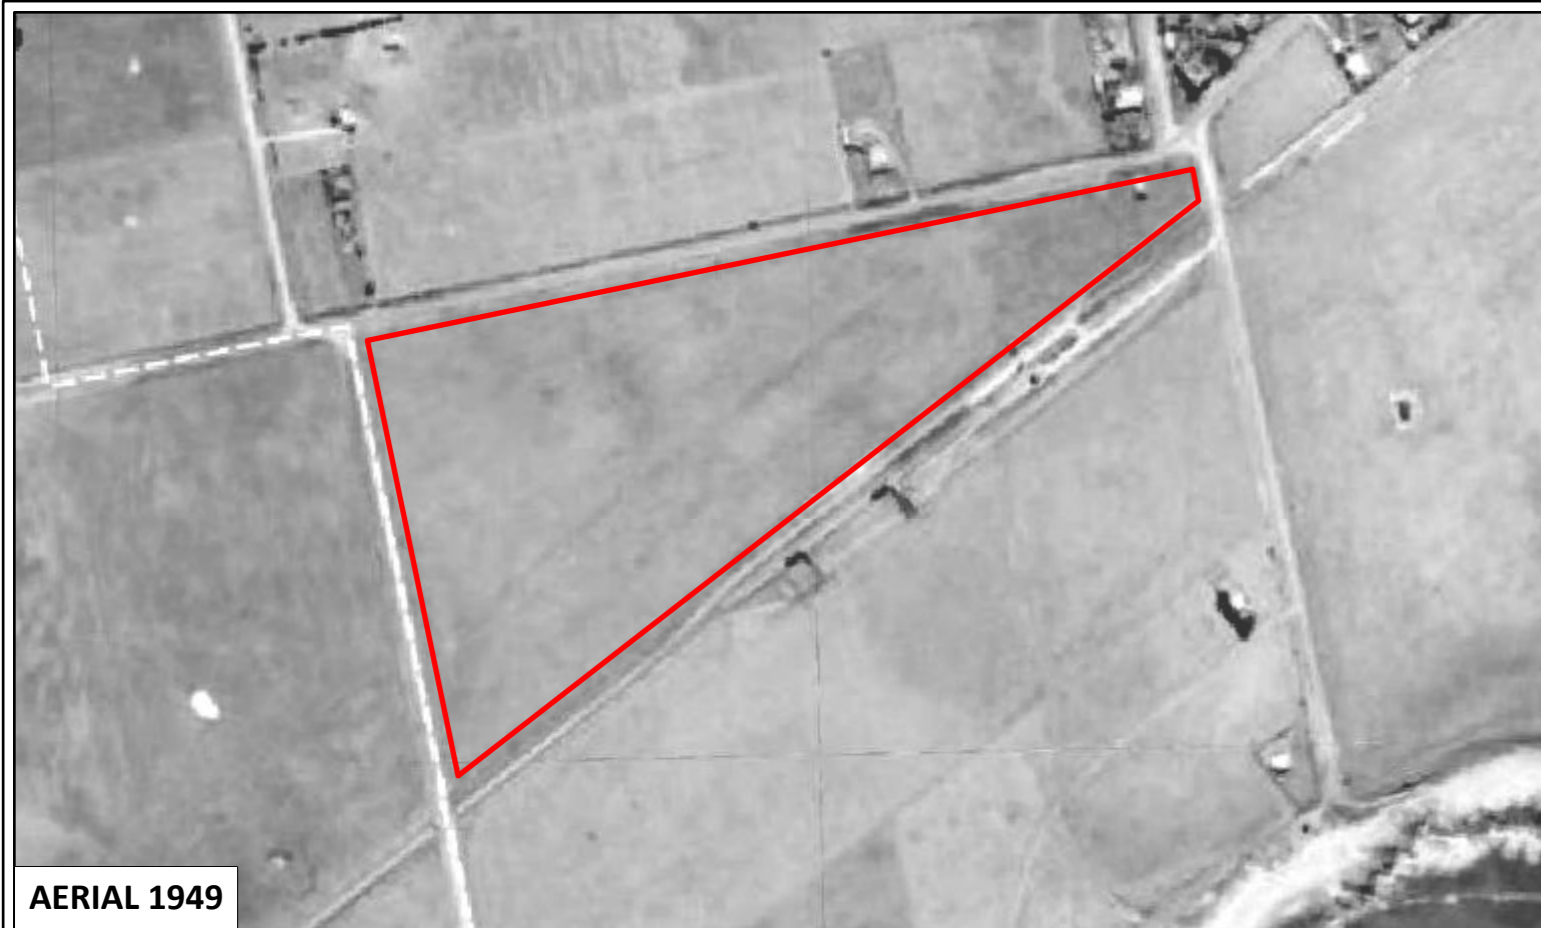
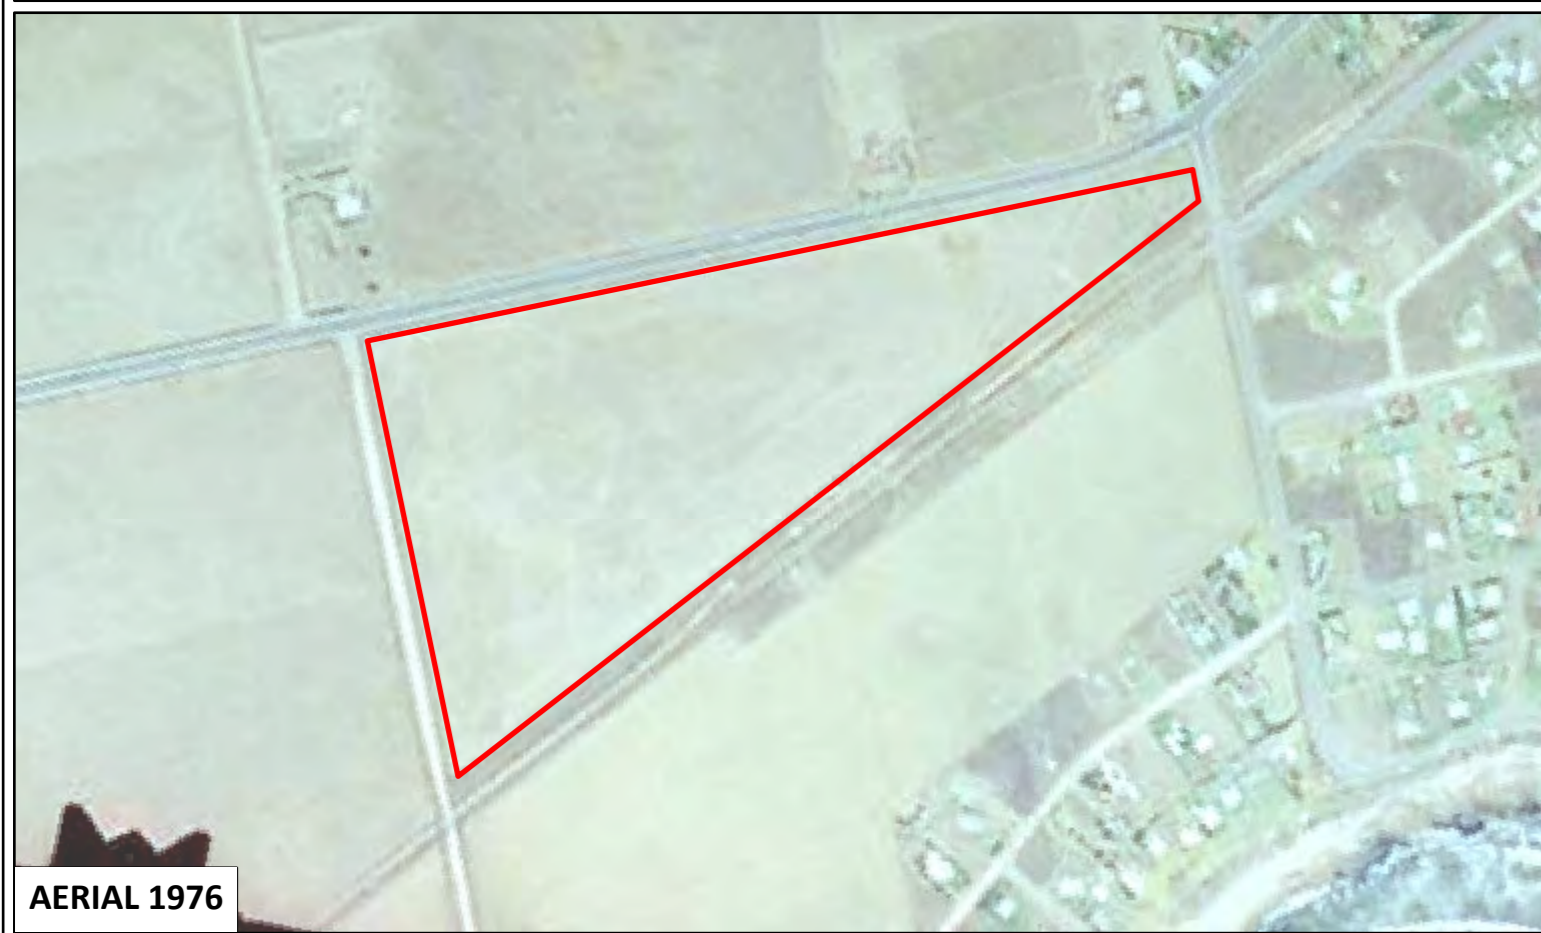
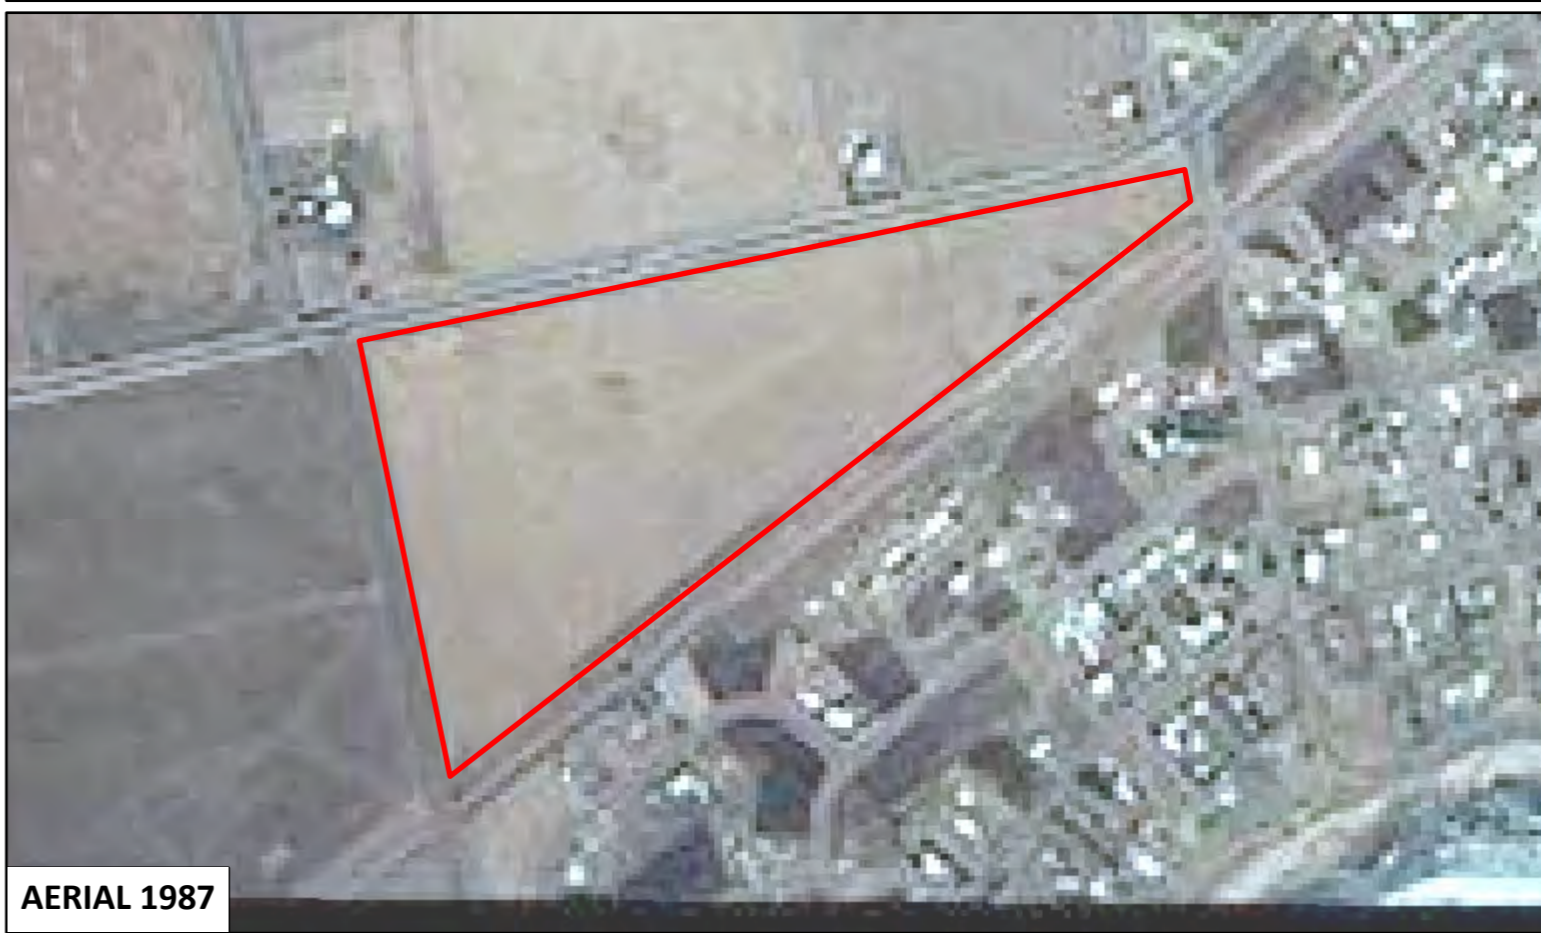
Figure: 3A

A historical aerial photograph since 1949 shows a small building on Lot 105 (north-eastern corner) which, according to Mr. Grant Lewis, was a horse stable. This stable was demolished shortly after he took ownership in 2000. No other changes to the site have occurred. Historical aerial photographs can be seen in Appendix G.

**HISTORICAL AERIAL
 1949 - 1987**

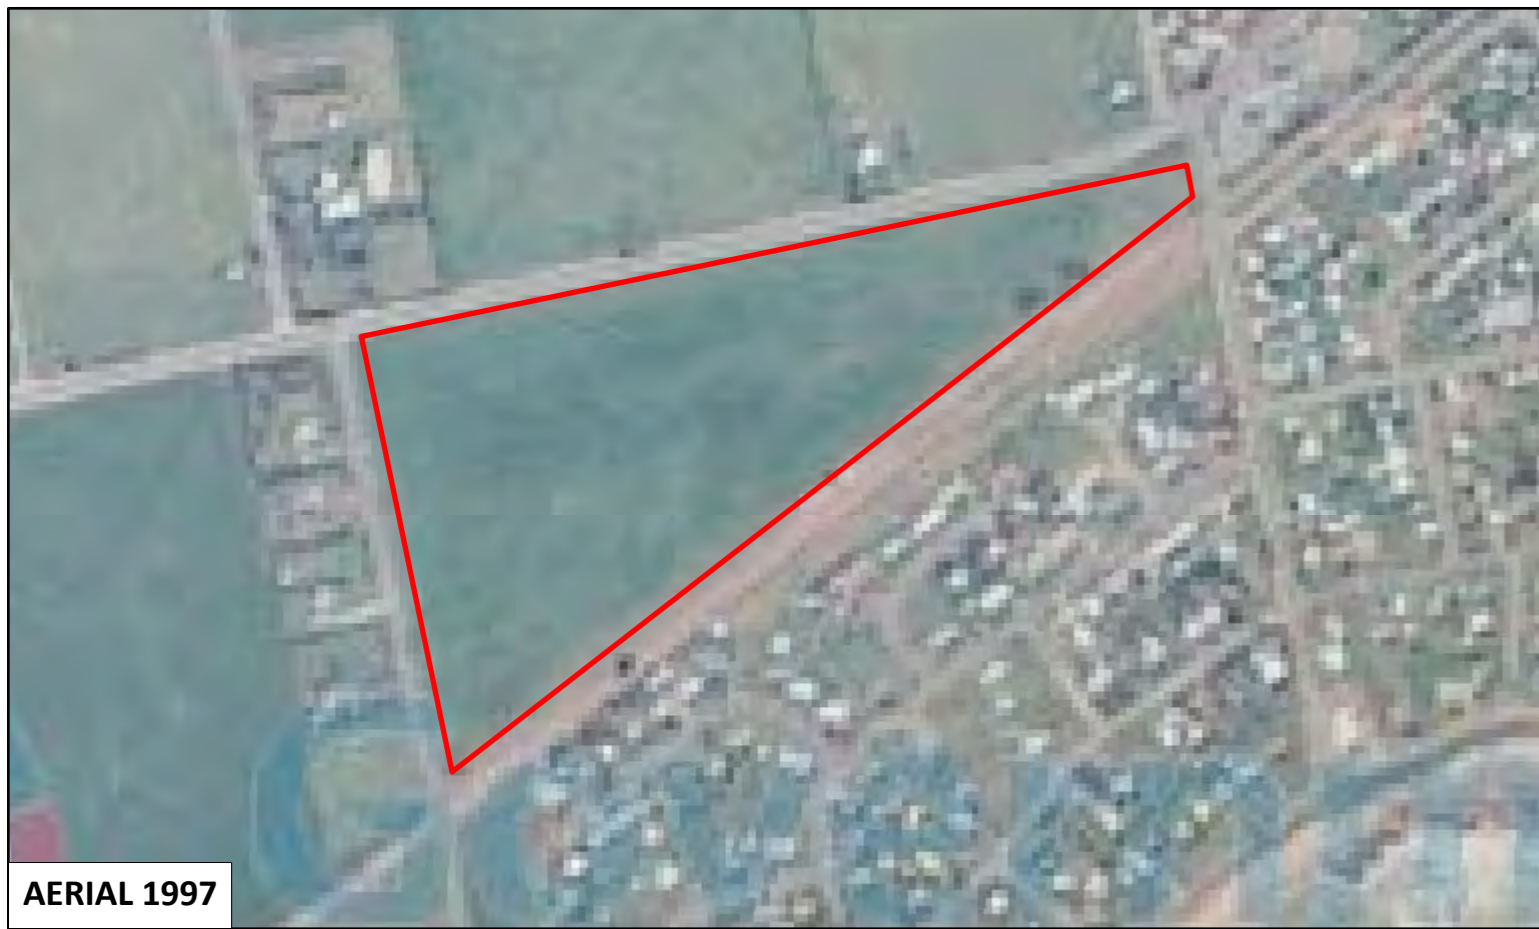
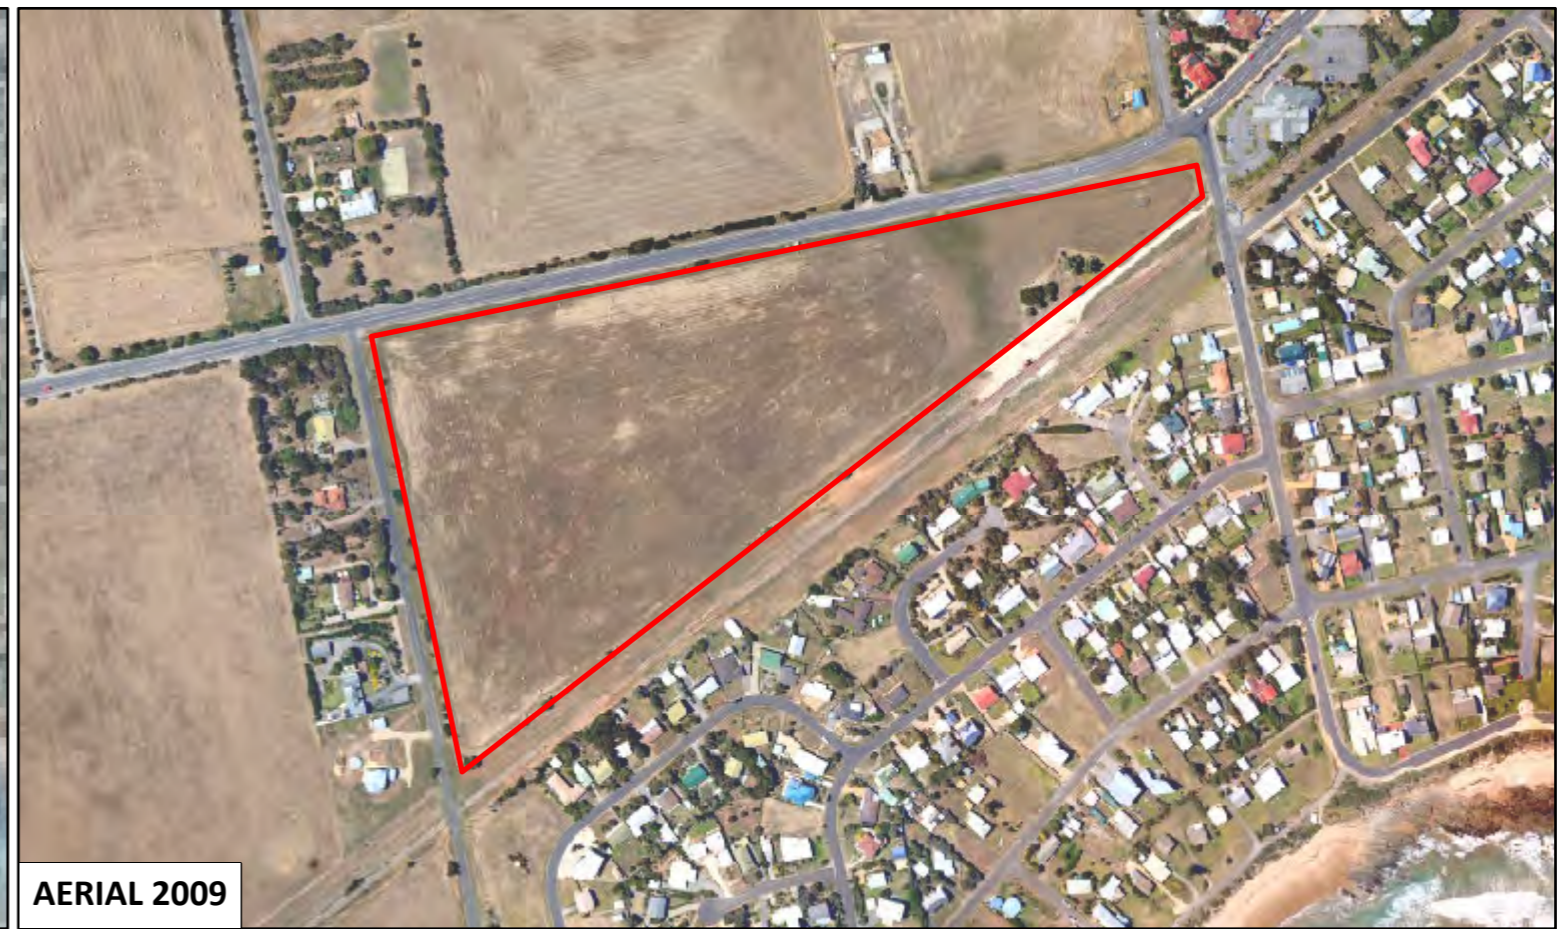
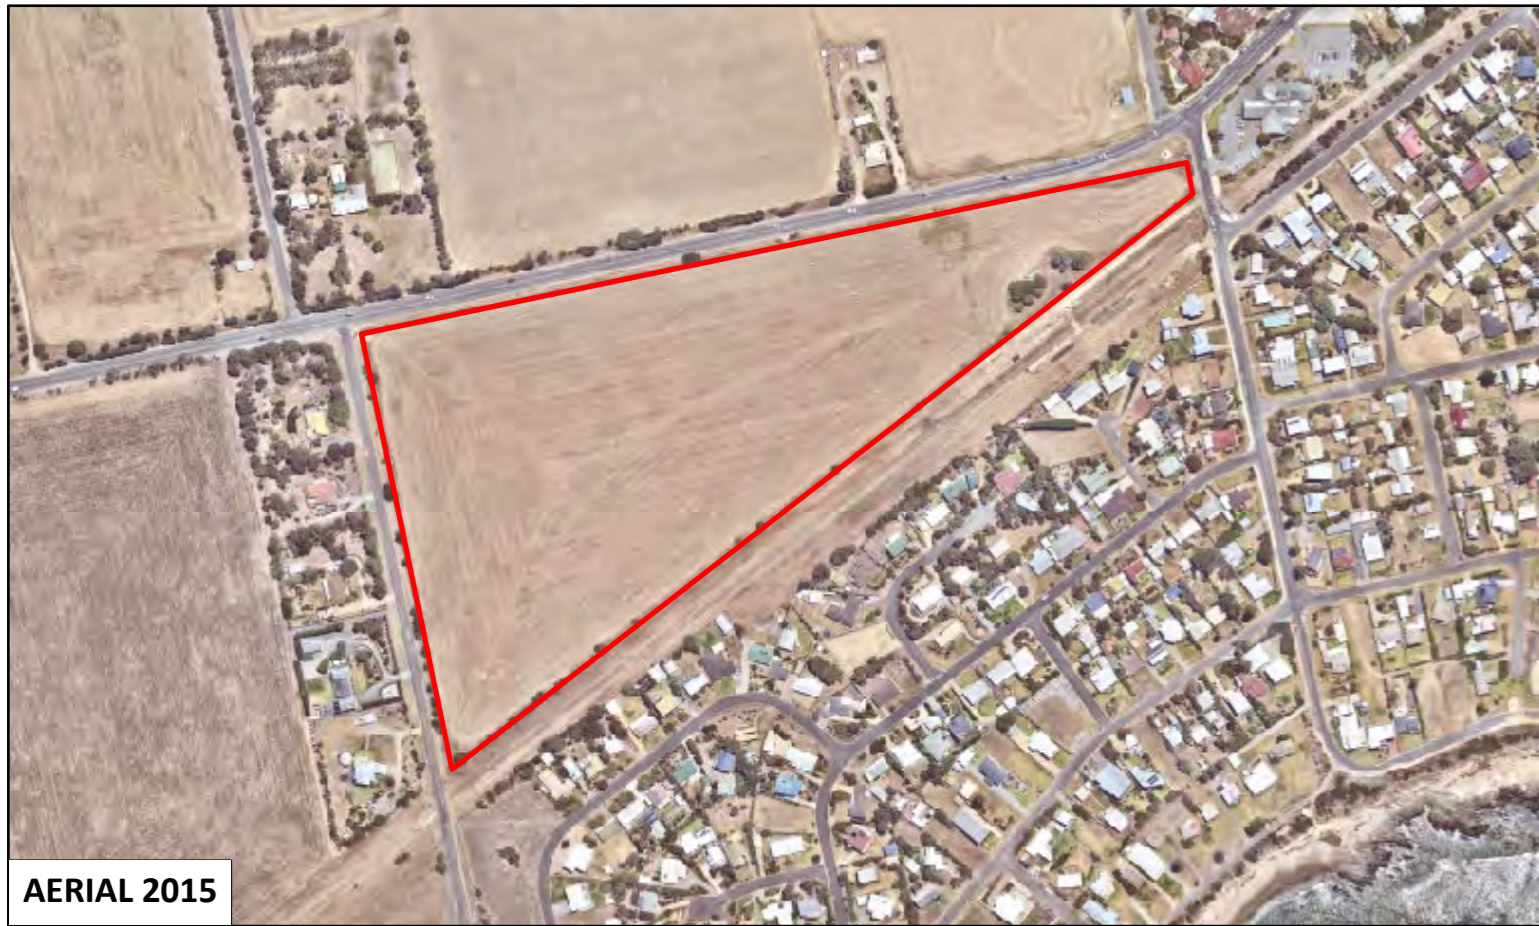
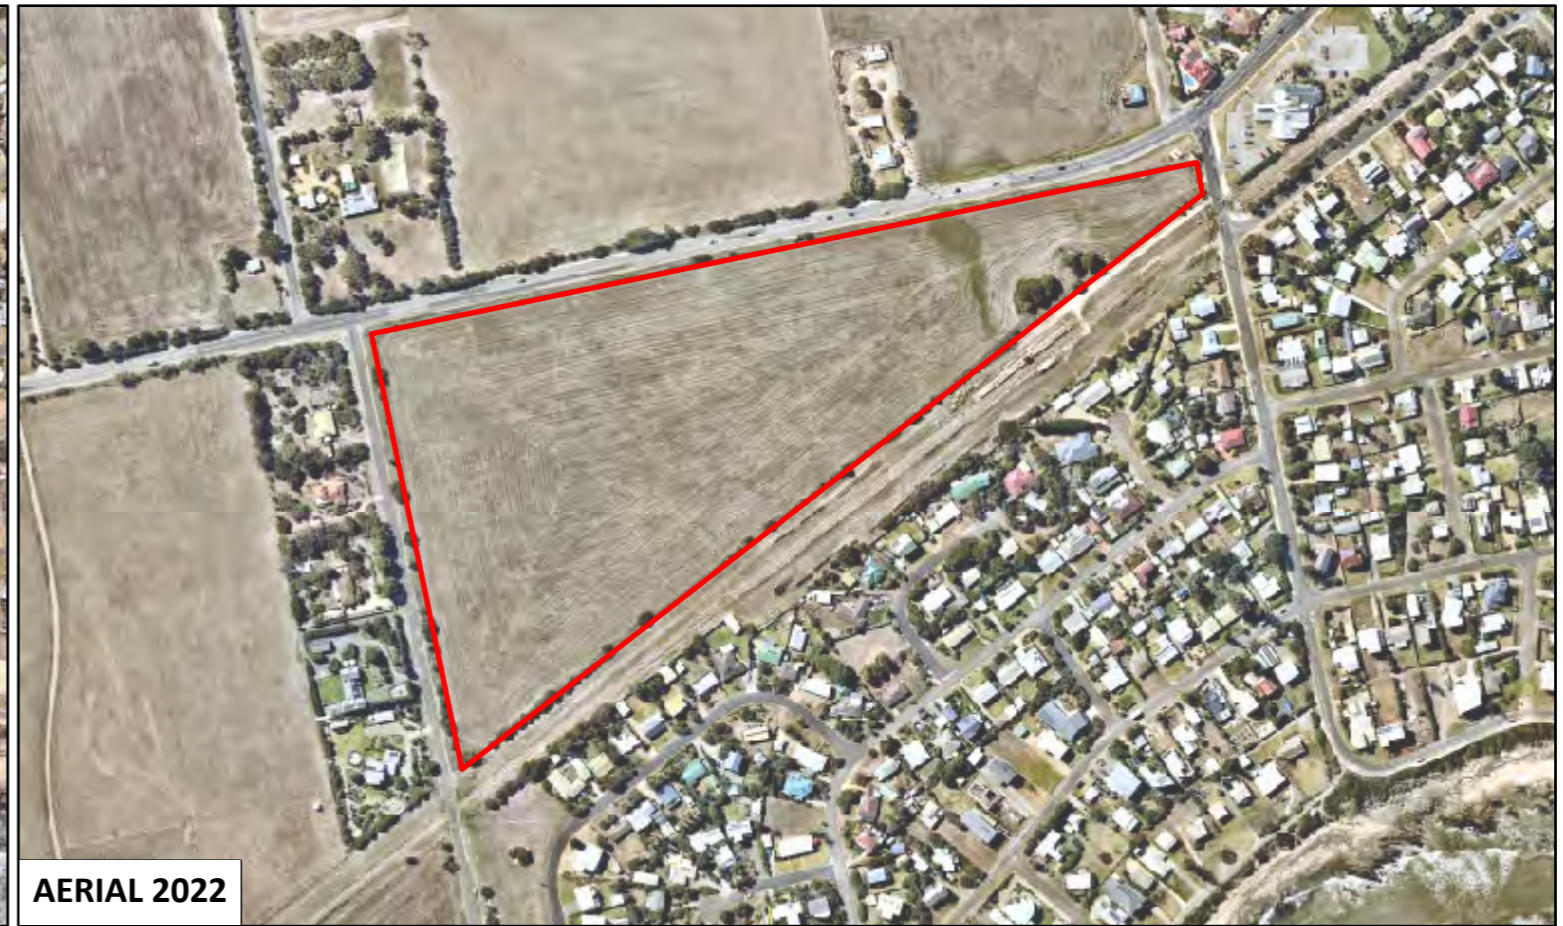
Figure: 3B

HISTORICAL AERIAL 1997 - 2022

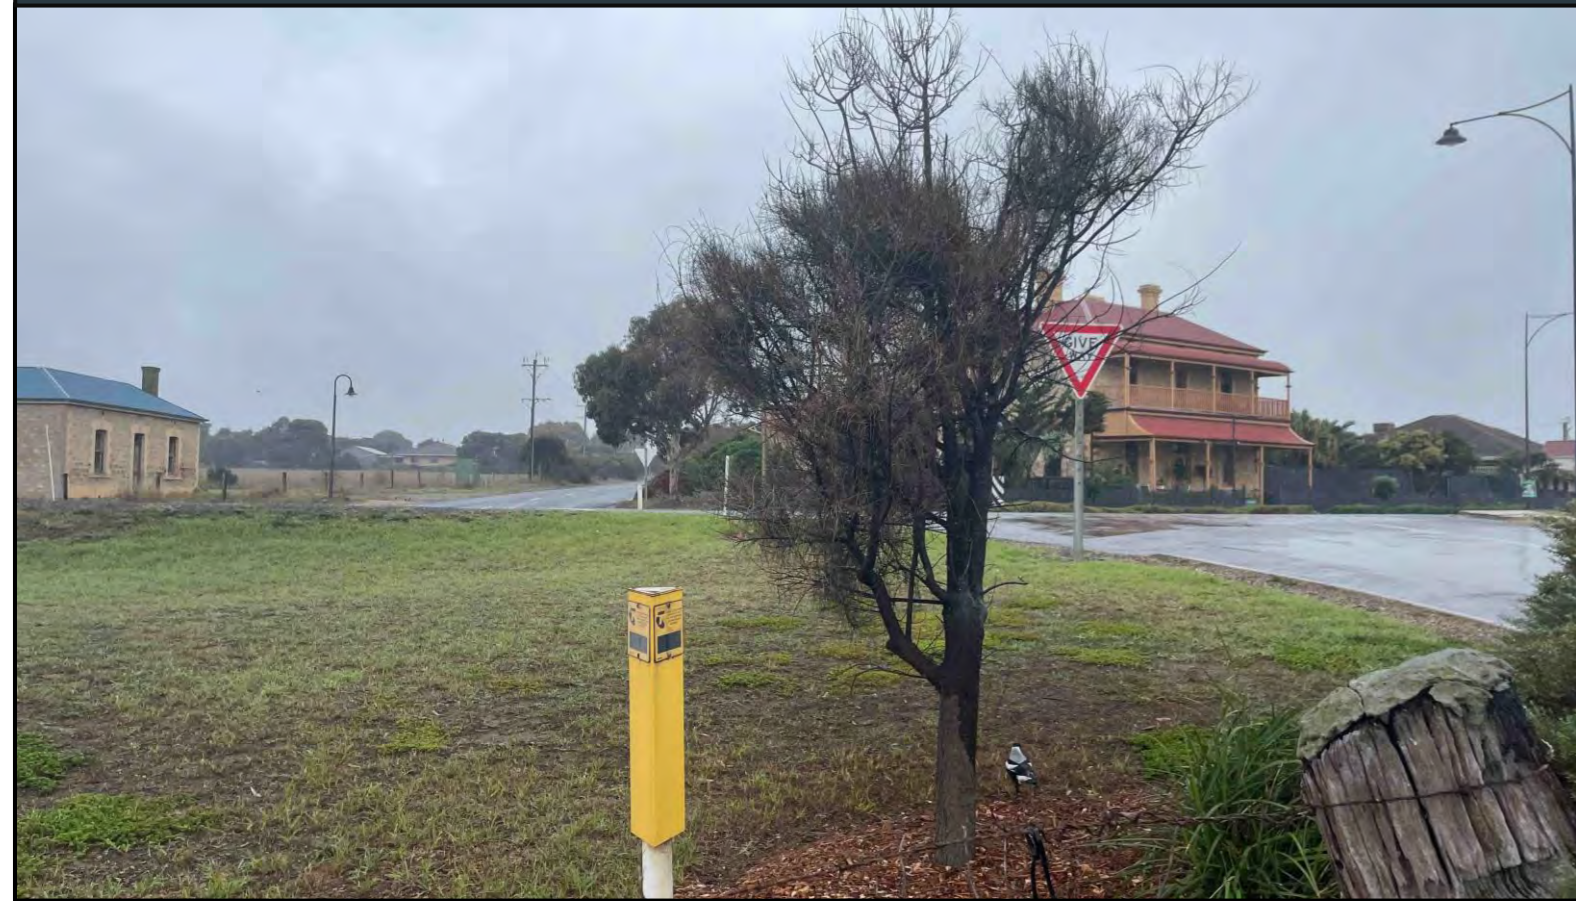
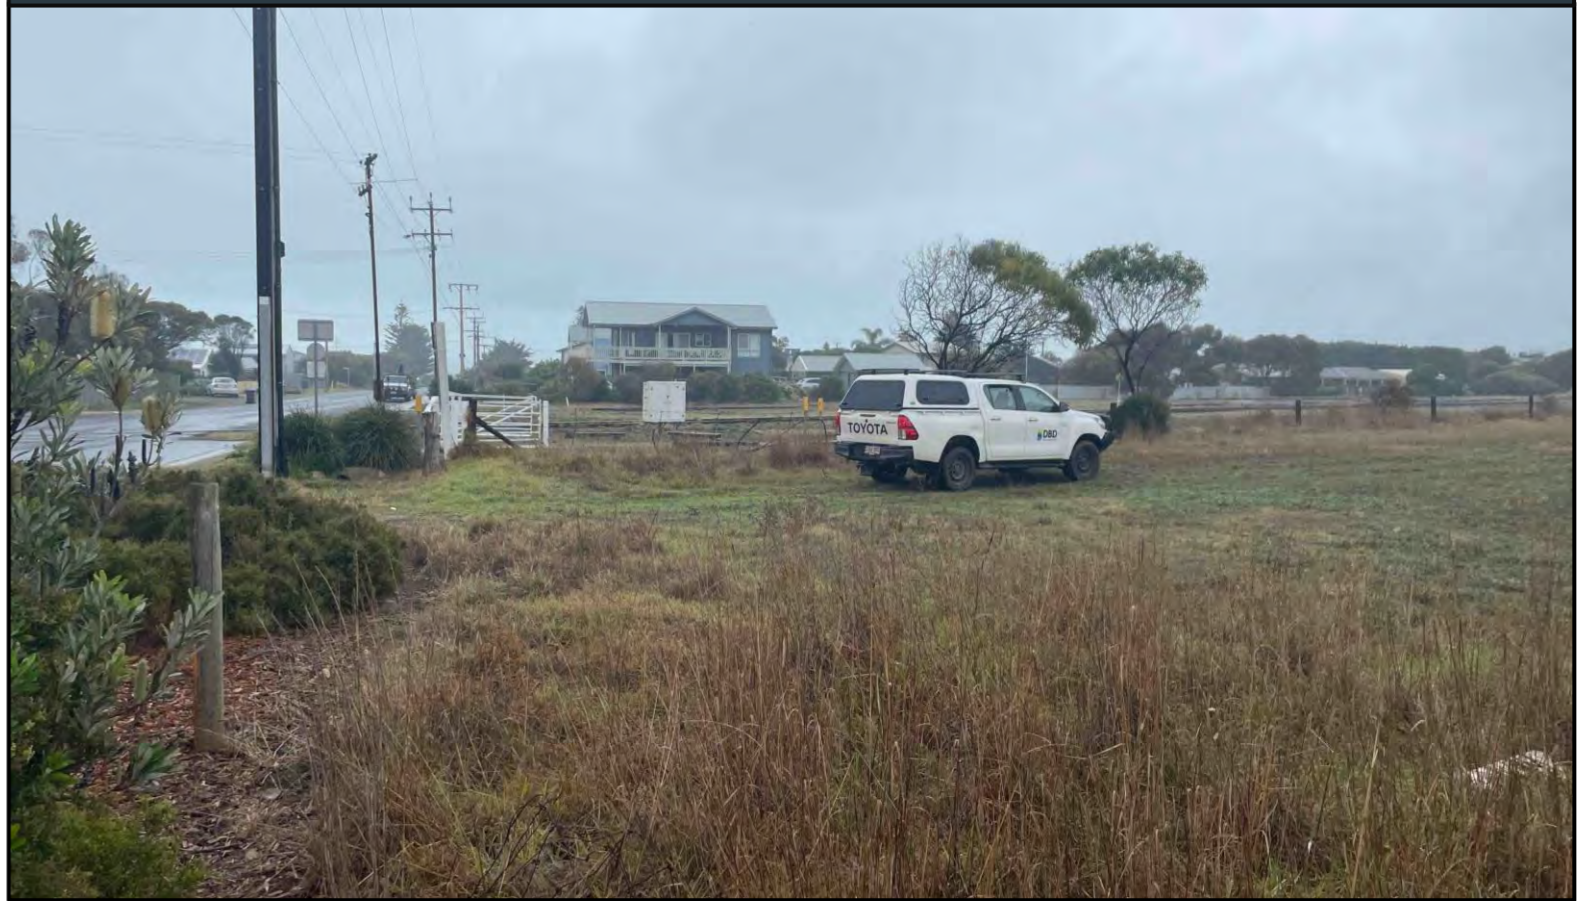
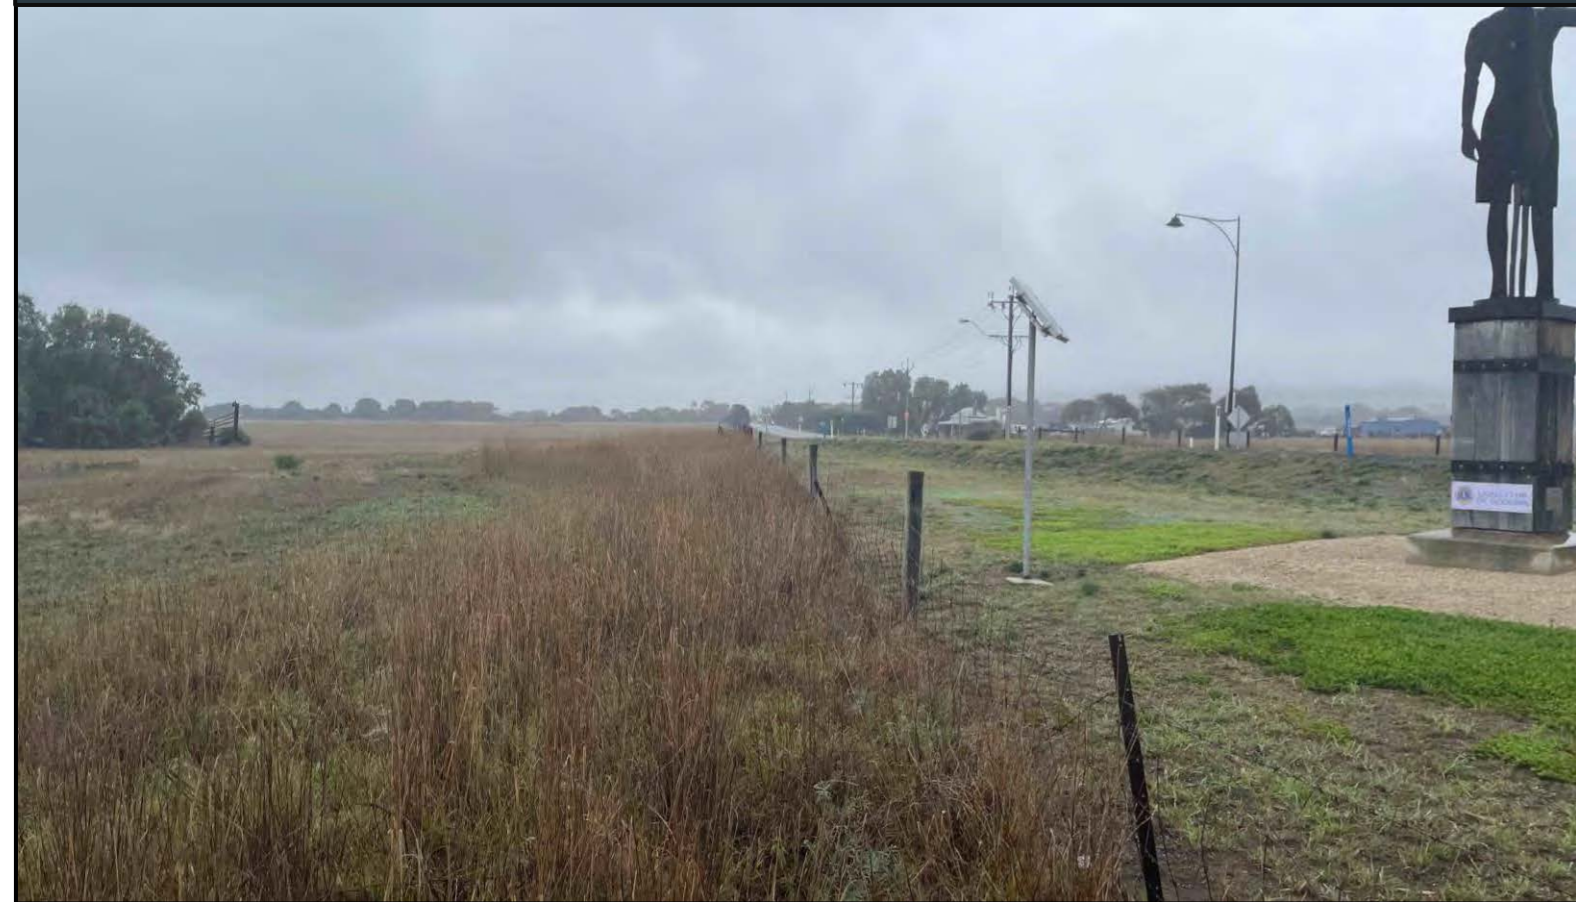
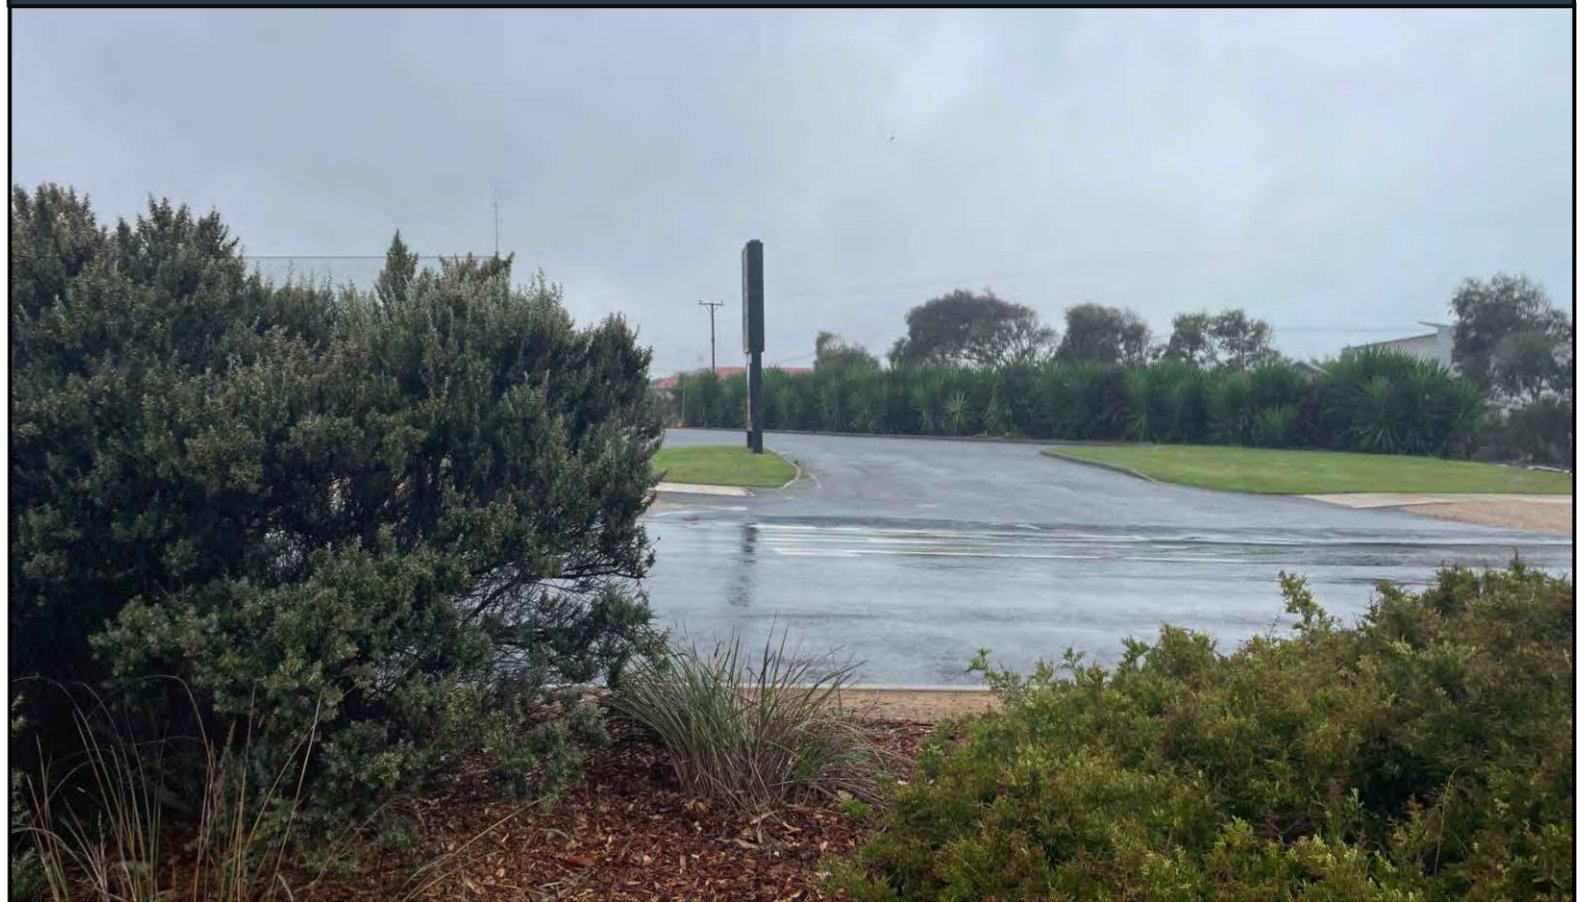
- The Site was covered in grass and appeared to have been mowed recently.
- Vegetation looked in good condition with no visible signs of stress.
- Old wooden railway infrastructure was observed close to the southern boundary.

- No asbestos containing material (ACM) is known to have existed on site or were identified during the site walkover.
- No fill material is known to have been imported to the Site and no fill was observed during the site walkover.

NE CORNER FACING NORTH

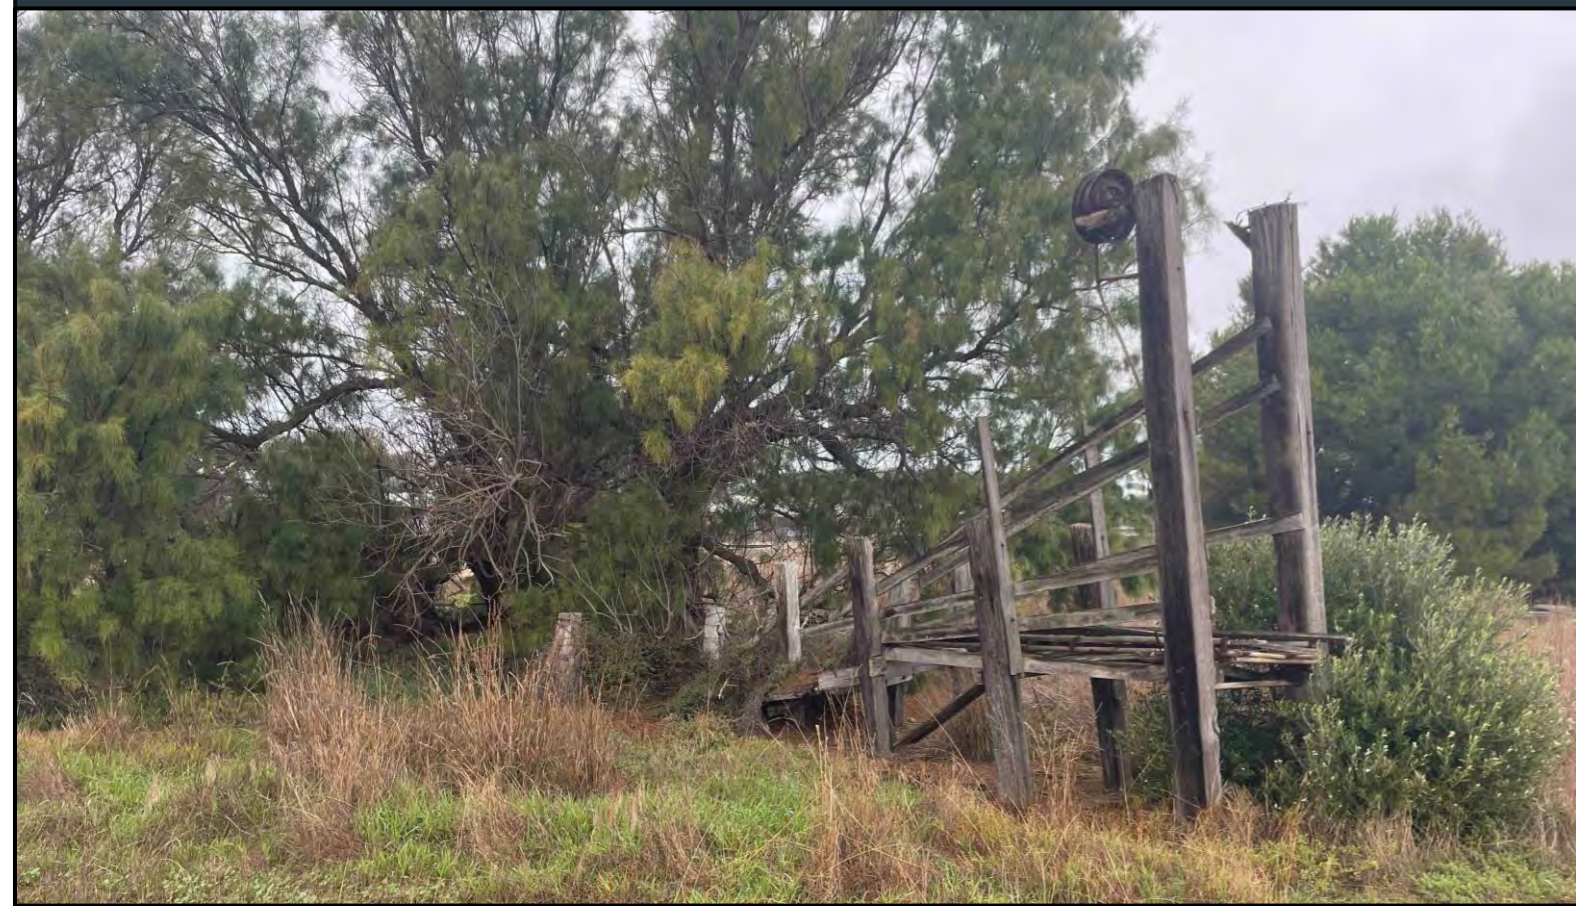
OLD RAILWAY INFRASTRUCTURE

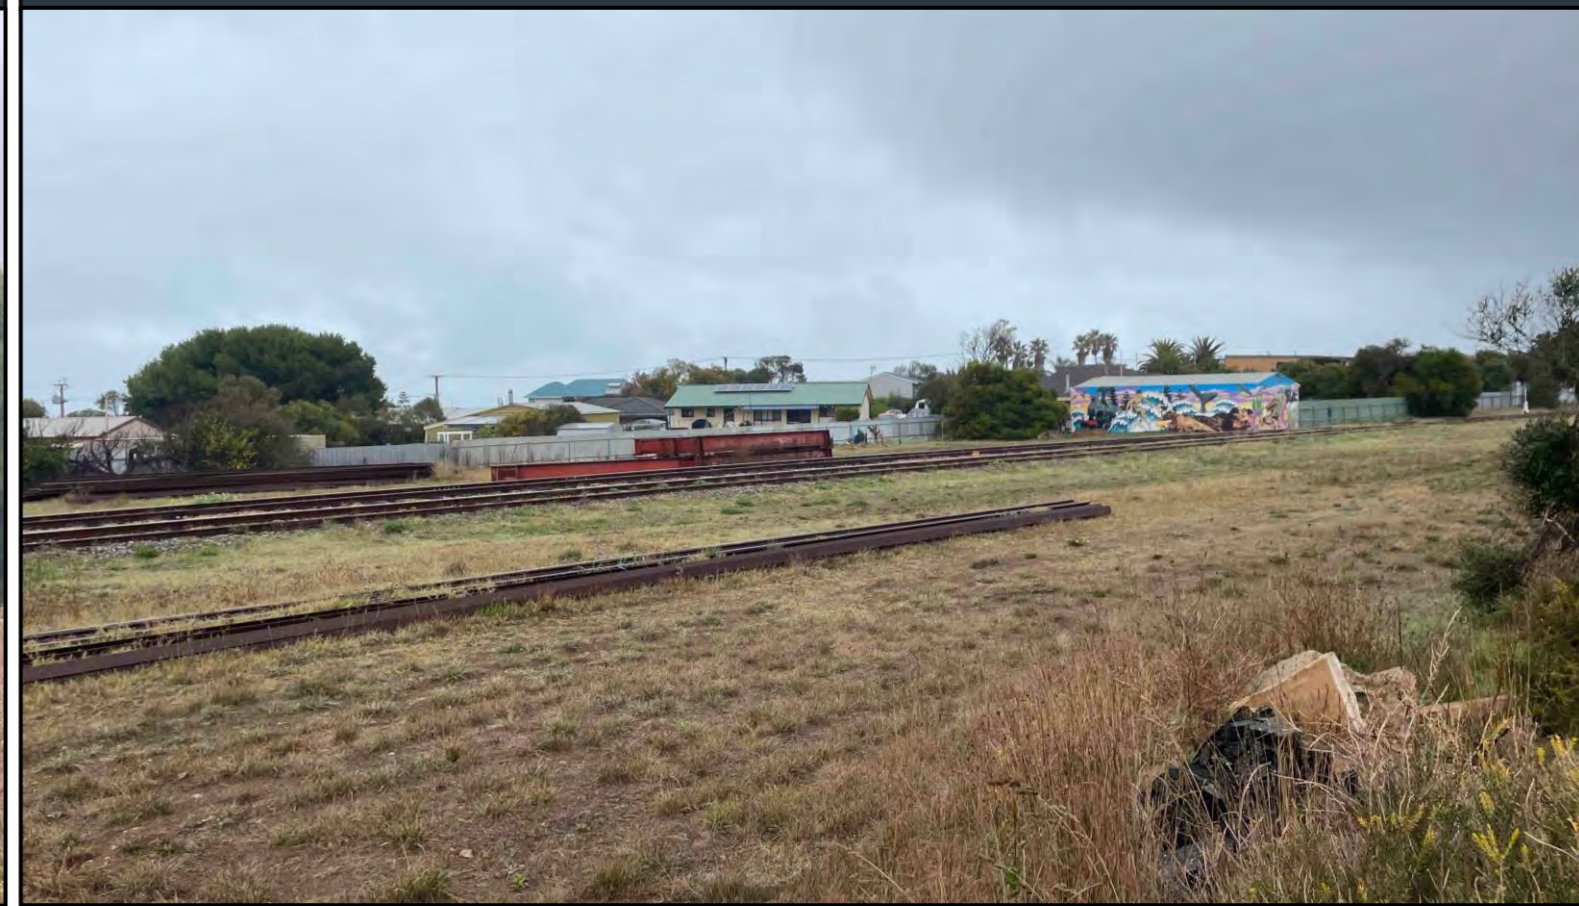
borders the property on the southern and eastern boundaries, with an additional smaller development on the western boundary. A railway Line extends the entirety of the southern boundary of Site and is still currently operational. The railway line was constructed in 1854 to provide a transportation route between the River Murray and the ocean wharfs and Port Elliot and the line was extended northwards in 1869 through Middleton and Strathalbyn. In 1986, this railway line was repurposed as the Victor Harbour Tourist Railway Line. A small station was visible from the 1949 aerial photograph in the middle of the southern boundary (approximately 15 meters from the boundary) and is still present in this location today. However, the extent of infrastructure associated with this railway appears to diminish over time. There appears to be no other railway infrastructure observed from the aerials and during the site walkover. Maintenance of the railway may have included the routine spraying of weeds. Contaminants of potential concern (COPCs) associated with railway activity include Total Petroleum Hydrocarbons (TPH), Benzene, Toluene, Ethylbenzene and Xylene (BTEX), Phenols, Heavy Metals, Nutrients, Pesticides and Herbicides. Contamination may exist as a result of the railway operations and could have affected the Site.

RAILWAY LINE ON SOUTHERN BOUNDARY

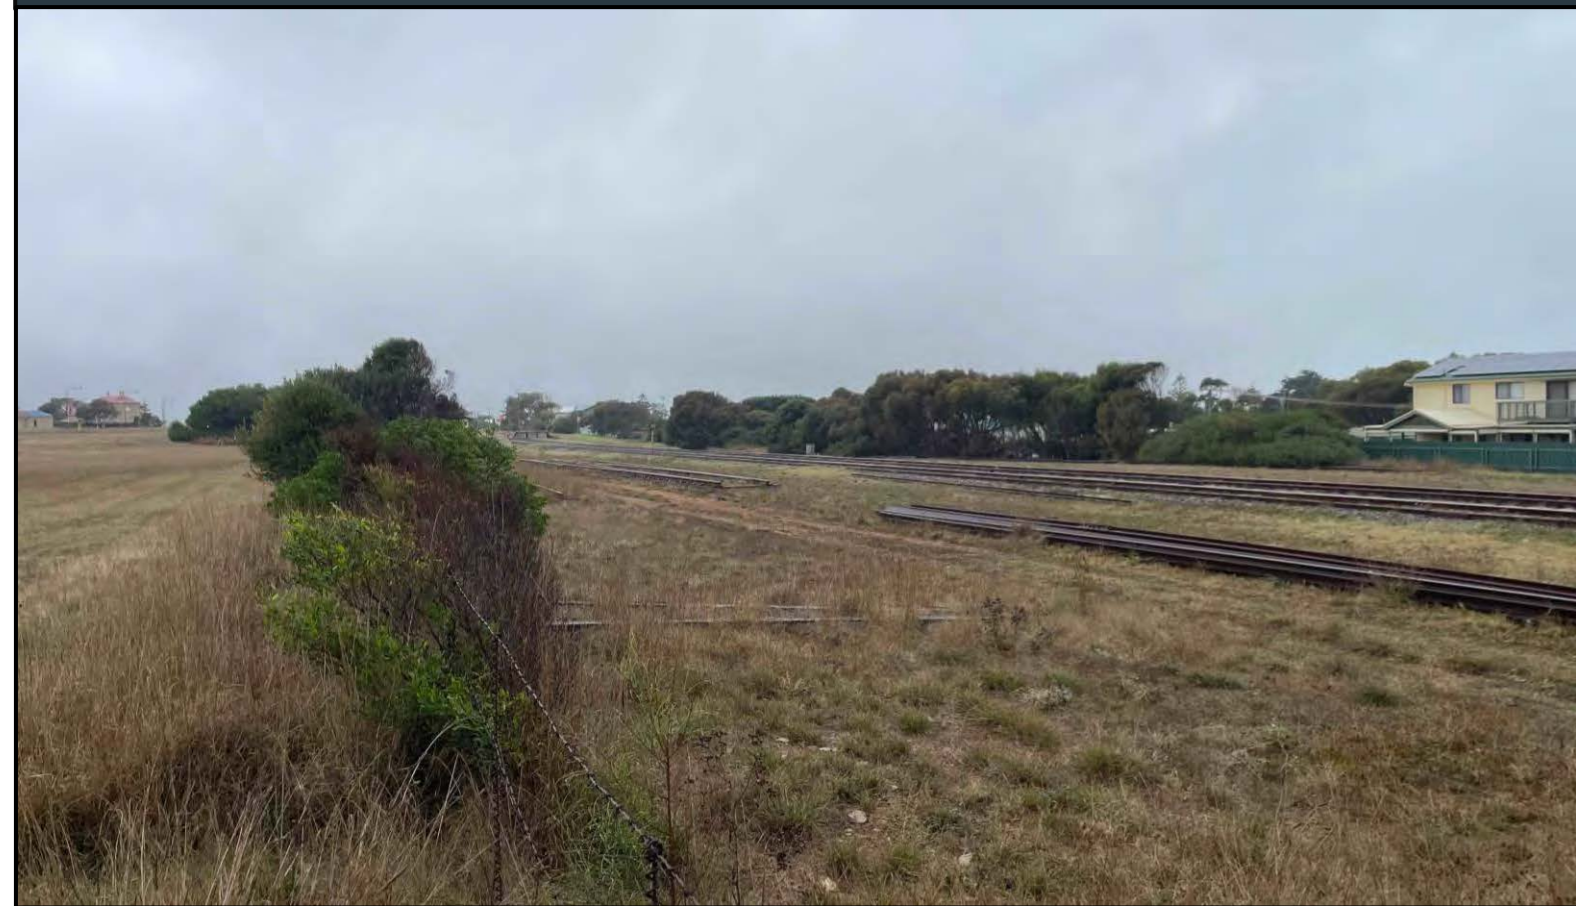
RAILWAY LINE ON SOUTHERN BOUNDARY
