Geotechnical Investigations - FMG

Preliminary Geotechnical Investigation Report

Civil Engineering at Stirling Golf Club

Job Number	275203
Client	Venture Capital Developments Pty Ltd
Site	Stirling Golf Club, 35 Golflinks Road, STIRLING, SA 5152
Date	04/05/2021
Revision	0

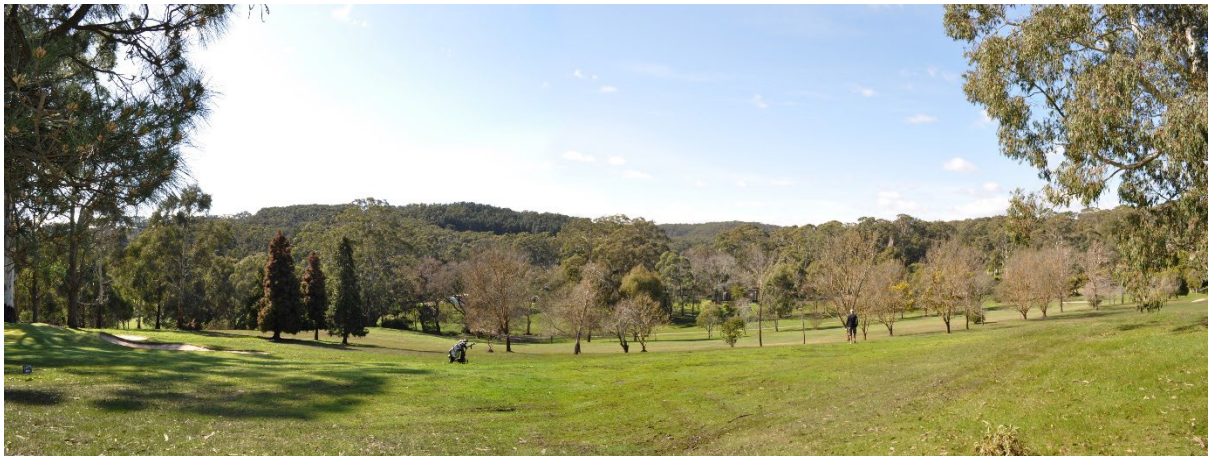
VIEW 01

This view is from Old Carey Gully Road and Golflinks Road, it is external from the site (2) and the post development view is barely visible (0) = total visual impact = (2) – **low to medium visual impact**

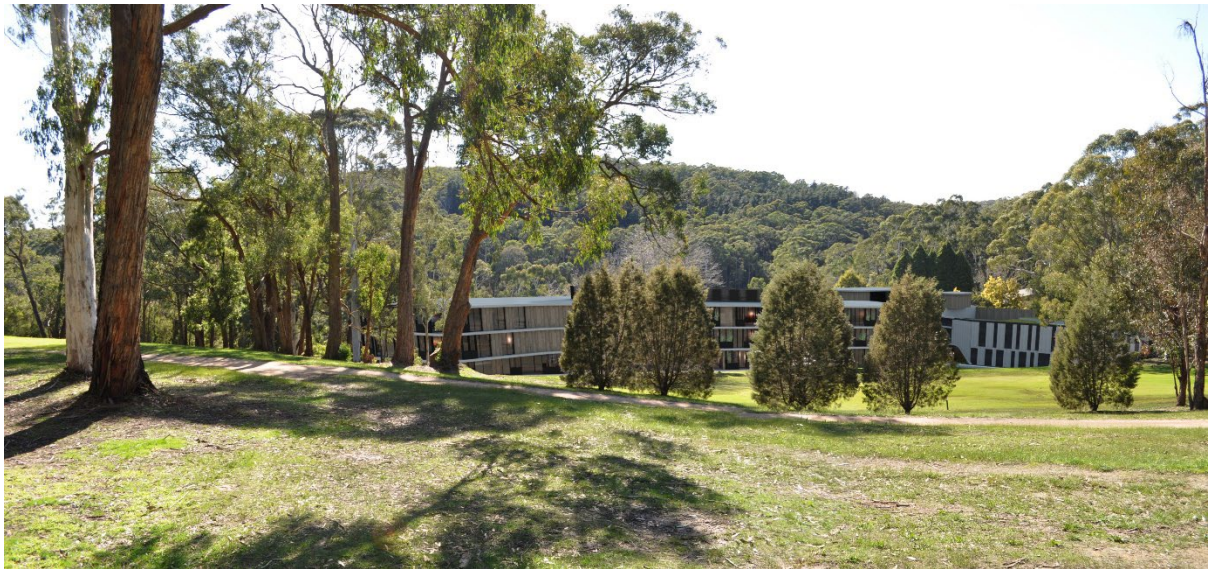
VIEW 02

This view is from well within the site, approximately 130m away from the nearest residential property at Golflinks Road. It demonstrates the topography of the site and the siting of the built form at low point of the land. It is an internal view (1) and the view is somewhat different (2) given that from this vantage point would have always contained the built form of the existing golf club buildings = total visual impact = 3 – **medium impact.**

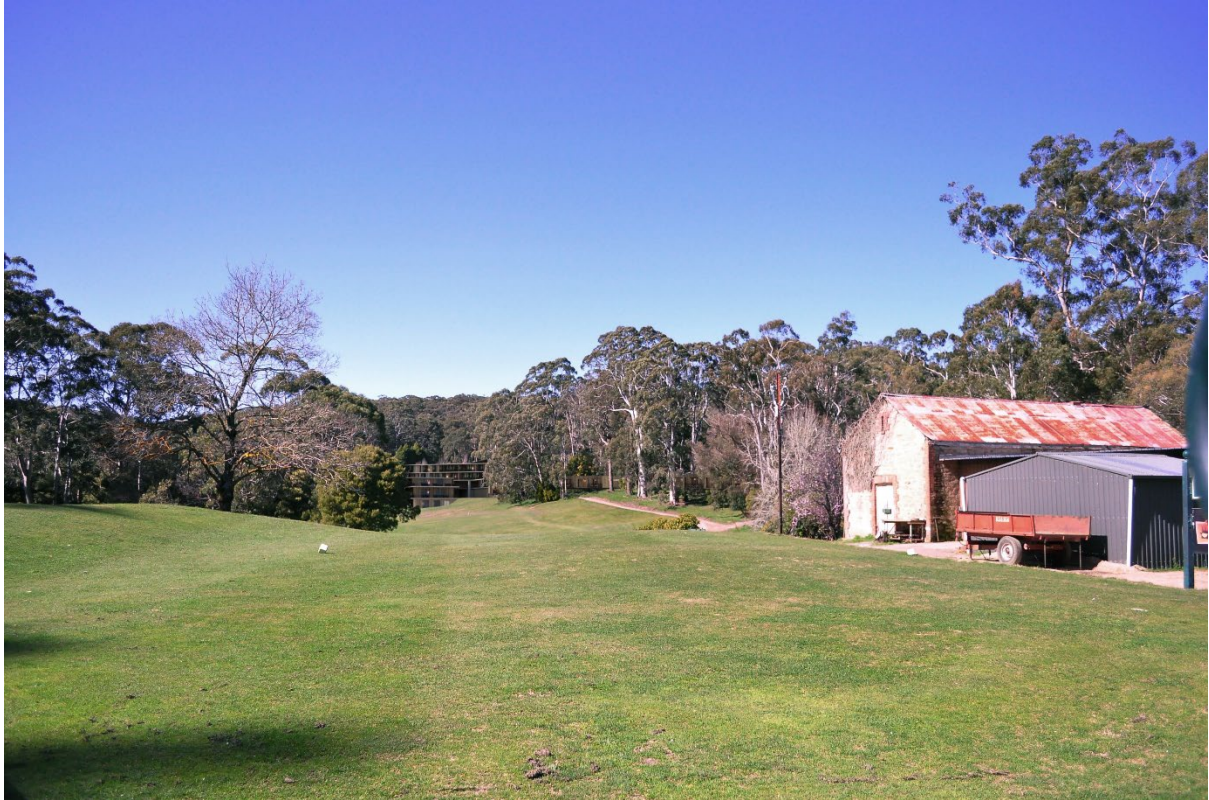
VIEW 03

This view is internal to the site (1). It is of the 18th hole towards the facilities building and new clubrooms. In the existing this view provides important visual relief, common to Golf Courses around the world, whereby the end of the course is in sight. This view demonstrates the buildings materiality in action and how it assists in blending it into its landscape context. The view is somewhat different (2) given that from this vantage point, a golfer would always be able to see the built form of the golf club buildings = total visual impact = 3 – **medium impact**.

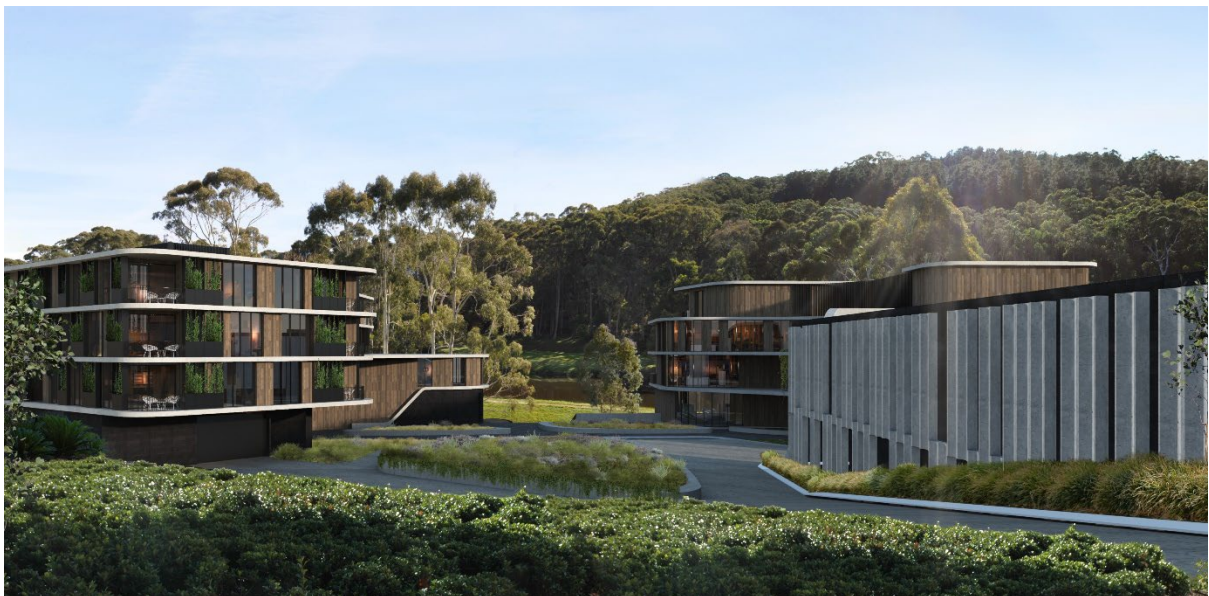
VIEW 04

View 04 is internal to the site (1). It was the architects intention to create a sense of arrival at this location. The split in the built form at this view point provides visual relief and provides a strong visual

link through to Mt George. This view is somewhat different (2). The total visual impact from View 04 is 3 - **medium impact**.

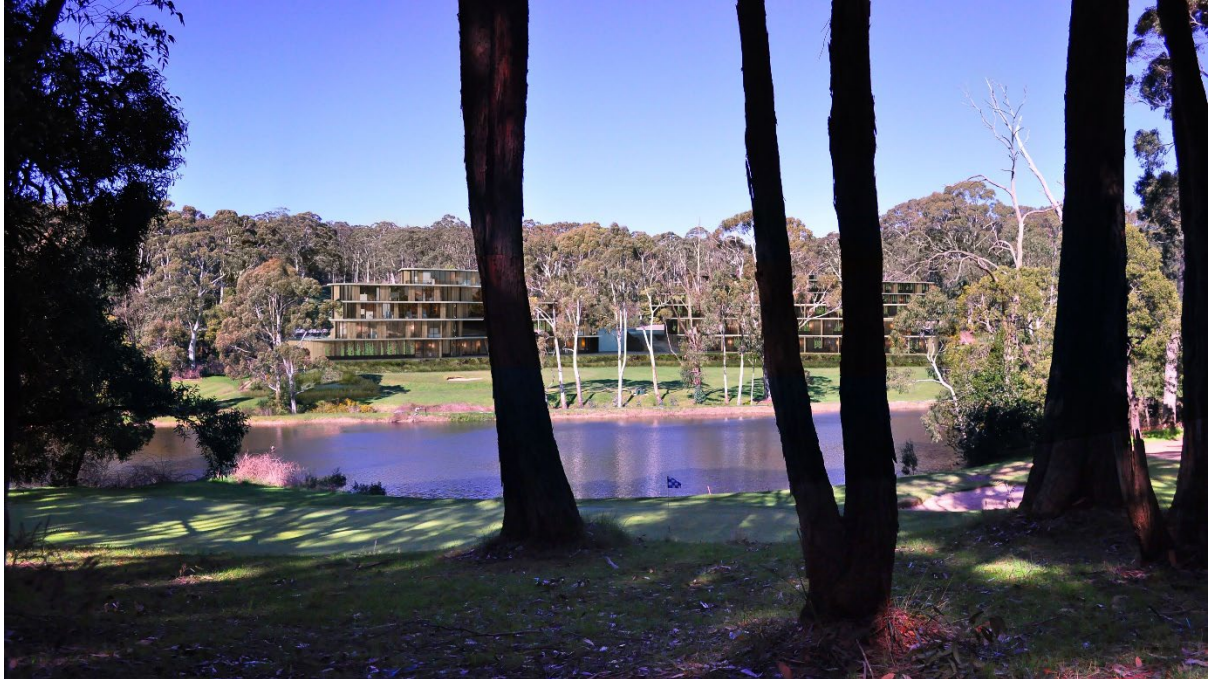
VIEW 05

This view is internal to the site (1), as the Heysen Trail traverses the site in this location. The visual impact from this vantage point is very different (3). Retention of established trees assists in mitigating the extent of visual impact of the development from this view. It is not uncommon that man-made structures are visible from the Heysen Trail given its expansive length and diverse terrain. A walker on the Heysen Trail would have always viewed built form from this location, albeit that the scale has now changed. The total visual impact from View 05 is 4 - **medium to high impact**.

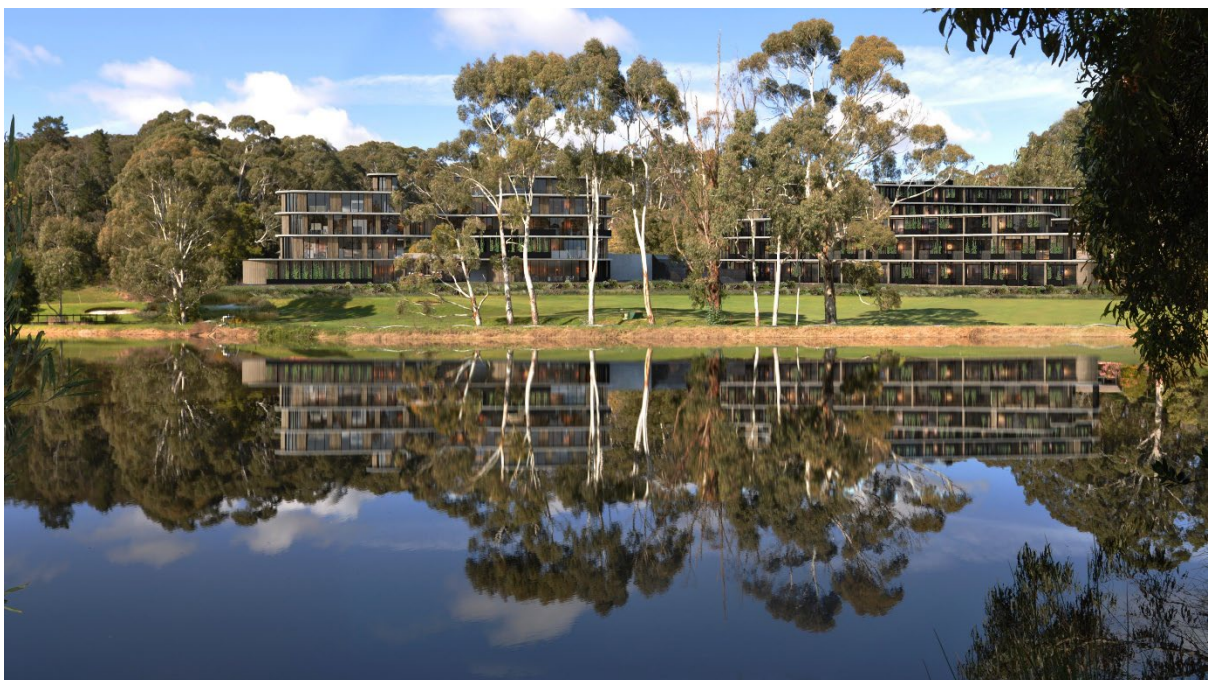
VIEW 06

As with View 05, this view is internal to the site (1) and the visual impact from this vantage point is very different (3). The impacts stated in View 05 are the same as View 06. The total visual impact from View 06 is 4 – **medium to high impact**.

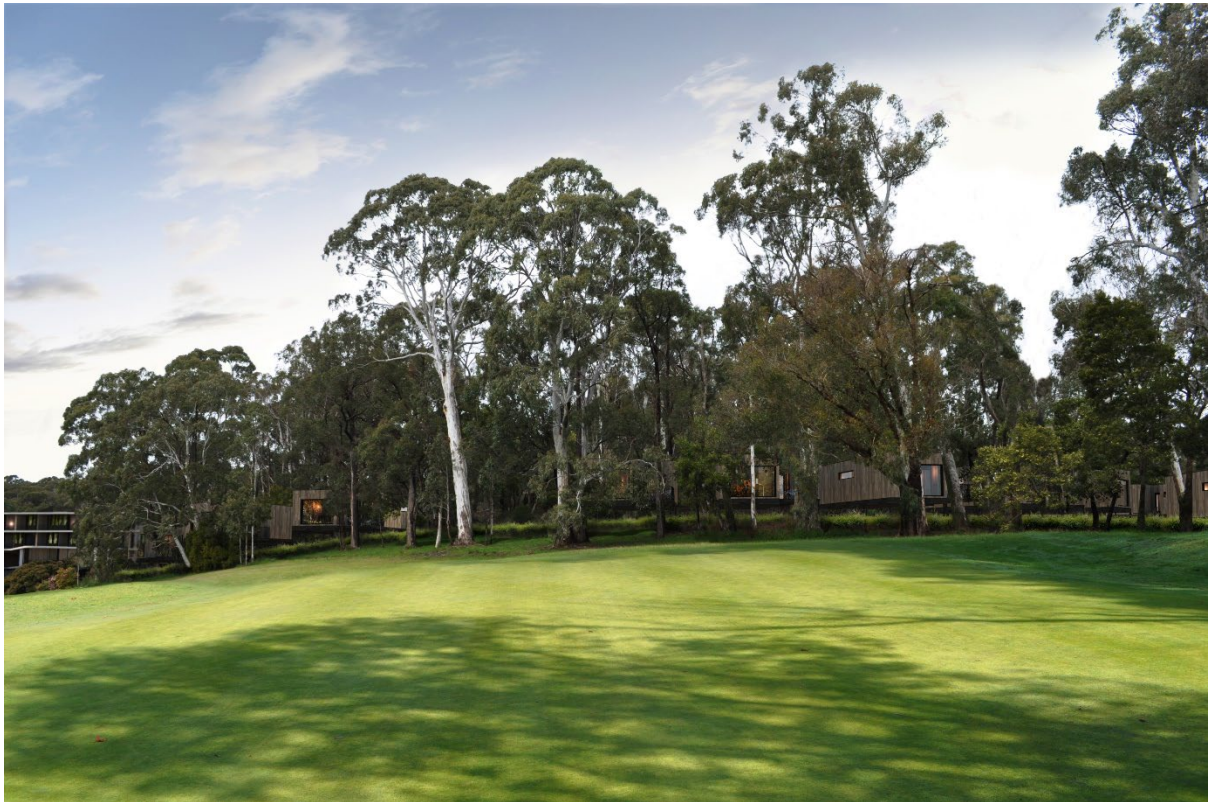
VIEW 07

View 07 is internal to the site (1). It is not very different when compared to existing (2). The use of materials, the scale of the PODs and their orientation assists in mitigating visual impacts from this view point. Total visual impact = 2 – **low to medium impact**

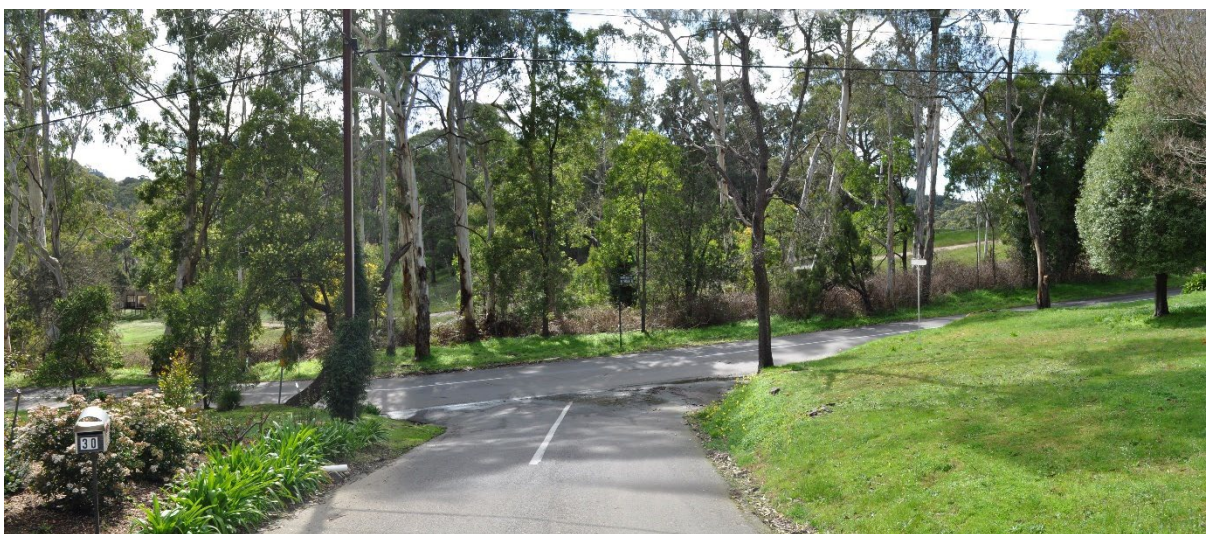
VIEW 08

View 08 is external to the site (2). The development is barely visible from this view (2). The siting of the PODs, the use of materials natural toned materials and their scale assists in mitigating visual impacts from this view point. Total visual impact = 2 – **low to medium impact**

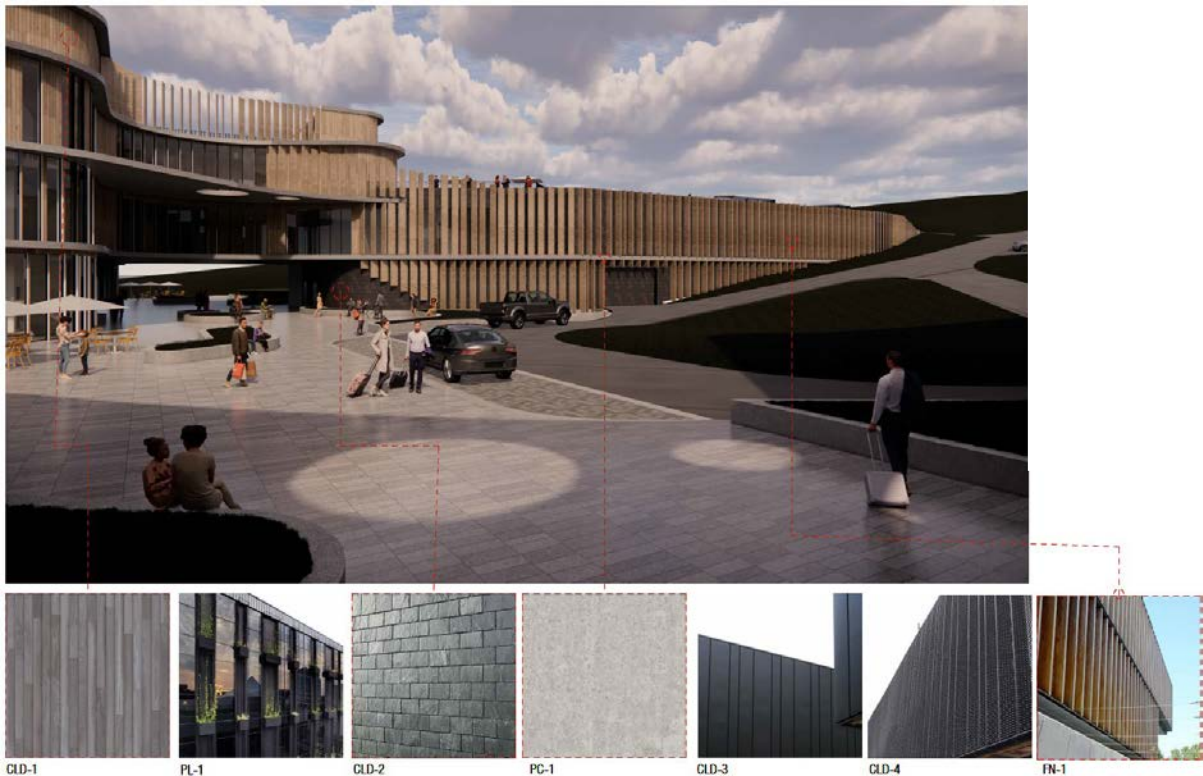
The chosen materials palette is depicted below. The use of timber cladding, curved precast concrete and slate cladding were key shifts in the design evolution which responded to the sites natural surroundings. The façade is intended to patina over time, allowing it to settle into its landscape context. Exposed concrete, complimented with black metal accents provide a sleek and modern appearance juxtaposed against the softness of the timber cladding.

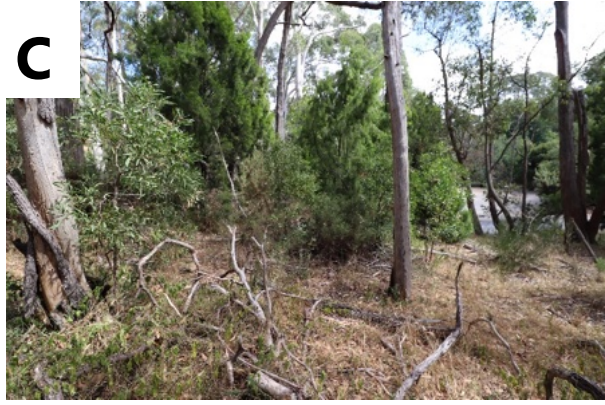
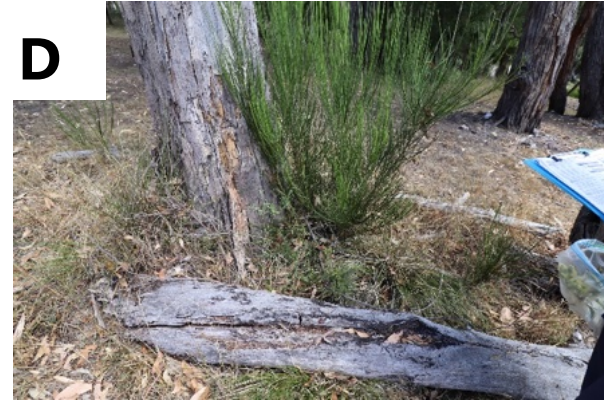
</div> <p data-bbox="108 660 1455 757">Figure 6: Vegetation within VA1. Multiple Tall <i>Eucalyptus obliqua</i> are present (Image A and B). <i>Cytisus scoparius</i>, a Declared Plant was observed throughout (Image D). <i>Exocarpos cupressiformis</i> scattered throughout VA1 (Image B and C) and <i>Vinca major</i> trailed throughout VA1 (Image C).</p>
	<p data-bbox="108 801 252 869">General description</p> <p data-bbox="300 801 1455 985">Vegetation within VA1 consists of an open forest of tall <i>Eucalyptus obliqua</i> and sparse <i>E. viminalis</i> ssp. <i>viminalis</i>, (Rare). The midstorey largely consisted of <i>Exocarpos cupressiformis</i> and <i>Acacia melanoxylon</i> and few scattered <i>Bursaria spinosa</i>, with an understorey of <i>Lomandra micrantha</i>, <i>Dianella revoluta</i>, <i>Pteridium esculentum</i> ssp. <i>esculentum</i> and sparse <i>Rytidosperma</i> sp. and <i>Austrostipa</i> sp.</p> <p data-bbox="300 1008 1455 1265">Other native species in VA1 include <i>Pultenaea graveolens</i> (NPW Act: Rare), <i>Acrotriche fasciculiflora</i> and <i>Hibbertia exutiacies</i>. Leaf litter was dense and continuous throughout, and some fallen timber and debris was observed. Fox Tail (<i>Alopecurus</i> sp.), Plantain (<i>Plantago</i> sp.), Blue Periwinkle (<i>Vinca major</i>), Flax-leaf Broom (<i>Genista linifolia</i>), and English Broom (<i>Cytisus scoparius</i>) were the dominant weeds recorded during the 2024 survey. Overall, VA1 was in good condition. VA1 provides dense tree canopy cover, fallen timber and tree hollows. However, Declared Plants and other weeds persist within the VA.</p>

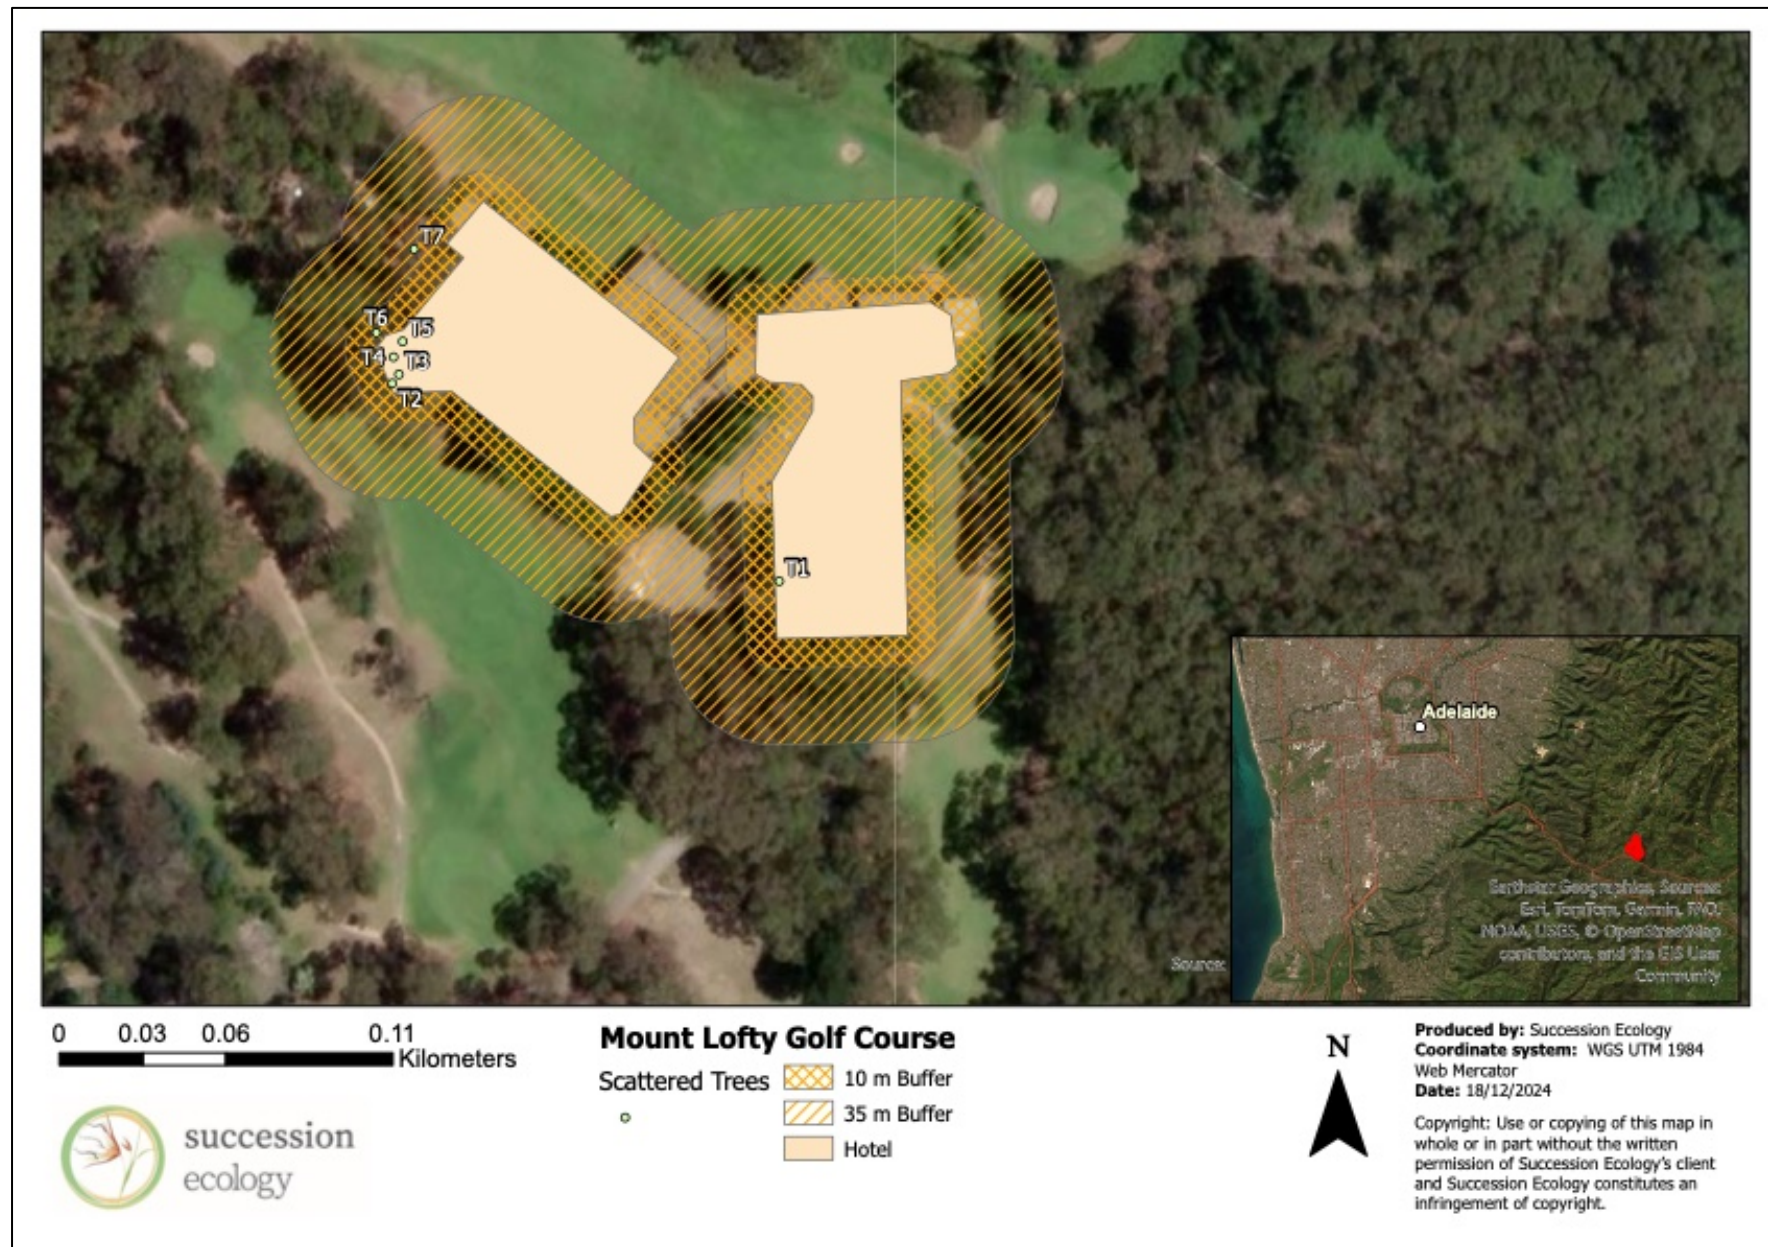
Figure 7: The seven scattered trees impacted by the Project are shown with green points.

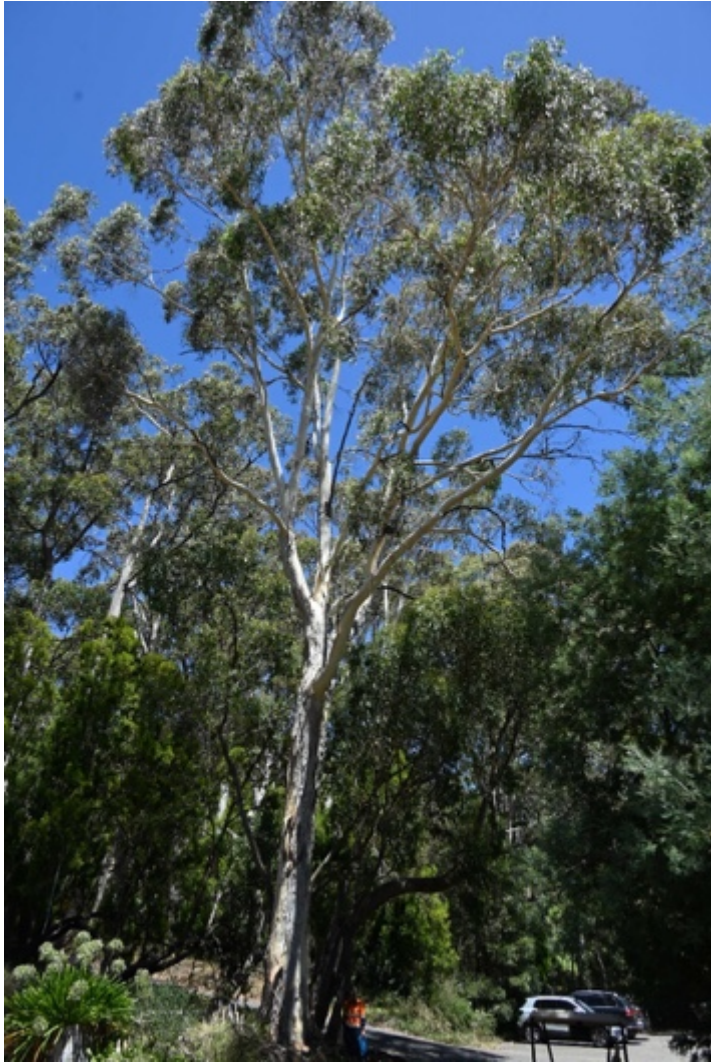
Tree T1 (Site: Mount Lofty Golf Estate)	<p>Figure 8: Tree T1, Manna Gum (<i>Eucalyptus viminalis</i> ssp. <i>viminalis</i>), facing south.</p>

Manna Gum (<i>Eucalyptus viminalis</i> ssp. <i>viminalis</i>)	
Number of trees – 1	
Height (m) – 18.6	
Diameter (cm) – 83 (1 stem)	
Hollows – #S:0, #M:0, #L:0	
Canopy dieback (%) – 10	
Total Biodiversity Score – 4.24	
Description	
<p><i>Eucalyptus viminalis</i> ssp. <i>viminalis</i> is listed as Rare under the NPW Act. This large tree appears to be in good condition, with minor dieback. Together with nearby trees, it would provide habitat for small birds, small reptiles, bats and invertebrates, in the form of shelter, perching/roosting, feeding, and nesting. In particular, <i>E. viminalis</i> ssp. <i>viminalis</i> provides a food resource for koalas (Nicolle 1997, pg. 135).</p> <p>No Threatened Ecological Communities were present at the site. However, six fauna species listed as threatened under the NPW Act have been identified within 5 km since 1995 and the native scattered tree considered suitable for the threatened species including:</p> <ul style="list-style-type: none">• <i>Petroica boodang boodang</i> (Scarlet Robin) NPW Act: (R) – Likely• <i>Zanda funerea whiteae</i> (Yellow-tailed Black Cockatoo) NPW Act: (V) – Known• <i>Trichosurus vulpecula</i> (Common Brushtail Possum) NPW Act: (R) – Highly Likely• <i>Zoothera lunulata halmaturina</i> (Bassian Thrush) EPBC Act: (EN), NPW Act (R) – Highly Likely• <i>Pteropus poliocephalus</i> (Grey-headed Flying-fox) EPBC Act (VU), NPW Act: (R)- Likely• <i>Corcorax melanorhamphos</i> (White-winged Chough) NPW Act: (R) - Likely

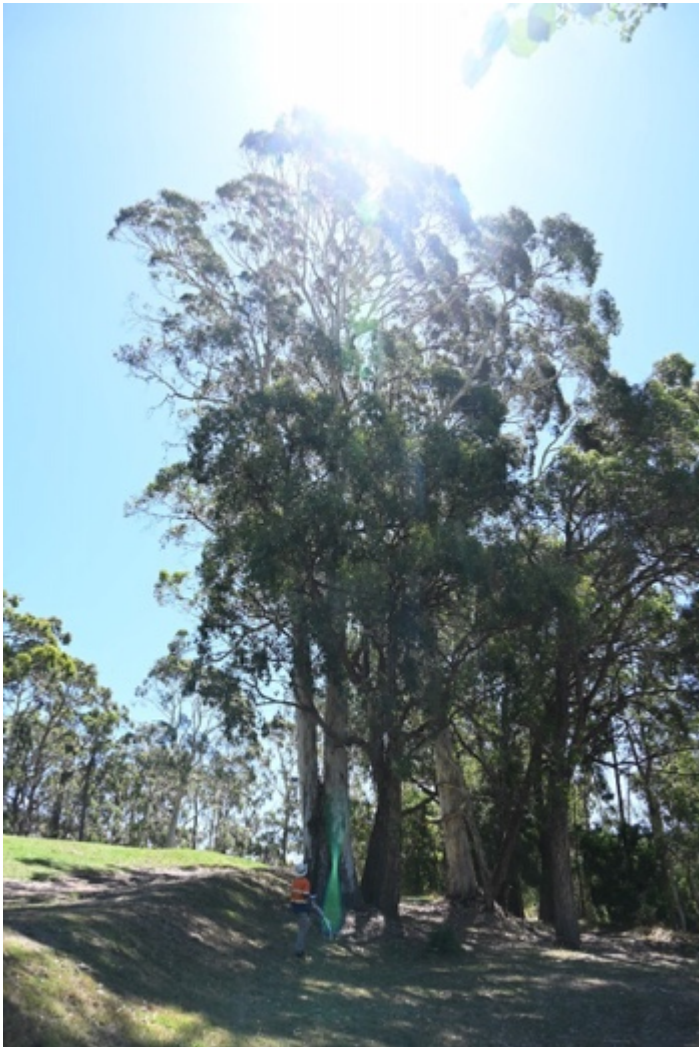
Tree T2 (Site: Mount Lofty Golf Estate)	Figure 9: Tree T2, Manna Gum (<i>Eucalyptus viminalis</i> ssp. <i>viminalis</i>), facing south.
Manna Gum (<i>Eucalyptus viminalis</i> ssp. <i>viminalis</i>)

Number of trees – 1	
Height (m) – 28.2	
Diameter (cm) – 166 (1 stem)	
Hollows – #S:2, #M:2, #L:0	
Canopy dieback (%) – 5	
Total Biodiversity Score – 11.59	
Description	
<p><i>Eucalyptus viminalis</i> ssp. <i>viminalis</i> is listed as Rare under the <i>NPW Act</i>. This large tree appears to be in good condition, with minor dieback. It contains a total of four hollows and together with nearby trees, would provide habitat for small birds, small reptiles, bats and invertebrates, in the form of shelter, perching/roosting, feeding, and nesting. <i>E. viminalis</i> ssp. <i>viminalis</i> provides a food resource for koalas (Nicolle 1997, pg. 135).</p> <p>No Threatened Ecological Communities were present at the site. However, six fauna species listed as threatened under the <i>NPW Act</i> have been identified within 5 km since 1995 and the native scattered tree considered suitable for the threatened species including:</p> <ul style="list-style-type: none">• <i>Petroica boodang boodang</i> (Scarlet Robin) <i>NPW Act</i>: (R) – Likely• <i>Zanda funerea whiteae</i> (Yellow-tailed Black Cockatoo) <i>NPW Act</i>: (V) – Known• <i>Trichosurus vulpecula</i> (Common Brushtail Possum) <i>NPW Act</i>: (R) – Highly Likely• <i>Zoothera lunulata halmaturina</i> (Bassian Thrush) <i>EPBC Act</i>: (EN), <i>NPW Act</i> (R) – Highly Likely• <i>Pteropus poliocephalus</i> (Grey-headed Flying-fox) <i>EPBC Act</i> (VU), <i>NPW Act</i>: (R)- Likely• <i>Corcorax melanorhamphos</i> (White-winged Chough) <i>NPW Act</i>: (R) - Likely

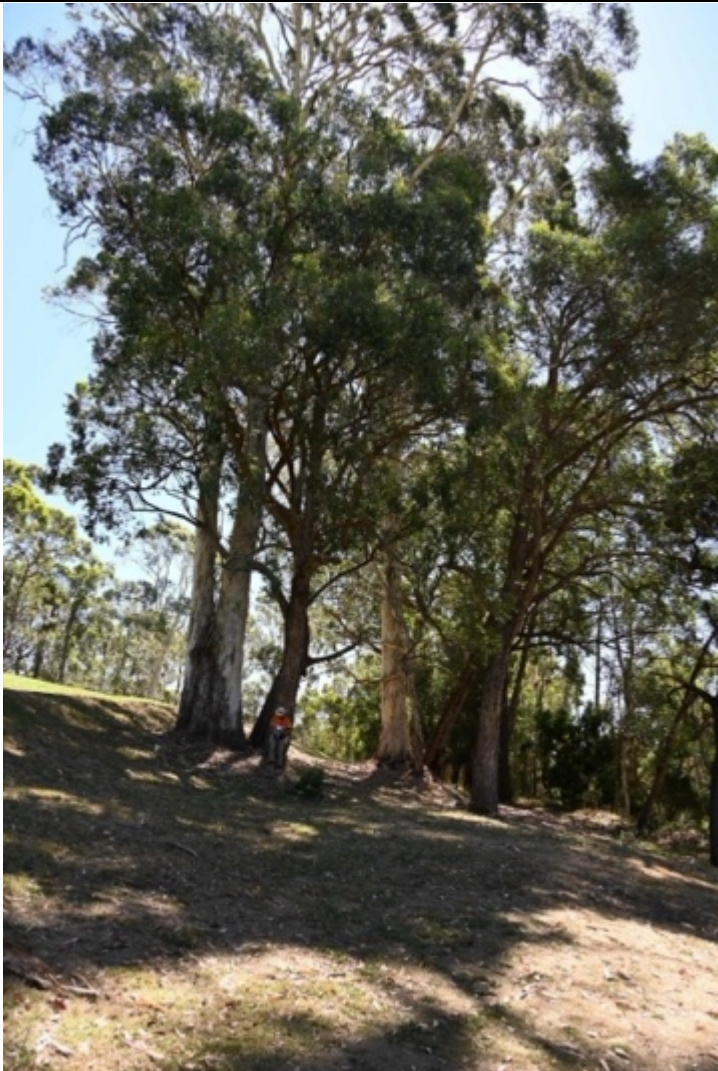
Tree T3 (Site: Mount Lofty Golf Estate)	Figure 10: Tree 3, Messmate Stringybark (<i>Eucalyptus obliqua</i>), facing south.

Number of trees – 1	
Height (m) – 13.8	
Diameter (cm) – 75 (1 stems)	
Hollows – #S:0, #M:0, #L:0	
Canopy dieback (%) – 10	
Total Biodiversity Score – 3.28	
Description	
<p>This tree appears to be in good condition, with minor dieback. While no hollows were recorded, together with nearby trees, would provide habitat for small birds, small reptiles, bats and invertebrates, in the form of shelter, perching/roosting, feeding, and nesting.</p> <p>No Threatened Ecological Communities were present at the site. However, six fauna species listed as threatened under the <i>NPW Act</i> have been identified within 5 km since 1995 and the native scattered tree considered suitable for the threatened species including:</p> <ul style="list-style-type: none"> • <i>Petroica boodang boodang</i> (Scarlet Robin) <i>NPW Act</i>: (R) – Likely • <i>Zanda funerea whiteae</i> (Yellow-tailed Black Cockatoo) <i>NPW Act</i>: (V) – Known • <i>Trichosurus vulpecula</i> (Common Brushtail Possum) <i>NPW Act</i>: (R) – Highly Likely • <i>Zoothera lunulata halmaturina</i> (Bassian Thrush) <i>EPBC Act</i>: (EN), <i>NPW Act</i> (R) – Highly Likely • <i>Pteropus poliocephalus</i> (Grey-headed Flying-fox) <i>EPBC Act</i> (VU), <i>NPW Act</i>: (R)- Likely • <i>Corcorax melanorhamphos</i> (White-winged Chough) <i>NPW Act</i>: (R) - Likely

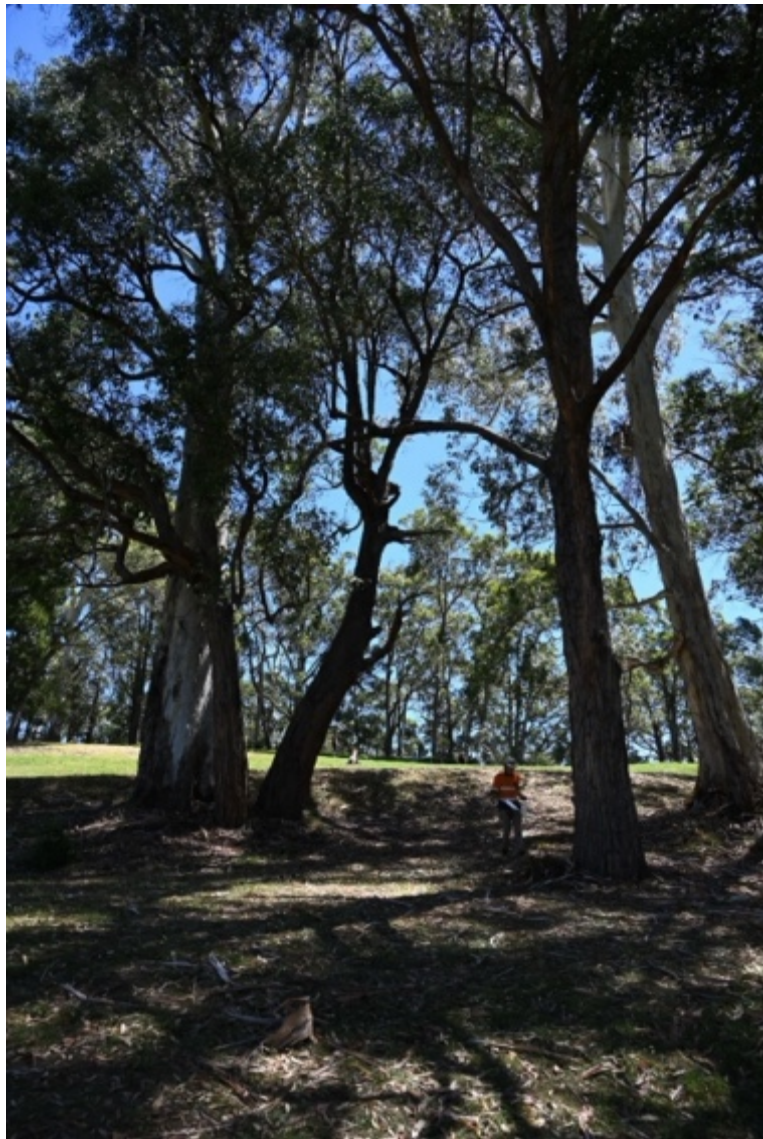
Tree T4 (Site: Mount Lofty Golf Estate)	Figure 11: Tree T4, Messmate Stringybark (<i>Eucalyptus obliqua</i>), facing south.
Messmate Stringybark (<i>Eucalyptus obliqua</i>)

Number of trees – 1	
Height (m) – 14.1	
Diameter (cm) – 75 (1 stem)	
Hollows – #S:0, #M:0, #L:0	
Canopy dieback (%) – 10	
Total Biodiversity Score – 4.06	
Description	
<p>This tree appears to be in good condition, with minor dieback observed. While no hollows were recorded, together with nearby trees, would provide habitat for small birds, small reptiles, bats and invertebrates, in the form of shelter, perching/roosting, feeding, and nesting.</p> <p>No Threatened Ecological Communities were present at the site. However, six fauna species listed as threatened under the <i>NPW Act</i> have been identified within 5 km since 1995 and the native scattered tree considered suitable for the threatened species including:</p> <ul style="list-style-type: none">• <i>Petroica boodang boodang</i> (Scarlet Robin) <i>NPW Act</i>: (R) – Likely• <i>Zanda funerea whiteae</i> (Yellow-tailed Black Cockatoo) <i>NPW Act</i>: (V) – Known• <i>Trichosurus vulpecula</i> (Common Brushtail Possum) <i>NPW Act</i>: (R) – Highly Likely• <i>Zoothera lunulata halmaturina</i> (Bassian Thrush) <i>EPBC Act</i>: (EN), <i>NPW Act</i> (R) – Highly Likely• <i>Pteropus poliocephalus</i> (Grey-headed Flying-fox) <i>EPBC Act</i> (VU), <i>NPW Act</i>: (R)- Likely• <i>Corcorax melanorhamphos</i> (White-winged Chough) <i>NPW Act</i>: (R) - Likely

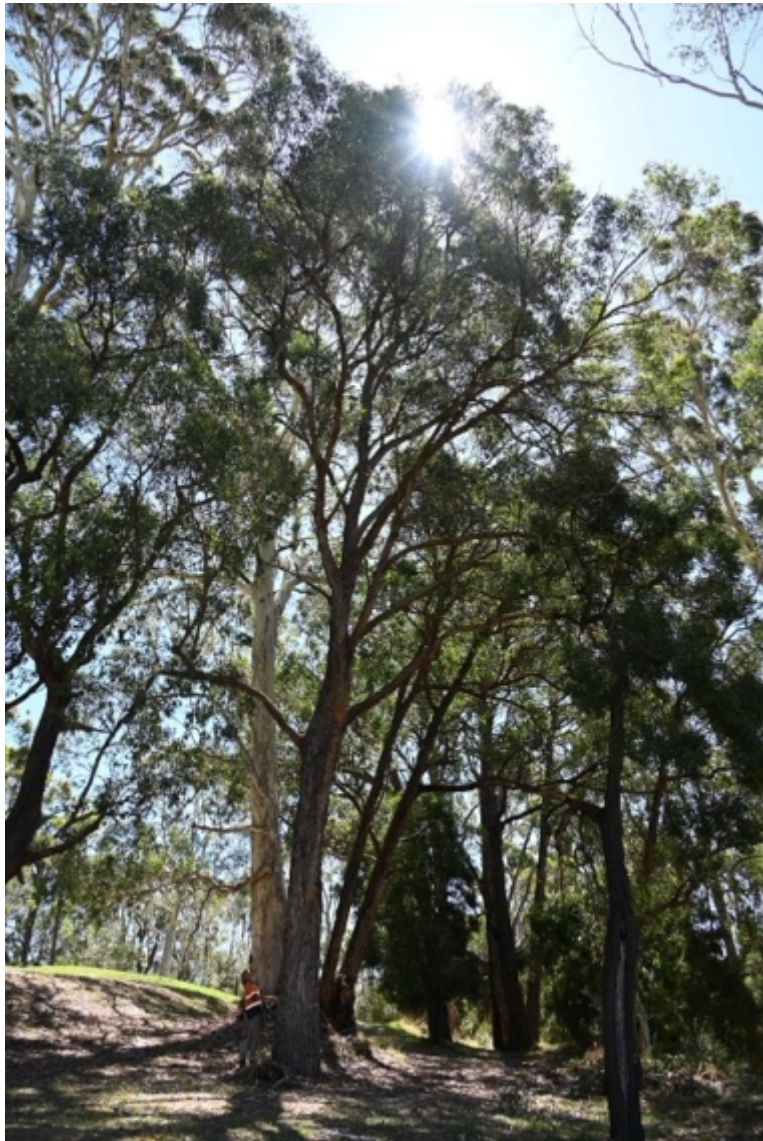
Tree T5 (Site: Mount Lofty Golf Estate)	Figure 12: Tree T5, Messmate Stringybark (<i>Eucalyptus obliqua</i>), facing south.
Messmate Stringybark (<i>Eucalyptus obliqua</i>)

Number of trees – 1	
Height (m) – 19.8	
Diameter (cm) – 84 (1 stems)	
Hollows – #S:0, #M:0, #L:0	
Canopy dieback (%) – 10	
Total Biodiversity Score – 4.57	
Description	
<p>This tree appears to be in good condition, with minor dieback. While no hollows were recorded, together with nearby trees, would provide habitat for small birds, small reptiles, bats and invertebrates, in the form of shelter, perching/roosting, feeding, and nesting.</p> <p>No Threatened Ecological Communities were present at the site. However, six fauna species listed as threatened under the <i>NPW Act</i> have been identified within 5 km since 1995 and the native scattered tree considered suitable for the threatened species including:</p> <ul style="list-style-type: none">• <i>Petroica boodang boodang</i> (Scarlet Robin) <i>NPW Act</i>: (R) – Likely• <i>Zanda funerea whiteae</i> (Yellow-tailed Black Cockatoo) <i>NPW Act</i>: (V) – Known• <i>Trichosurus vulpecula</i> (Common Brushtail Possum) <i>NPW Act</i>: (R) – Highly Likely• <i>Zoothera lunulata halmaturina</i> (Bassian Thrush) <i>EPBC Act</i>: (EN), <i>NPW Act</i> (R) – Highly Likely• <i>Pteropus poliocephalus</i> (Grey-headed Flying-fox) <i>EPBC Act</i> (VU), <i>NPW Act</i>: (R)- Likely• <i>Corcorax melanorhamphos</i> (White-winged Chough) <i>NPW Act</i>: (R) - Likely

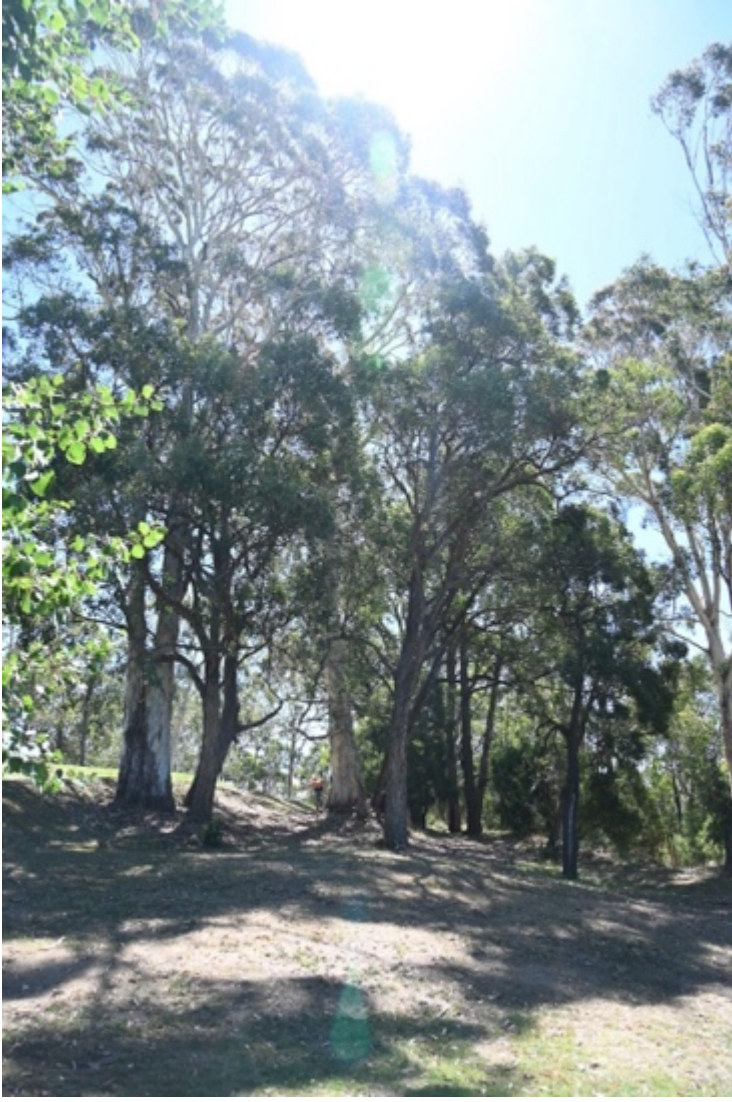
Tree T6 (Site: Mount Lofty Golf Estate)	<p>Figure 13: Tree T7, Manna Gum (<i>Eucalyptus viminalis</i> ssp. <i>viminalis</i>), facing south.</p>
Manna Gum (<i>Eucalyptus viminalis</i> ssp. <i>viminalis</i>)

Number of trees – 1	
Height (m) – 32.4	
Diameter (cm) – 141 (1 stems)	
Hollows – #S:3, #M:2, #L:1	
Canopy dieback (%) – 5	
Total Biodiversity Score – 10.69	
Description	
<p><i>Eucalyptus viminalis</i> ssp. <i>viminalis</i> is listed as Rare under the <i>NPW Act</i>. This tree appears to be in good condition, with minor dieback. The tree contained a total of six hollows and together with nearby trees, would provide habitat for small birds, small reptiles, bats and invertebrates, in the form of shelter, perching/roosting, feeding, and nesting. <i>E. viminalis</i> ssp. <i>viminalis</i> provides a food resource for koalas (Nicolle 1997, pg. 135).</p> <p>No Threatened Ecological Communities were present at the site. However, six fauna species listed as threatened under the <i>NPW Act</i> have been identified within 5 km since 1995 and the native scattered tree considered suitable for the threatened species including:</p> <ul style="list-style-type: none"> • <i>Petroica boodang boodang</i> (Scarlet Robin) <i>NPW Act</i>: (R) – Likely • <i>Zanda funerea whiteae</i> (Yellow-tailed Black Cockatoo) <i>NPW Act</i>: (V) – Known • <i>Trichosurus vulpecula</i> (Common Brushtail Possum) <i>NPW Act</i>: (R) – Highly Likely • <i>Zoothera lunulata halmaturina</i> (Bassian Thrush) <i>EPBC Act</i>: (EN), <i>NPW Act</i> (R) – Highly Likely • <i>Pteropus poliocephalus</i> (Grey-headed Flying-fox) <i>EPBC Act</i> (VU), <i>NPW Act</i>: (R)- Likely • <i>Corcorax melanorhamphos</i> (White-winged Chough) <i>NPW Act</i>: (R) - Likely

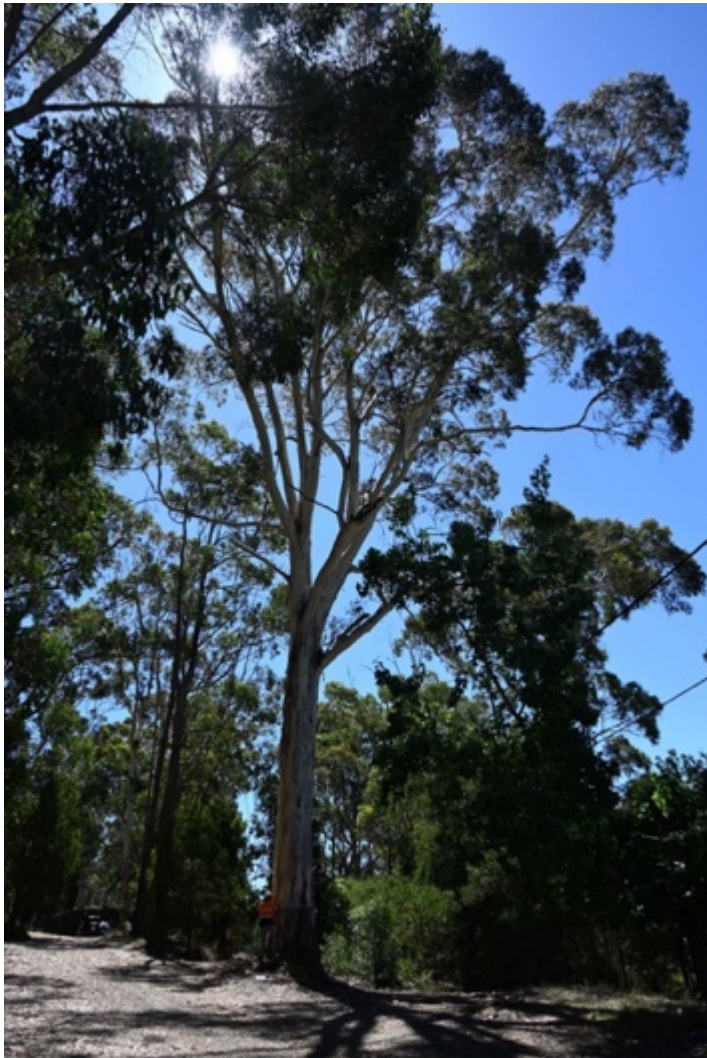
Tree T7 (Site: Mount Lofty Golf Estate)	Figure 14: Tree T10, Manna Gum (<i>Eucalyptus viminalis</i> ssp. <i>viminalis</i>), facing south.
Manna Gum (<i>Eucalyptus viminalis</i> ssp. <i>viminalis</i>)

Number of trees – 1	
Height (m) – 31.2	
Diameter (cm) – 142 (1 stems)	
Hollows – #S:2, #M:0, #L:0	
Canopy dieback (%) – 5	
Total Biodiversity Score – 9.71	
Description	
<p><i>Eucalyptus viminalis</i> ssp. <i>viminalis</i> is listed as Rare under the <i>NPW Act</i>. This tree appears to be in good condition, 5% mistletoe dieback was observed. The tree contained a total of two small hollows and together with nearby trees, would provide habitat for small birds, small reptiles, bats and invertebrates, in the form of shelter, perching/roosting, feeding, and nesting. <i>E. viminalis</i> ssp. <i>viminalis</i> provides a food resource for koalas (Nicolle 1997, pg. 135).</p> <p>No Threatened Ecological Communities were present at the site. However, six fauna species listed as threatened under the <i>NPW Act</i> have been identified within 5 km since 1995 and the native scattered tree considered suitable for the threatened species including:</p> <ul style="list-style-type: none"> • <i>Petroica boodang boodang</i> (Scarlet Robin) <i>NPW Act</i>: (R) – Likely • <i>Zanda funerea whiteae</i> (Yellow-tailed Black Cockatoo) <i>NPW Act</i>: (V) – Known • <i>Trichosurus vulpecula</i> (Common Brushtail Possum) <i>NPW Act</i>: (R) – Highly Likely • <i>Zoothera lunulata halmaturina</i> (Bassian Thrush) <i>EPBC Act</i>: (EN), <i>NPW Act</i> (R) – Highly Likely • <i>Pteropus poliocephalus</i> (Grey-headed Flying-fox) <i>EPBC Act</i> (VU), <i>NPW Act</i>: (R)- Likely • <i>Corcorax melanorhamphos</i> (White-winged Chough) <i>NPW Act</i>: (R) - Likely

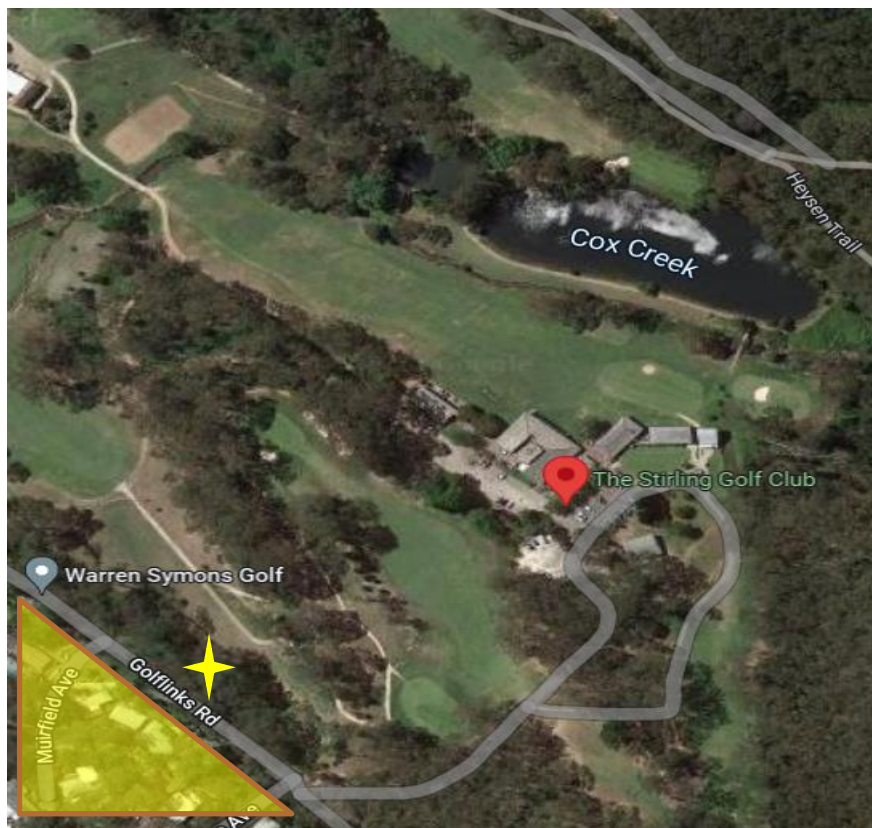
Figure 1: Site location

A continuous noise survey was conducted between 01 September and 05 September 2022 with an automatic noise logger located near the boundary between The Stirling Golf Course and the property where the nearest noise sensitive receiver is located (indicated with a star on Figure 1 in order to establish the existing ambient and background noise levels. The survey was conducted using an automatic noise logger Norsonic Nor139.

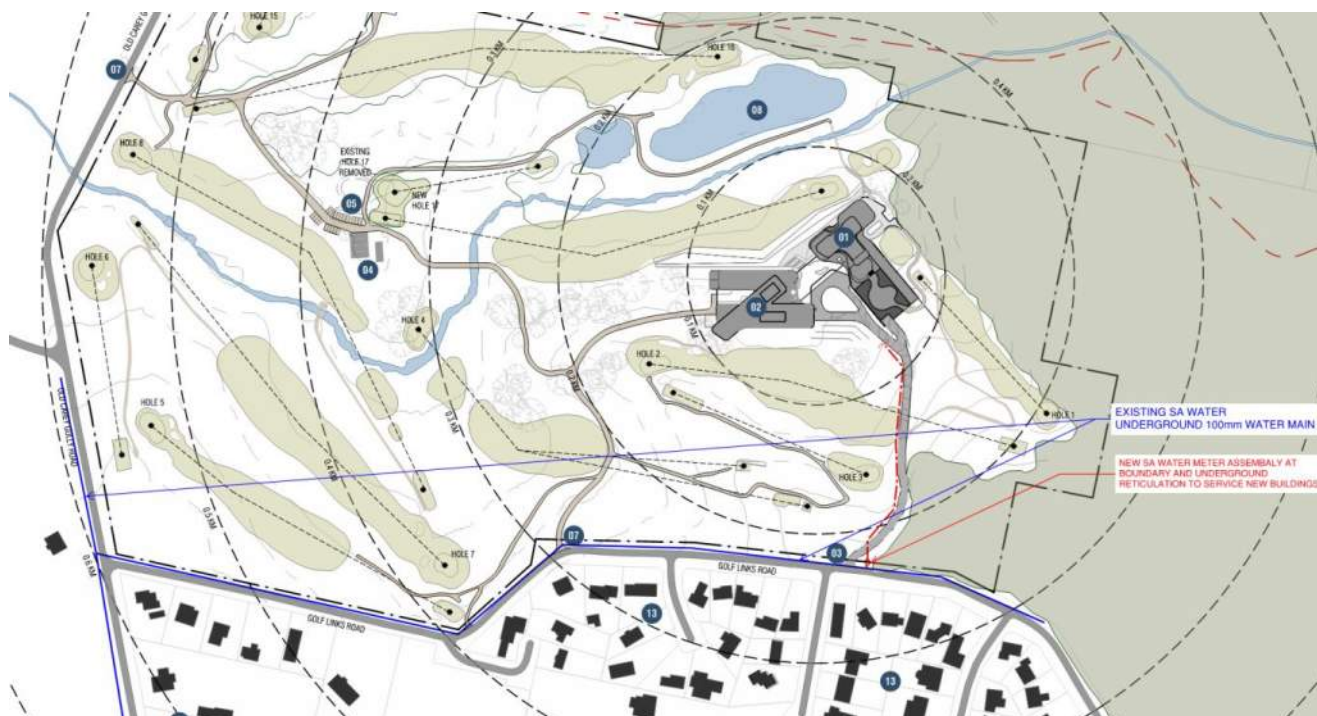
The existing site is serviced via 2 off 100mm SA Water Corporation towns mains within Golflinks Road and Old Cary Gully Road. There is currently no authority recycled water mains within the local area of the site.

Image 1 – SA Water Corporation Water Infrastructure
