GEOTECHNICAL INVESTIGATION AND SOIL STUDY

Sheep Hill Marine Port Facility Baseline Study

Report Number: 087661006 031 R Rev1

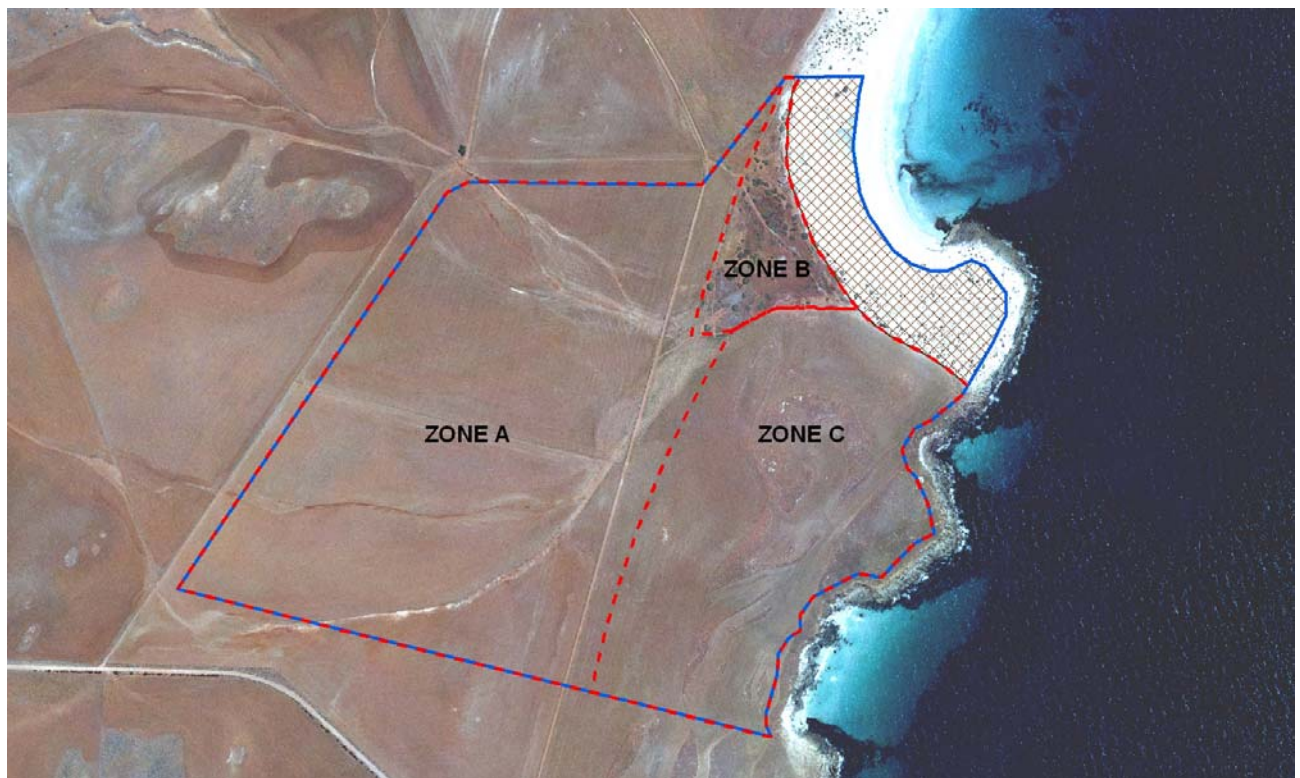
Based on our investigations, the port site may be separated into three zones, each with distinct geotechnical characteristics. The zones are shown in the figure below.

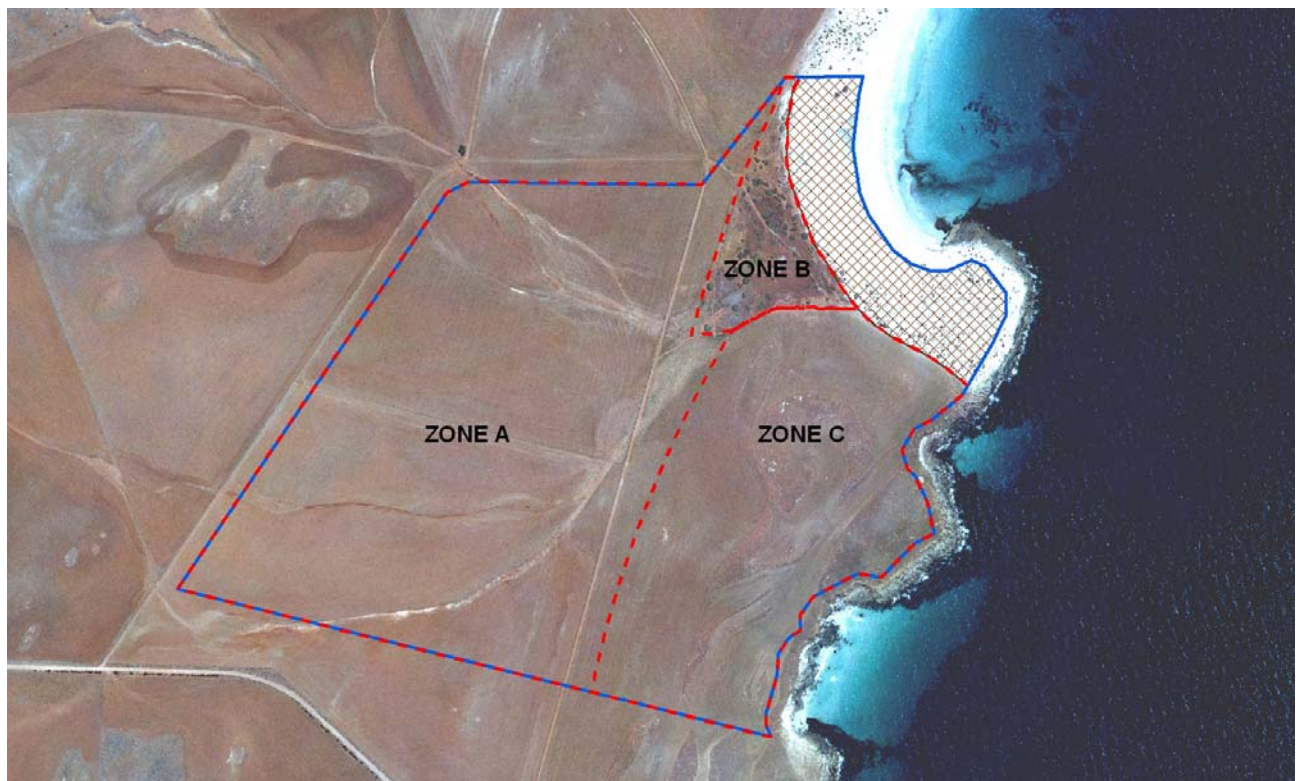
Based on our investigations, the port site may be separated into three zones, each with distinct geotechnical characteristics. The zones are shown in the figure below.

The boundaries between the zones cannot be interpreted accurately on the basis of the relatively few widely spaced test pits and boreholes placed during the present investigation and hence the interzone boundaries shown on the figure 2A must be regarded as approximate only.

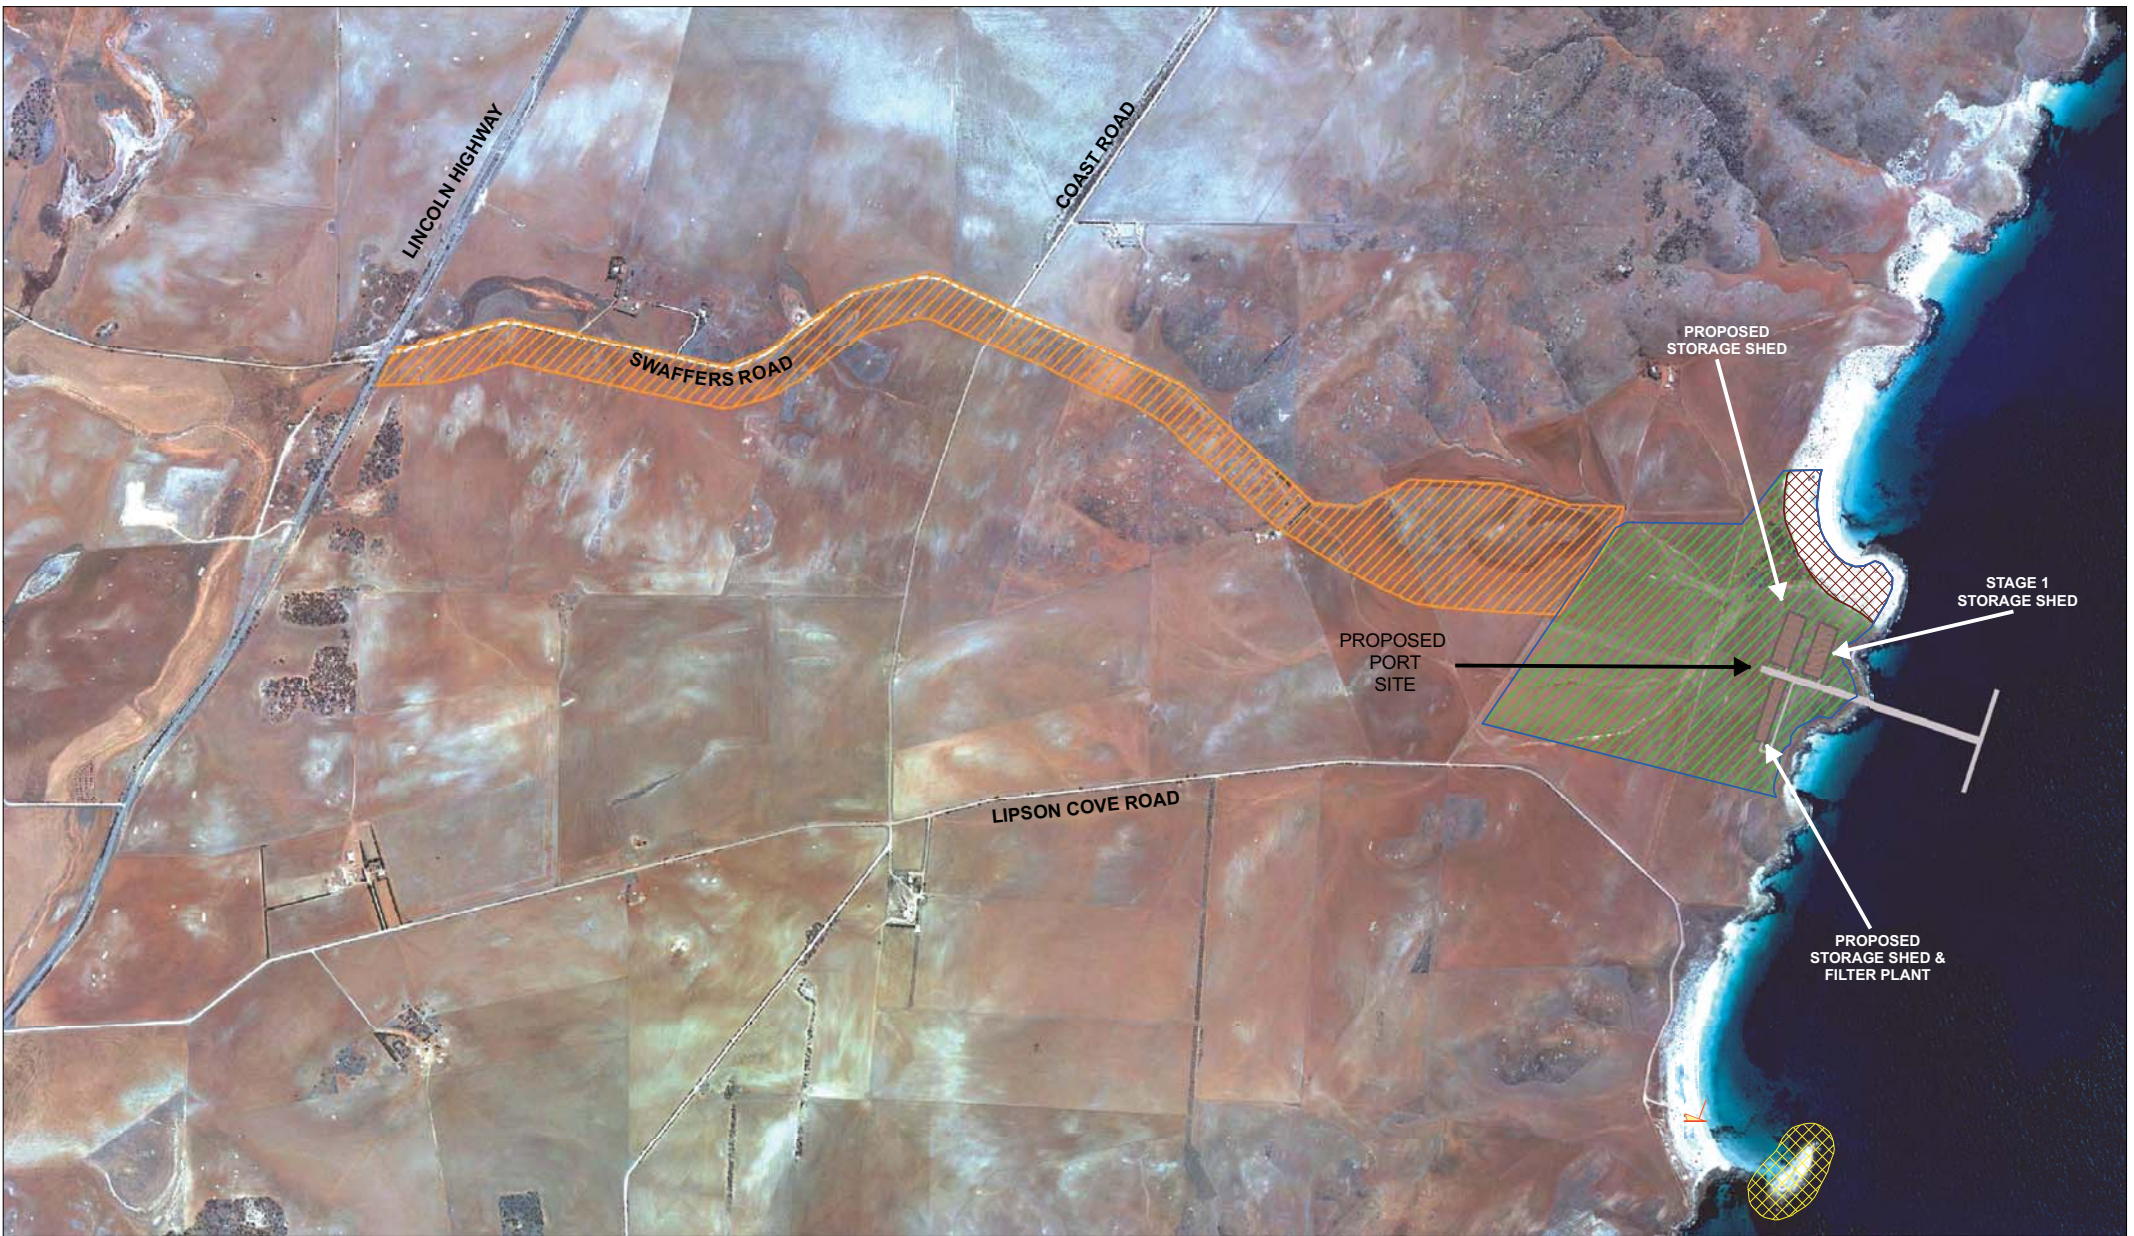
FIGURE 2A

The site is flanked to the north, west and south by rounded hills approximately 50 m in elevation. The coastline to the north of the port site consists of a small bay with a sandy beach. The aerial photograph of the site (Figure 2A) shows an intertidal zone to the west of the small bay in the northern part of the site.

Laboratory results for samples recovered from test pits TP5 and TP19, and field observations indicate that saline soils are present within zone B of the site (refer to Figure 2A).

Figure 2A – Investigation Locations (Test Pits TP01 to TP24 and Boreholes BH01 to BH08)

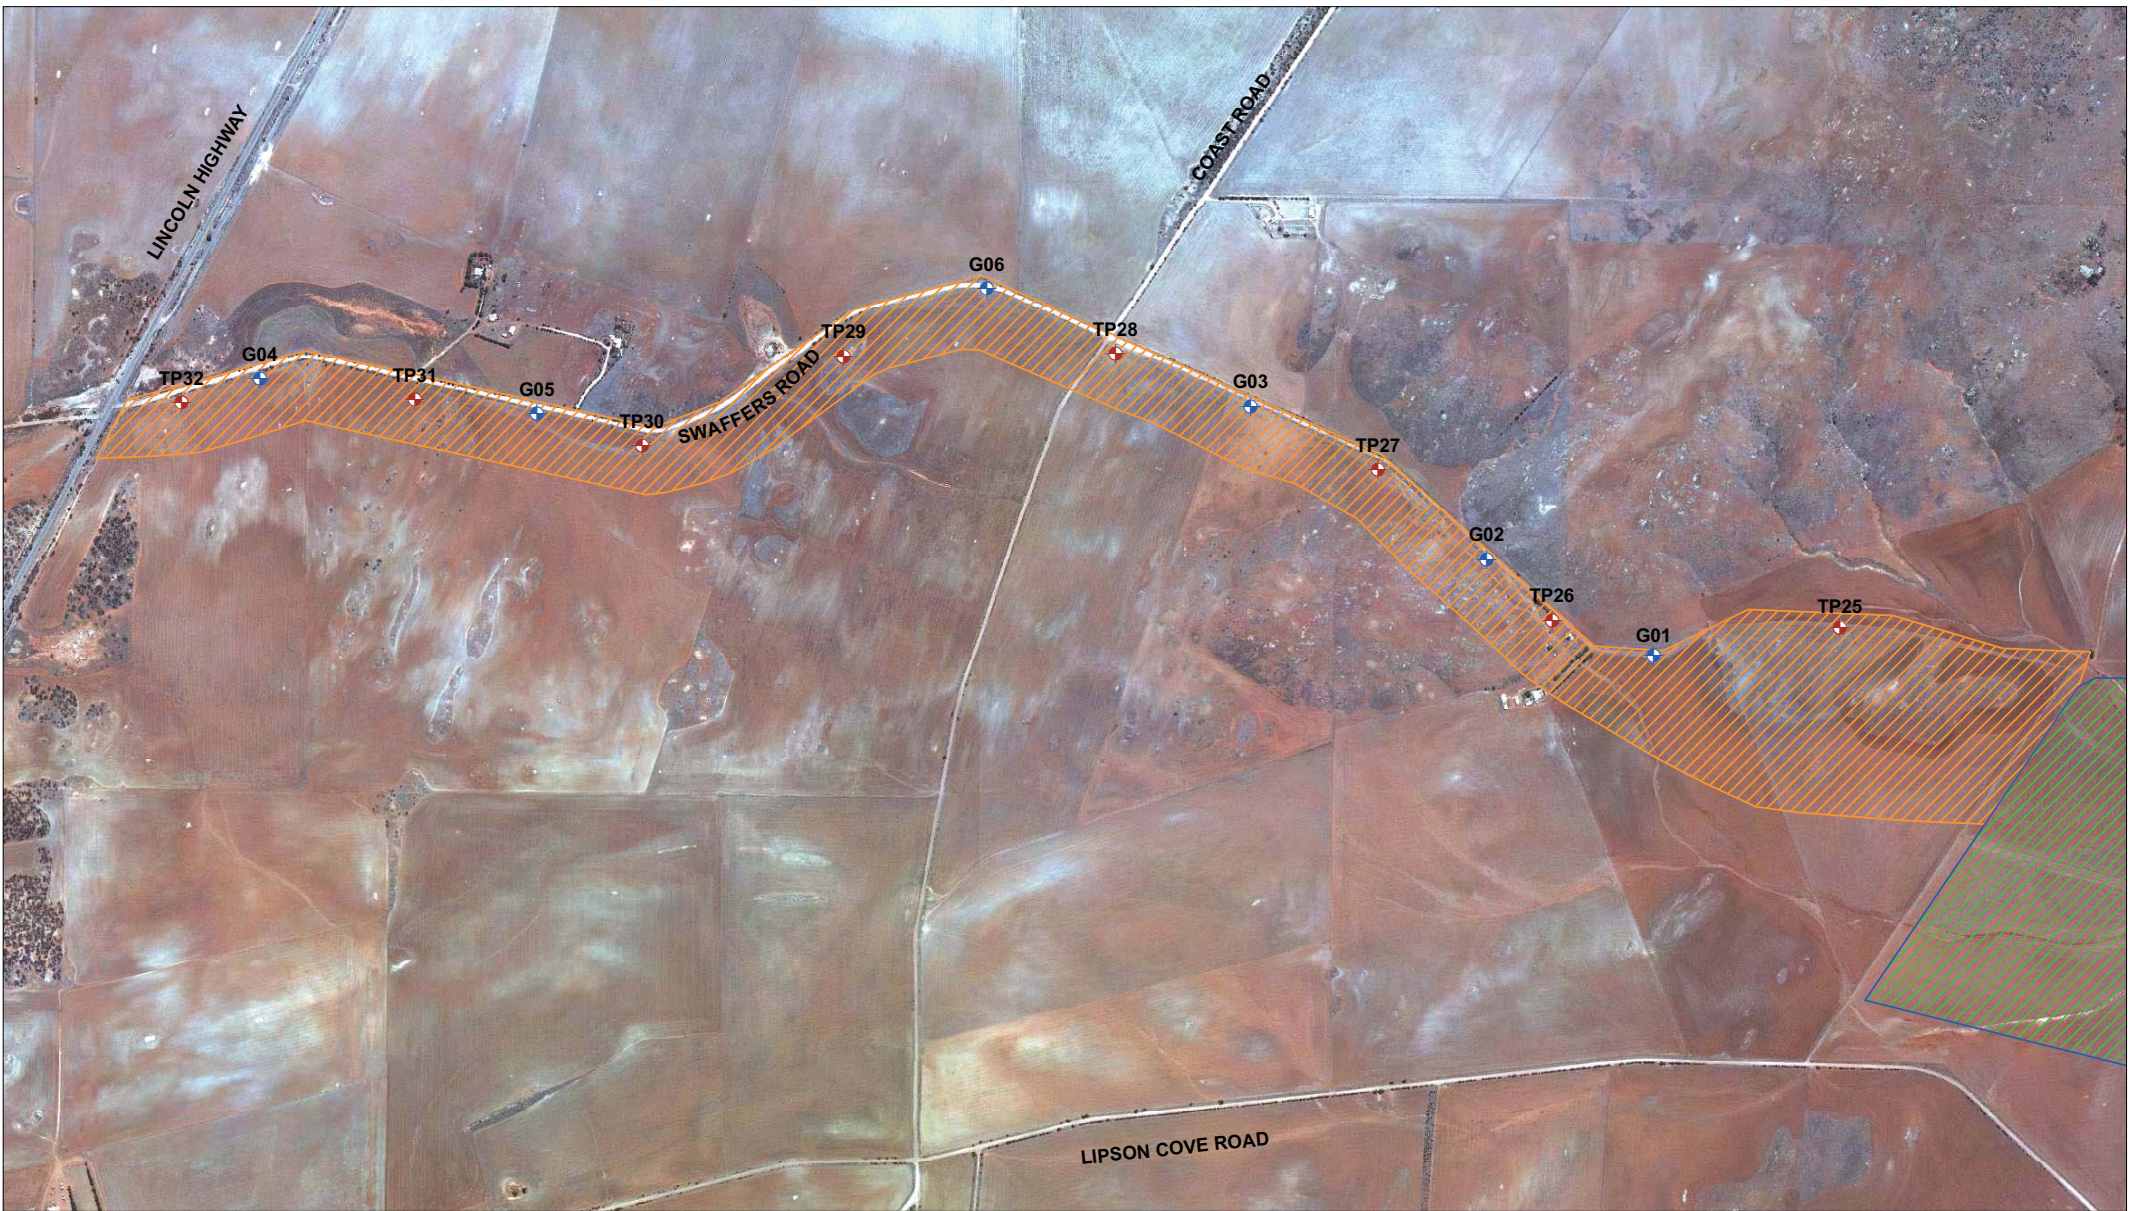
FIGURE 2B

Test Pits TP25 to TP32 were located along the Transport Access Corridor (refer to Figure 2B), in numerical order from east to west:

Figure 2B – Investigation Locations (Test Pits TP25 to TP32)

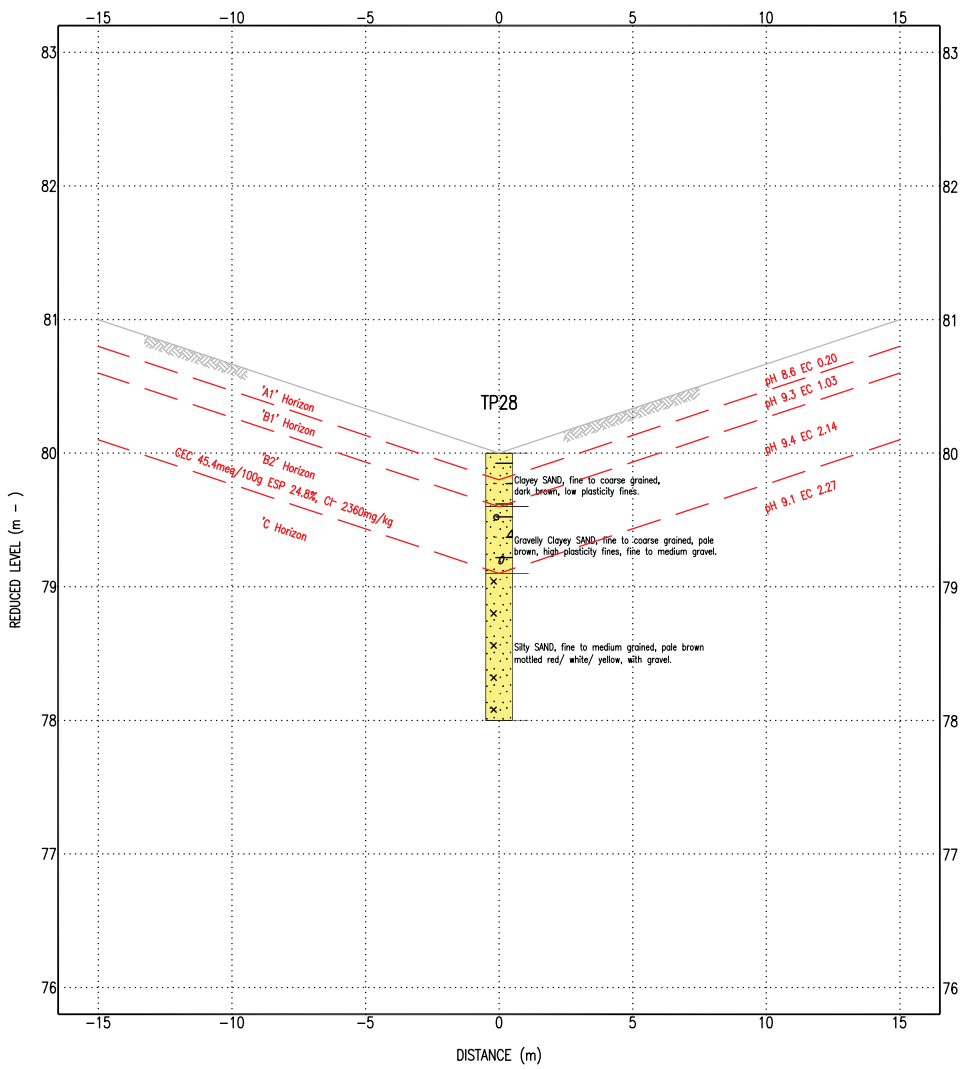
SECTION B-B

CLIENT CENTREX		PROJECT Sheep Hill Port Investigation	
	DRAWN GPG	DATE 10/02/2009	TITLE TRANSPORT CORRIDOR CROSS SECTION A-A, B-B	
CHECKED *HEP	DATE 10/02/2009	PROJECT No 087661006-001		FIGURE No 3A
SCALE H 1:200 V 1:40	REV No A		A3

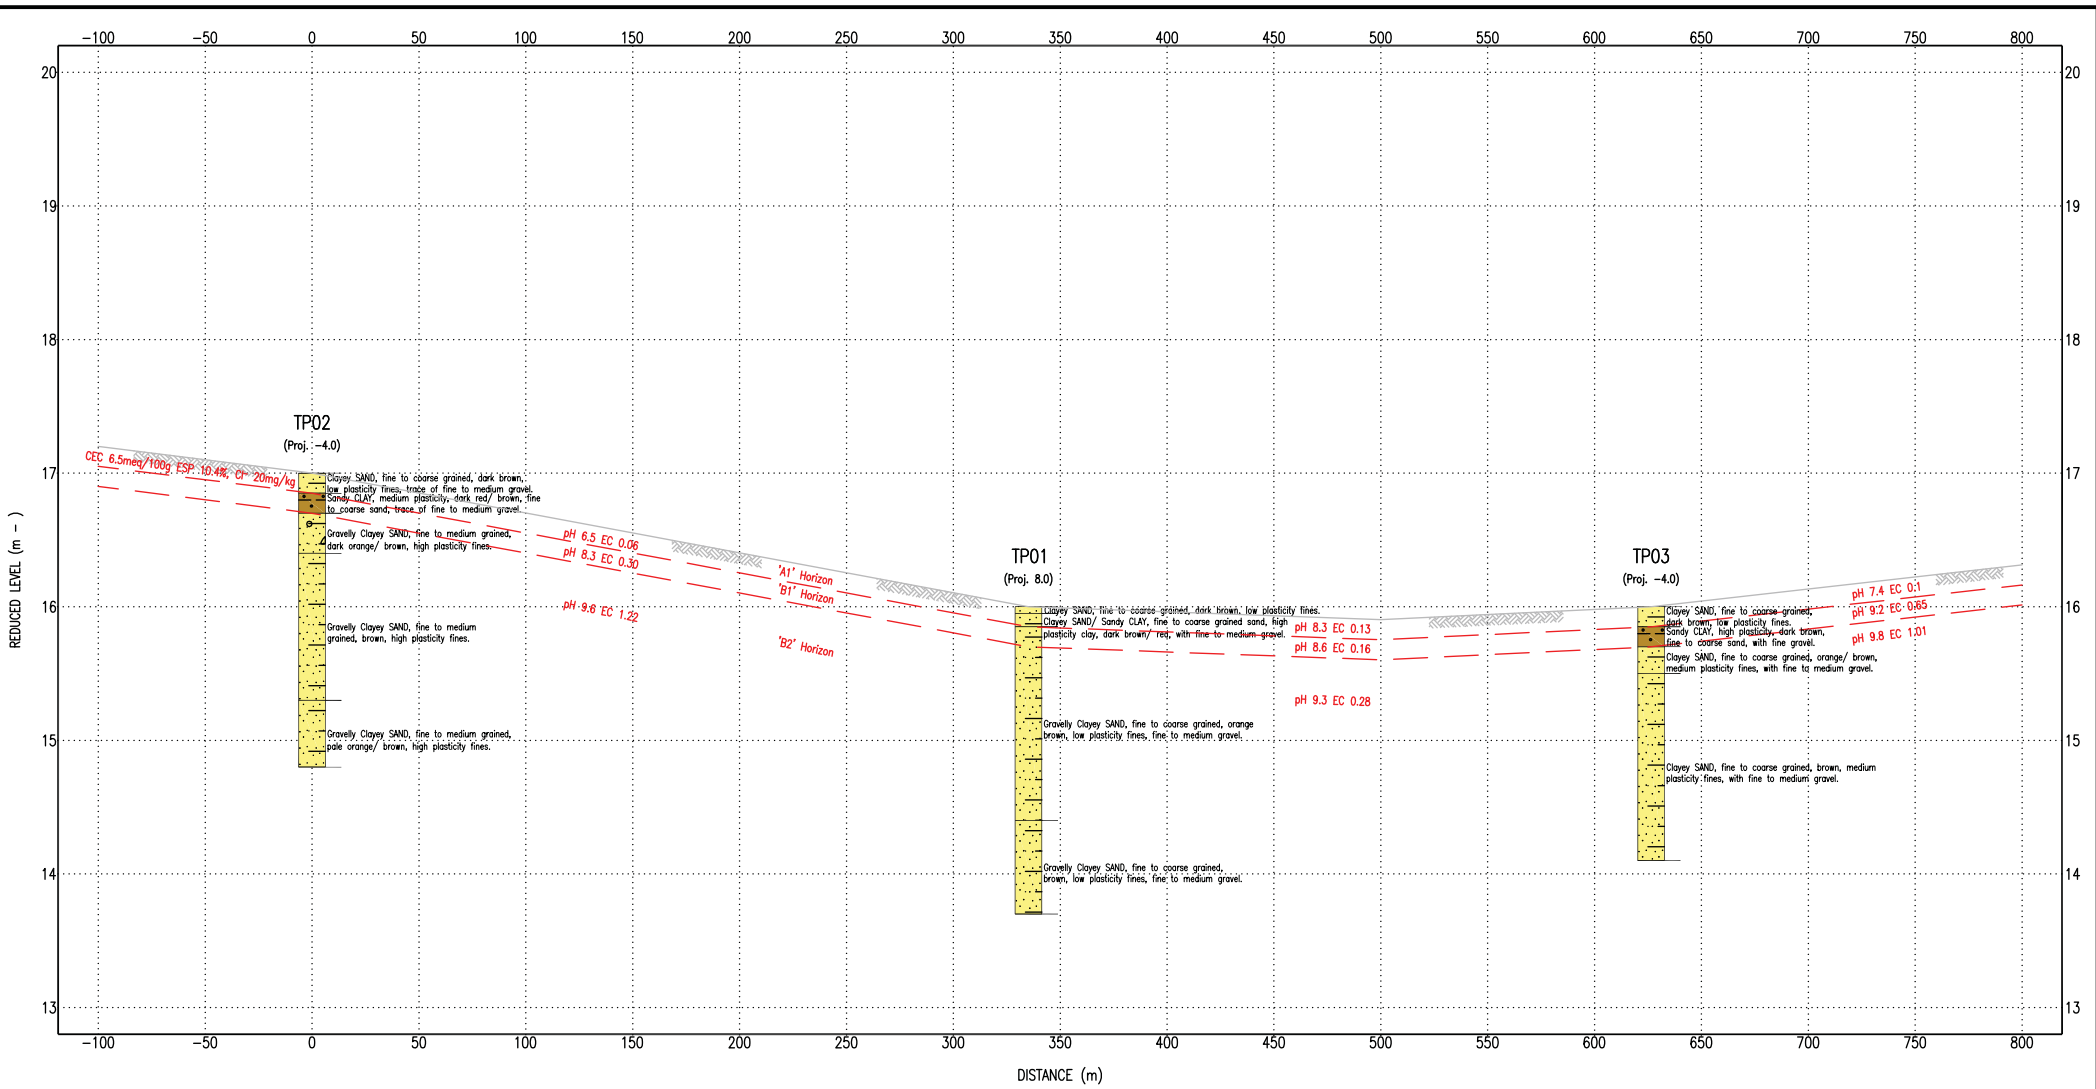
SECTION E-E'

CLIENT CENTREX		PROJECT Sheep Hill Port Investigation	
	DRAWN GPG	DATE 10/02/2009	TITLE PORT SITE CROSS SECTION E-E	
	CHECKED *HEP	DATE 10/02/2009	PROJECT No 087661006-001	FIGURE No 3C
	SCALE H 1:2500 V 1:40		REV No A	A3

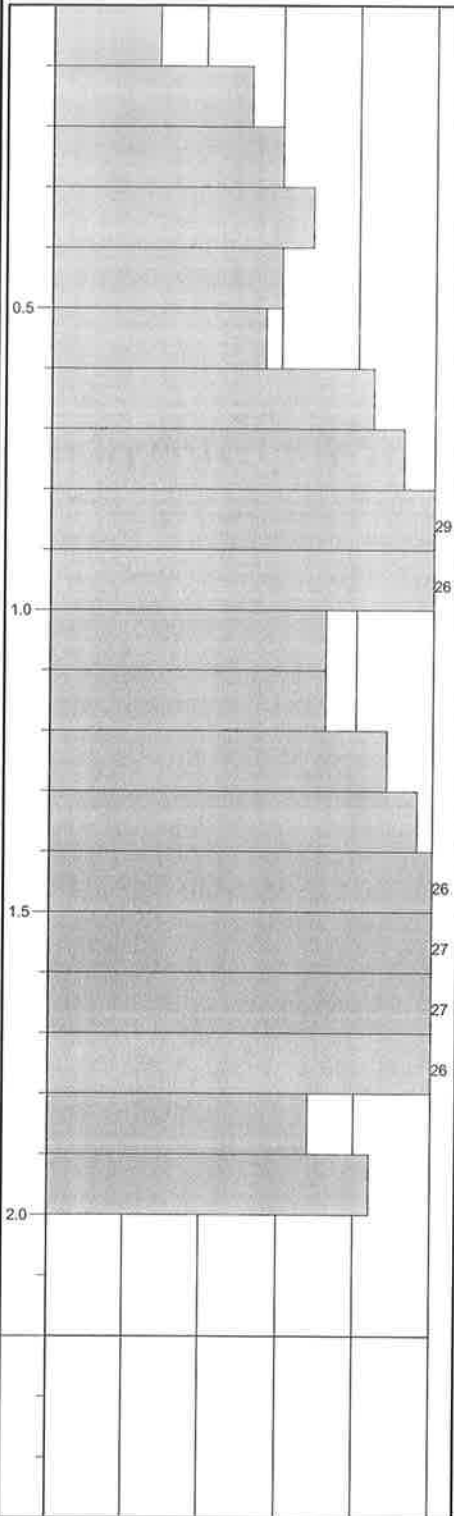
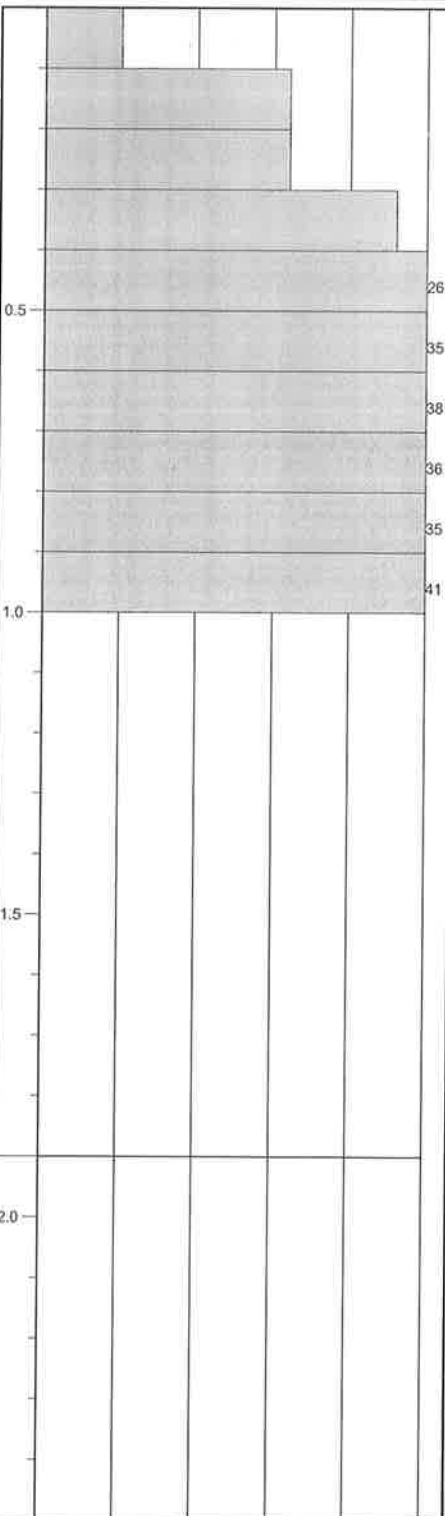
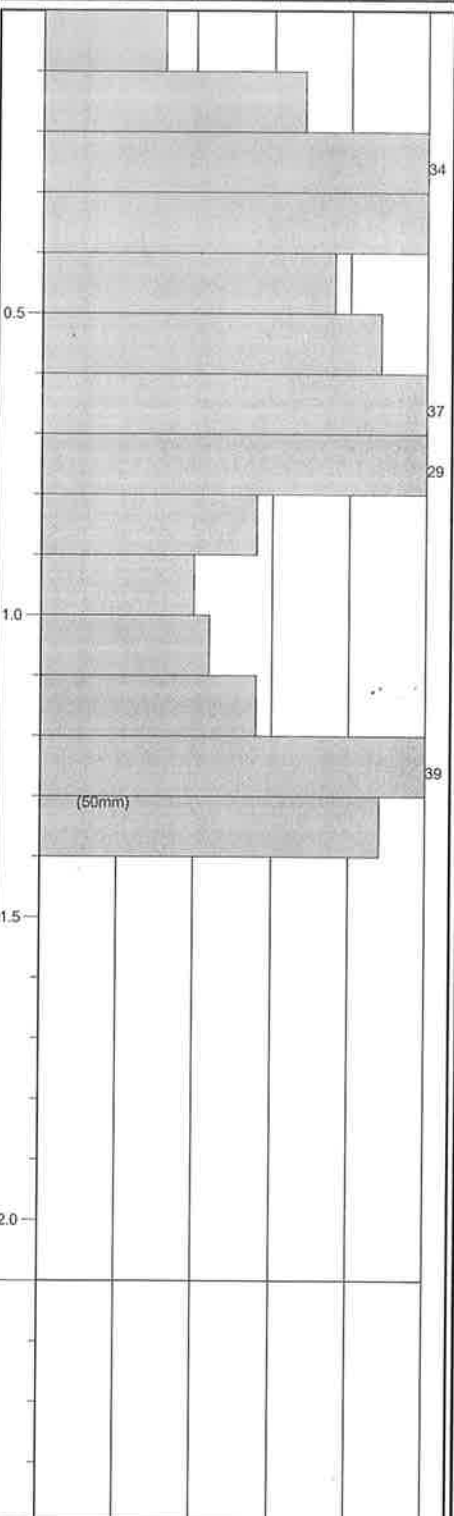
TESTED: AJB DATE: 07/11/2008 **TEST: TP03**
 COORDS: 616050.0 m E 6210250.0 m N MGA94 53
 SURFACE RL: DATUM: AHD
 (AS1289.6.3.2) Blows per 100 mm

TESTED: AJB DATE: 07/11/2008 **TEST: TP04**
 COORDS: 616250.0 m E 6210200.0 m N MGA94 53
 SURFACE RL: DATUM: AHD
 (AS1289.6.3.2) Blows per 100 mm

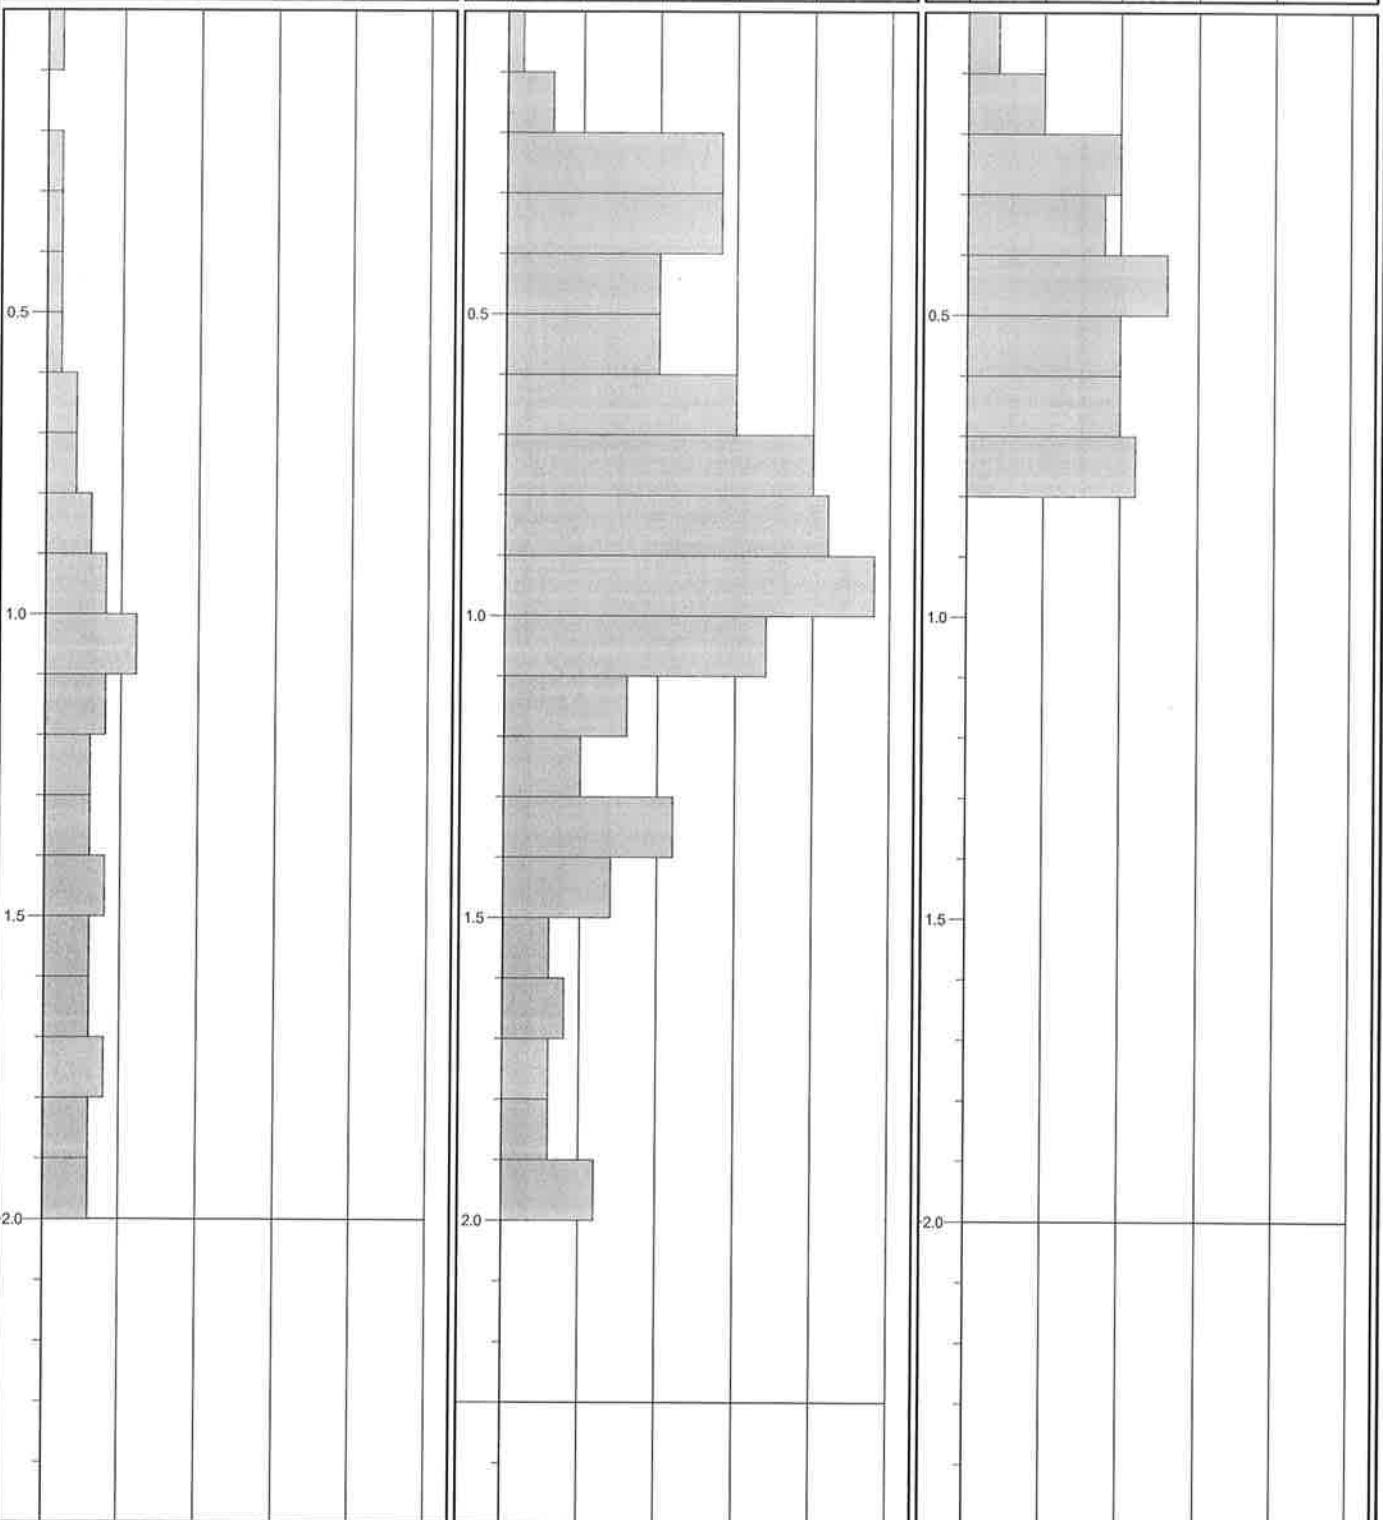
TESTED: AJB DATE: 04/11/2008 TEST: TP05 COORDS: 616450.0 m E 621050.0 m N MGA94 53 SURFACE RL: DATUM: AHD	TESTED: AJB DATE: 04/11/2008 TEST: TP06 COORDS: 616300.0 m E 6209950.0 m N MGA94 53 SURFACE RL: DATUM: AHD	TESTED: AJB DATE: 05/11/2008 TEST: TP08 COORDS: 616050.0 m E 6209600.0 m N MGA94 53 SURFACE RL: DATUM: AHD
(AS1289.6.3.2) Blows per 100 mm DEPTH (metres) 0 5 10 15 20 25	(AS1289.6.3.2) Blows per 100 mm DEPTH (metres) 0 5 10 15 20 25	(AS1289.6.3.2) Blows per 100 mm DEPTH (metres) 0 5 10 15 20 25

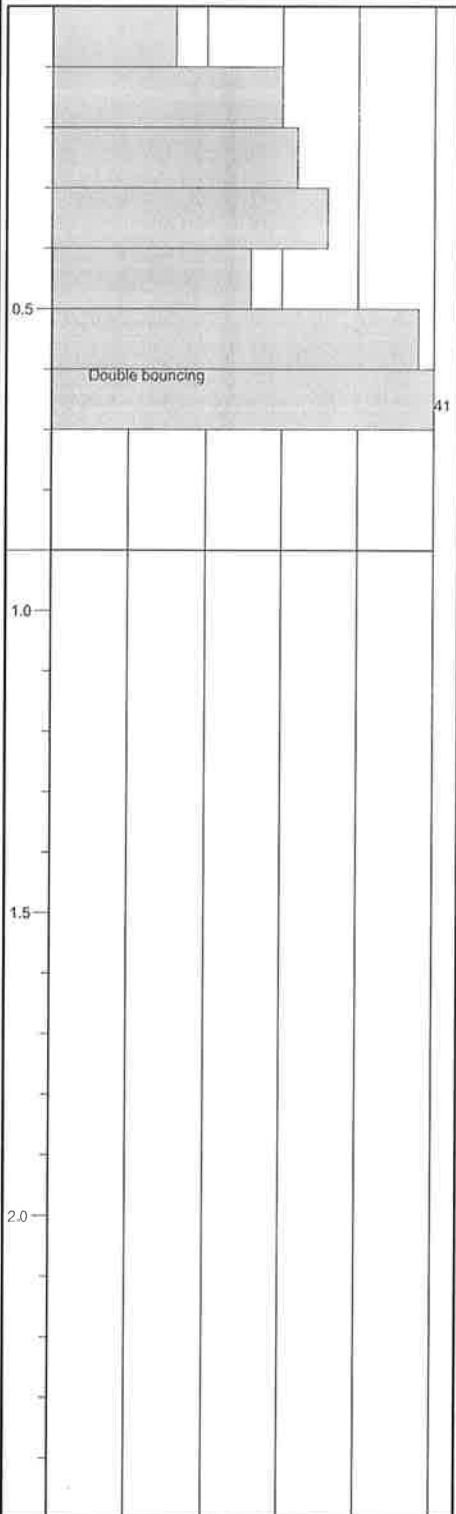
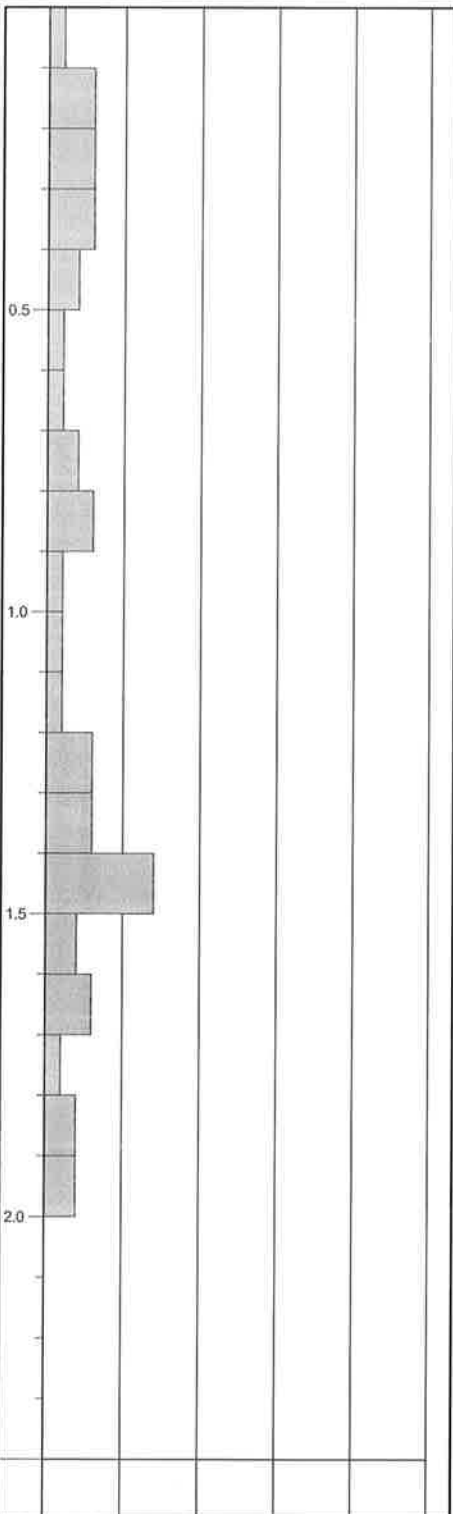
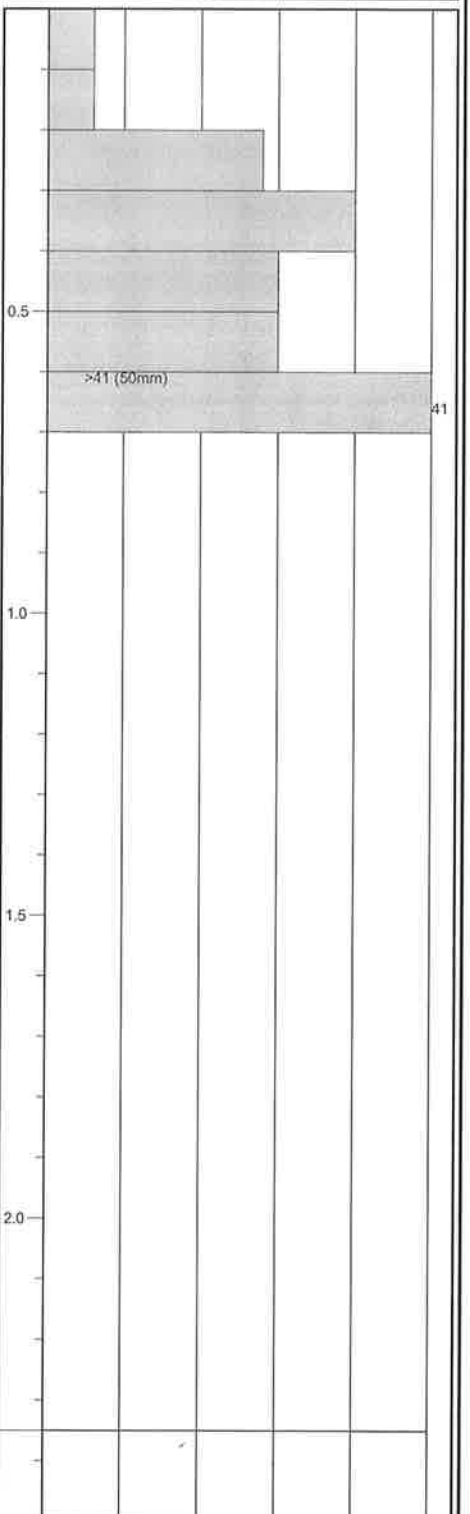
TESTED: AJB DATE: 04/11/2008 TEST: TP19
 COORDS: 616400,0 m E 6210050,0 m N MGA94 53
 SURFACE RL: DATUM: AHD
 (AS1289,6,3,2) Blows per 100 mm

TESTED: AJB DATE: 03/11/2008 TEST: TP20
 COORDS: 616400,0 m E 6209500,0 m N MGA94 53
 SURFACE RL: DATUM: AHD
 (AS1289,6,3,2) Blows per 100 mm

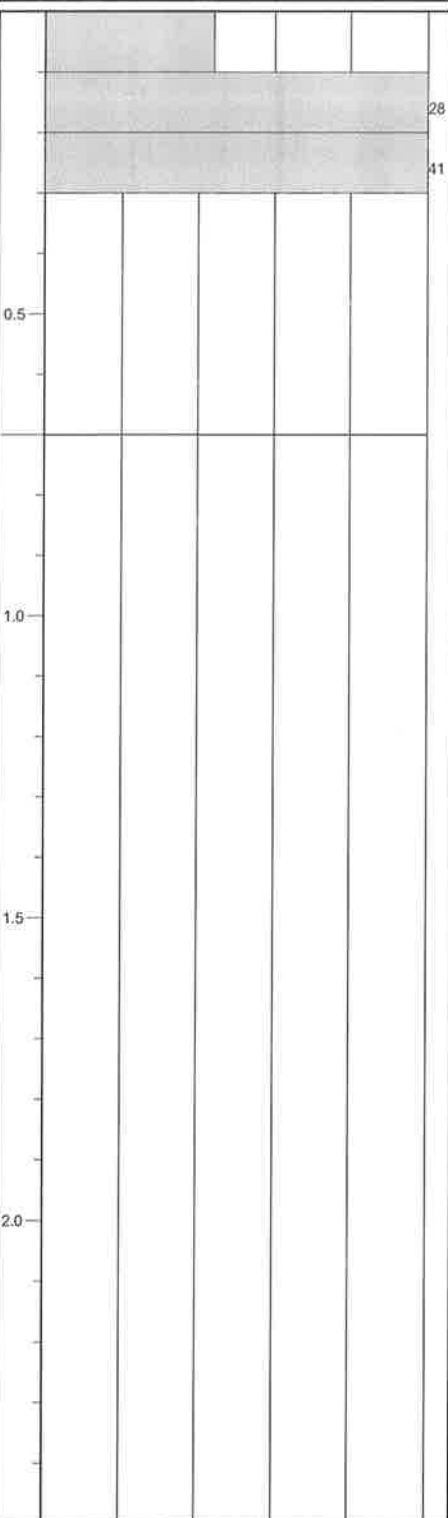
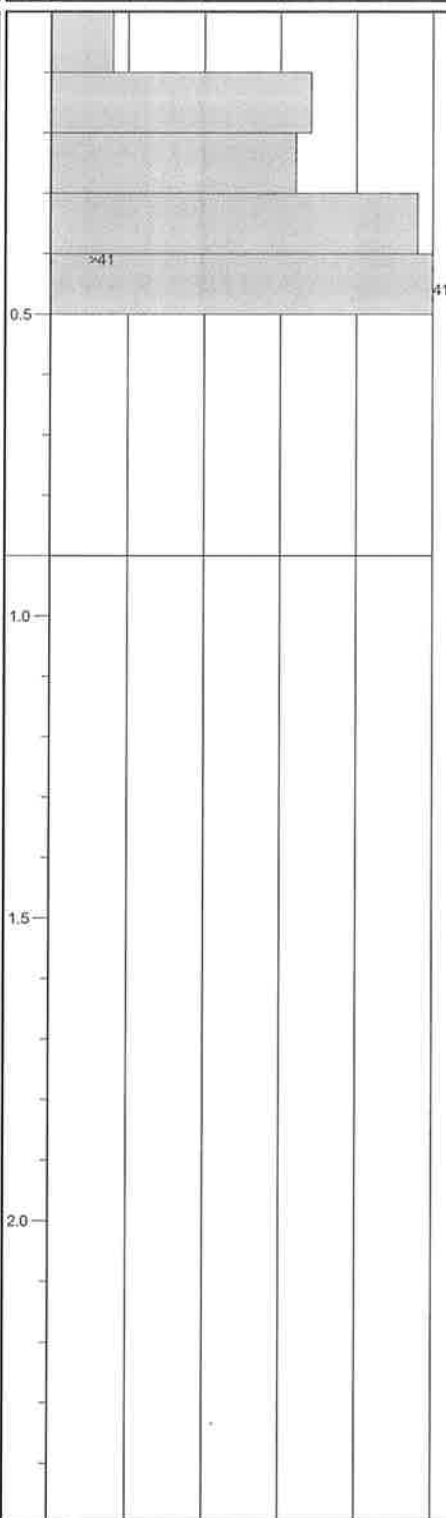
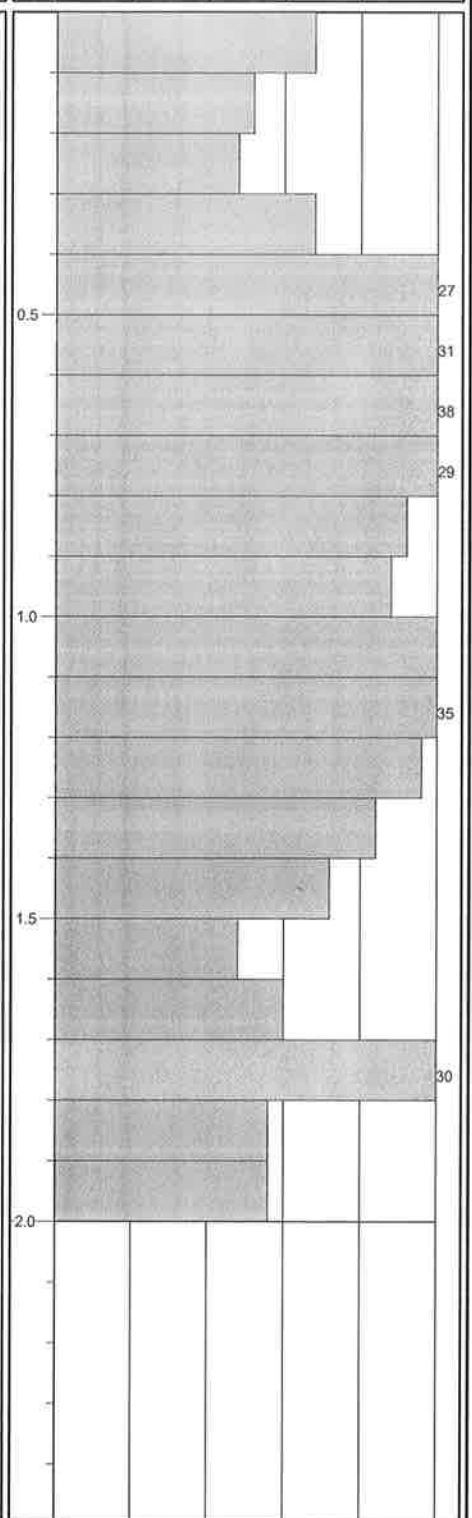
TESTED: AJB DATE: 05/11/2008 **TEST: TP25**
 COORDS: 615314.0 m E 6210419.0 m N MGA94 53
 SURFACE RL: DATUM: AHD
 (AS1289.6.3.2) Blows per 100 mm

TESTED: AJB DATE: 05/11/2008 **TEST: TP26**
 COORDS: 614640.0 m E 6210436.0 m N MGA94 53
 SURFACE RL: DATUM: AHD
 (AS1289.6.3.2) Blows per 100 mm

- TP25 was located in a valley close to the base of a hill and encountered refusal on inferred calcrete at 0.9 m depth. We observed brown/dark brown clayey sand to 0.3 m depth, underlain by calcrete gravel and cobbles in a matrix of brown clayey sand.
- TP26 and TP27 were located in a valley. These pits contained brown or dark brown and fine to coarse grained clayey sand to 2 m depth. There were calcareous inclusions and pale brown or pale orange/white mottling from around 0.5 m to 1.5 m depth.
- TP28 was placed on a saddle, with the ground rising towards the north along Coast Road, and dropping in other directions. This pit encountered dark brown clayey sand to 0.4 m depth, underlain by pale brown gravelly clayey sand to 0.9 m depth. Beneath that there was red/white/yellow mottled silty sand to the base of the pit at 2.0 m.
