# CHAPTER 13

## TERRESTRIAL FLORA AND FAUNA

## 13 Terrestrial Flora and Fauna

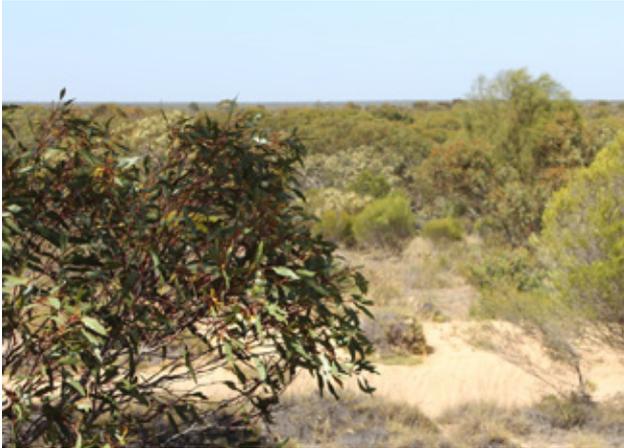
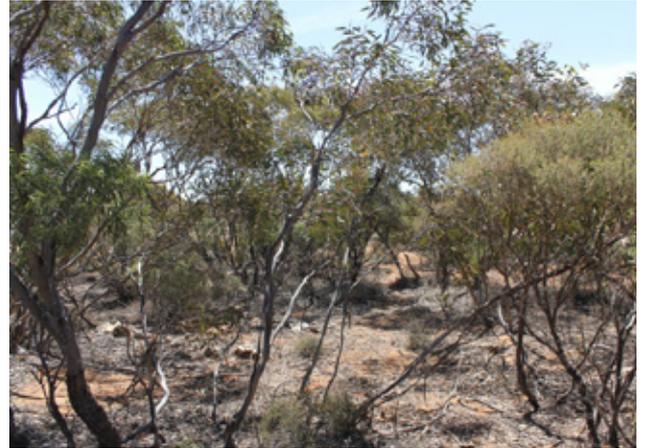
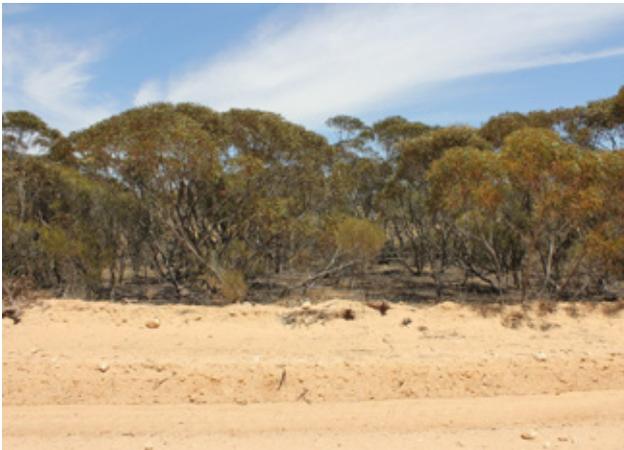
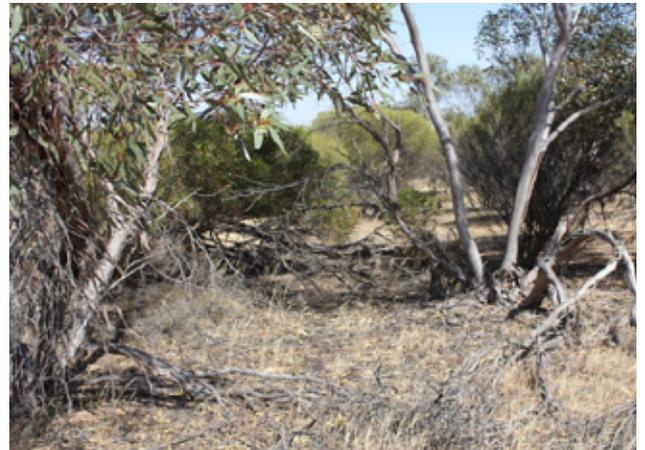
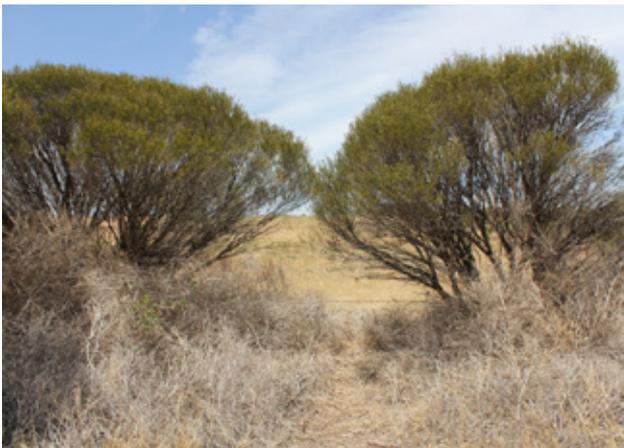
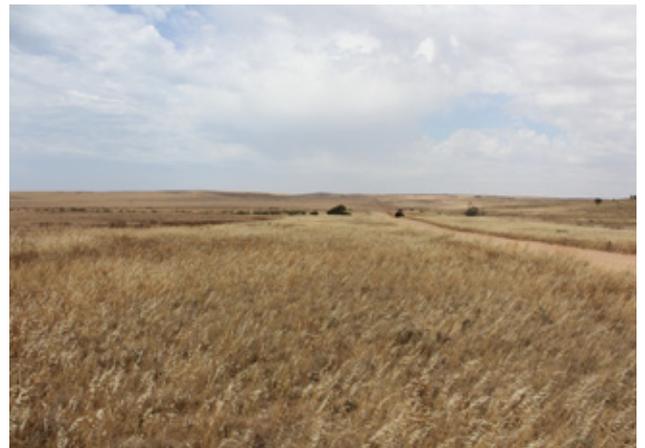
Plate 13-6 Visual Comparison of EP Community 5 Compared to Regional Benchmark from Hambidge WPA

Hambidge WPA (excellent condition, 10:1)

Patch 183a (good condition, 8:1)

Patch 175a (moderate condition, 6:1)

Patch 132 (poor condition, 4:1)

Patch 133 (very poor condition, 2:1)

100% cleared of native vegetation, 0:1

There are 149 vegetation patches that intersect the final infrastructure corridor footprint (including a footprint buffer of 10 m). Condition ratings have been estimated, using data collected in the field and from inference (see Section 13.2.1); with the majority of patches considered to be of very poor to moderate quality (Table 13-4). Species composition for a large portion of the patches was also considered to be poor, when compared with benchmark community descriptions from Milne (et al. 2008). Plate 13-6 below shows a benchmark comparison of Hambidge WPA vegetation (EP Community 5) against examples of good to very poor quality vegetation encountered throughout the alignment.
