**APPENDIX 5**  
**Operational Management Plan (Draft)**

**Willunga Basin Water Co Pty Ltd**

**WBWC-IMS-DOC-xxx**  
**Whittings Rd Recycled Water Storage Operations Environmental Management Plan**

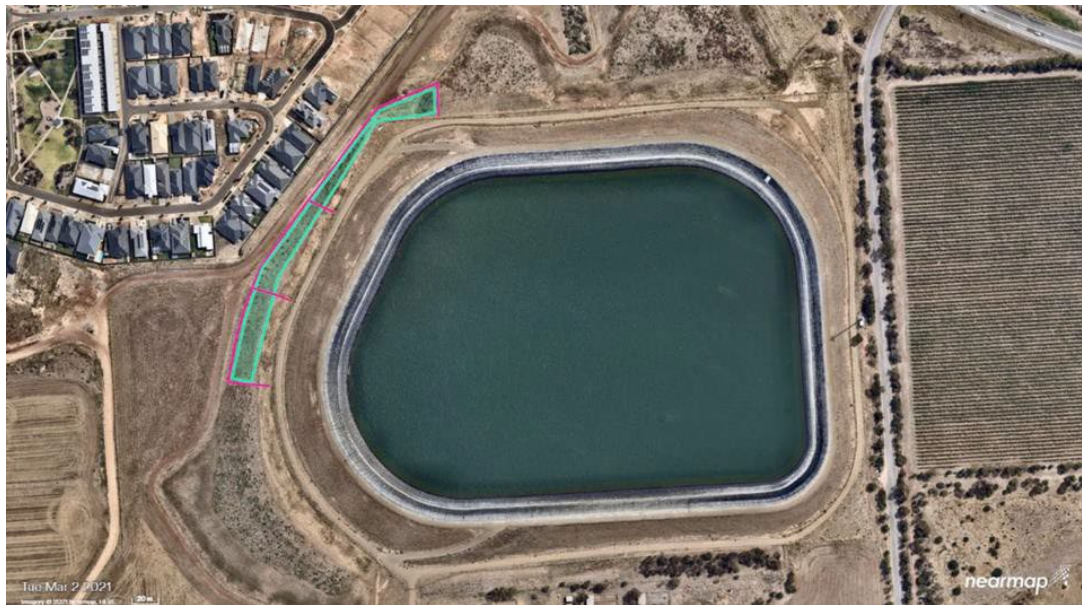
*Figure 2: the fence (pink) will enclose and surround the western perimeter of the dam closest to the housing development; vegetation (green) will be planted on the inside of the fence*

The installation of a shade cloth covered fence will provide an instantaneous partial barrier to minimise the risk of nuisance population of midges reaching the residential development. The conceptual design of the fence is to include a 255m long section that creates a barrier between the residential development and the dam. The fence design will also contain smaller sections that will run from the fence barrier towards the dam to assist keeping the midges trapped within the fenced off area and minimise the number of midge flies dispersed by strong prevailing winds (figure 2).

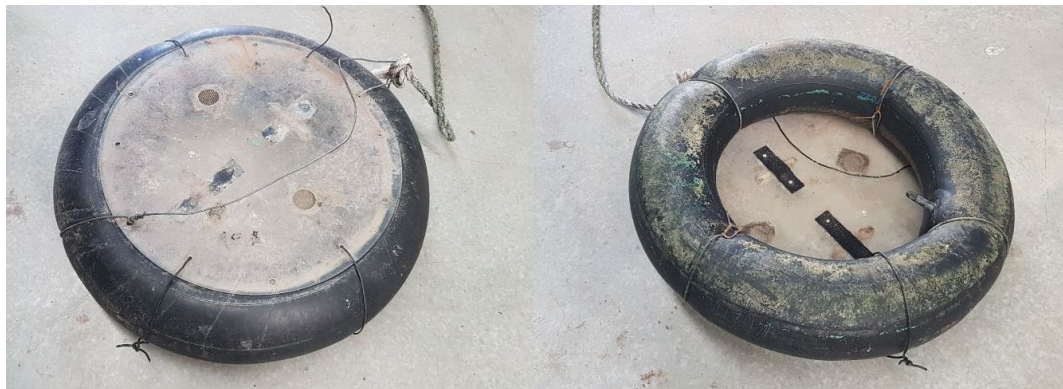
*Figure 3: emergence monitoring buoy*

Emergence monitoring will be conducted by using a float such as a rubber tube / lifebuoy similar to those employed by SA Water at Bolivar (figure 3). The top of the float is covered with a sticky substrate to ensure that the entire internal area is enclosed. The float will naturally provide a sealed environment when placed in the water. Any adult midges that emerge from within the covered area of the floatation device will adhere to the sticky substrate that covers any escape to allow for easy enumeration. After emerging midges have been assessed, the float should be lined with a new adhesive substrate so that consecutive measurements are not cumulative.

This simple device provides a known area of cover over the dam surface and can be extrapolated to provide an indicative estimation of adult midge numbers emerging from the SRWRA dam.

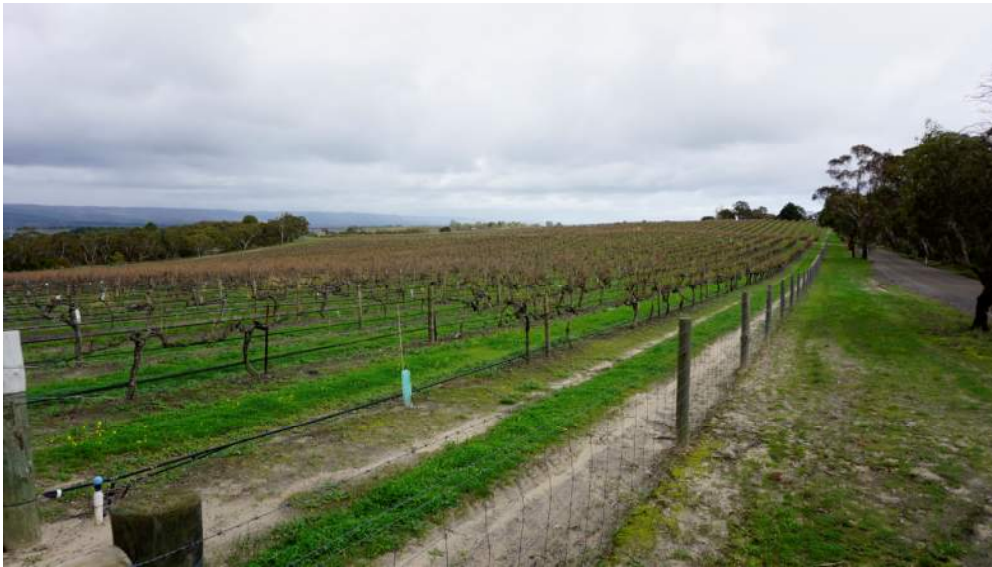
*Figure 3: View of the subject land looking west*

- 2.2.1 The subject land is located on 260 Whitings Road, Blewitt Springs and comprises of a portion of Certificate of Title Volume 5667 Folio 407. The subject land is approximately 35 hectares in size and is located within the Onkaparinga Council area.
- 2.2.2 The subject land includes an existing dwelling and associated ancillary structures, located in the middle of the site with access from Whitings Road. The existing land cover of the subject land in the northern section of the site is a vineyard, as shown in Figure 3, with grazing land in the southern portion. This results in seasonal variations in vegetation retention, harvesting and other agricultural operations on the land.

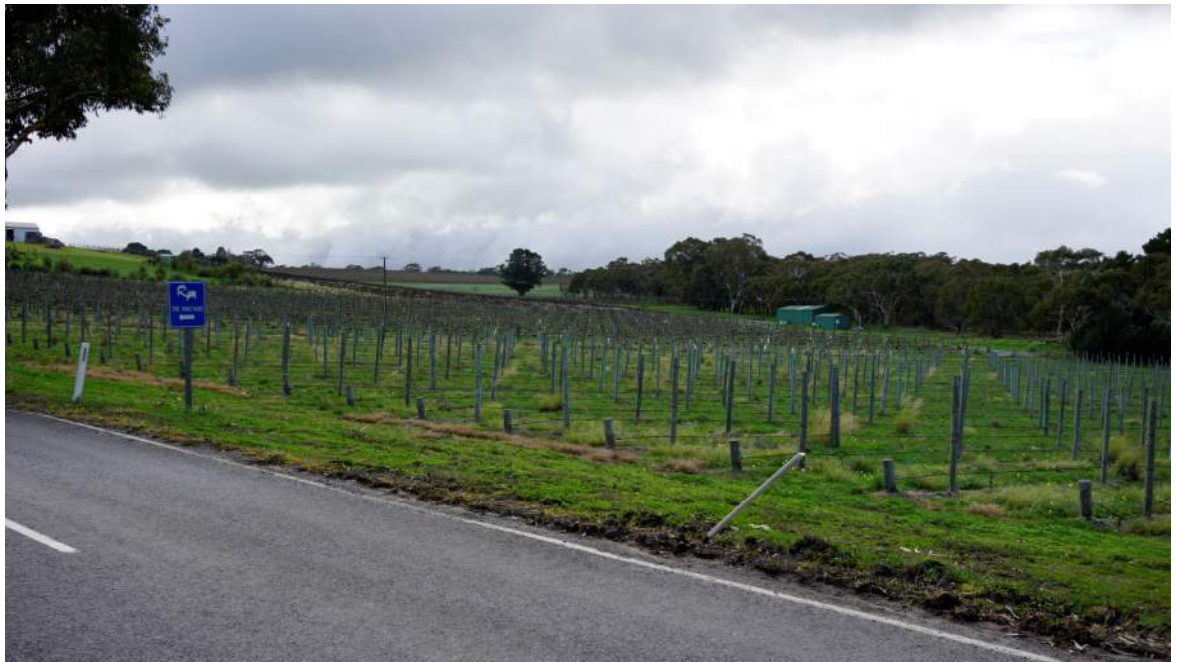
3.2.2 Along Whitings Road, adjacent to 165 Whitings Road, there is a defined view corridor towards the subject land, as shown in Figure 9. This is a result of the proximity to the subject land, local topography and vegetation. This local view corridor will increase the visibility of the southern dam wall. The proposed landform of the southern dam wall will appear as a constructed topographic element within the existing undulating landscape character. The proposed landform is likely to visually replace the existing vine-covered slope with a more inclined landscaped profile. The existing foreground land uses and vegetation will remain.

Figure 9: View towards the subject land taken from The Vineyard Retreat, 165 Whitings Road

3.2.3 The proposed dam will alter the visual character when looking towards the subject land from this location. Over time, the remediation of the earthworks and the introduction of vegetation or other landscape treatments, and with ongoing landscape management, the visual effect of the proposed dam wall is likely to be reduced. It is worth noting that the field of view is narrow (recorded as a 17-degree view corridor), which reduces the potential visual effect within the broader landscape context.

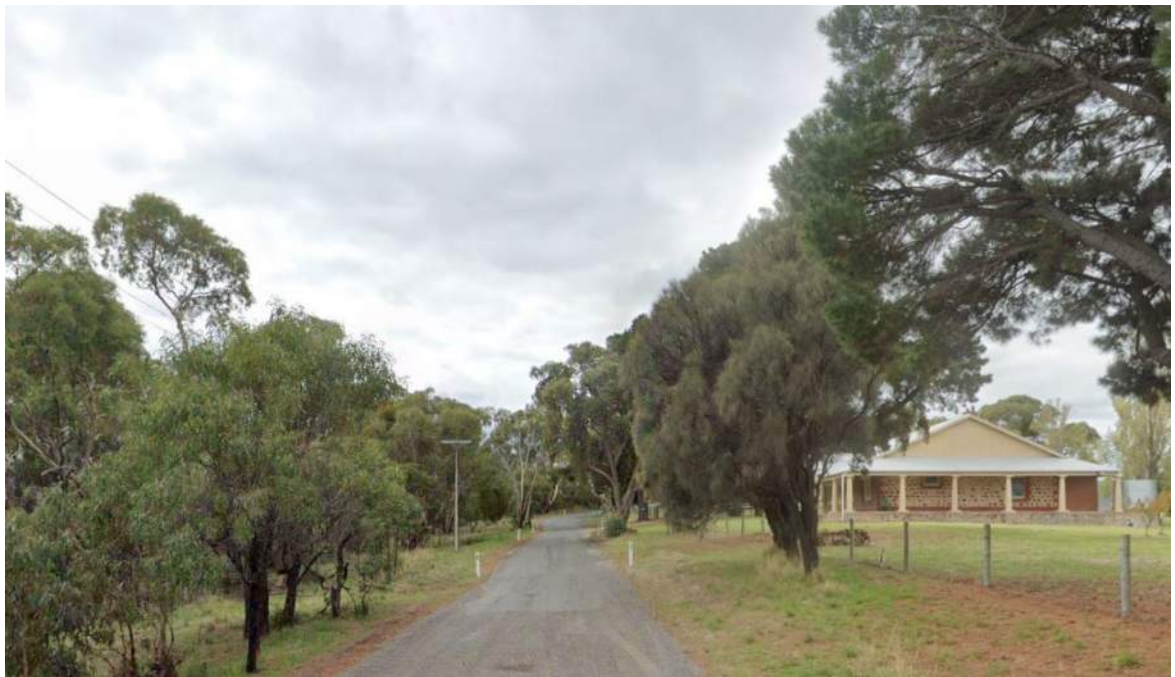
- 3.3.1 The northern boundary of the subject land is located adjacent to Whittings Road, shown in Figure 10. This boundary is approximately 1 kilometre in length. The dense vegetation and established woodland of the Onkaparinga River National Park will remain along the northern road edge. The boundary treatment of the proposed dams will alter the visual character along the southern edge of the road corridor, effectively creating an asymmetrical cross-section profile along Whiting Road.

Figure 10: 260 Whittings Road and Onkaparinga River National Park

- 3.3.2 Looking south across the subject land, the existing agricultural land use and glimpsed views towards the south will be replaced by vegetated dam walls. The proposed dam wall varies from natural ground directly adjacent to the existing dwelling at 260 Whittings Road, to 2.8 metres above natural ground in the south and 4.6 metres above natural ground in the north.

- 3.3.3 The resulting earthworks and landscape treatments will modify the visual character, screening views to the south and replacing them with a revegetated embankment of grasses and shrubs that respond to the remnant native vegetation of the adjacent National Park. Views to the top of the Sellick Hill Range escarpment are likely to remain, becoming a prominent backdrop to the north eastern extent of Whittings Road. These views may become filtered with the planting of verge-side trees.

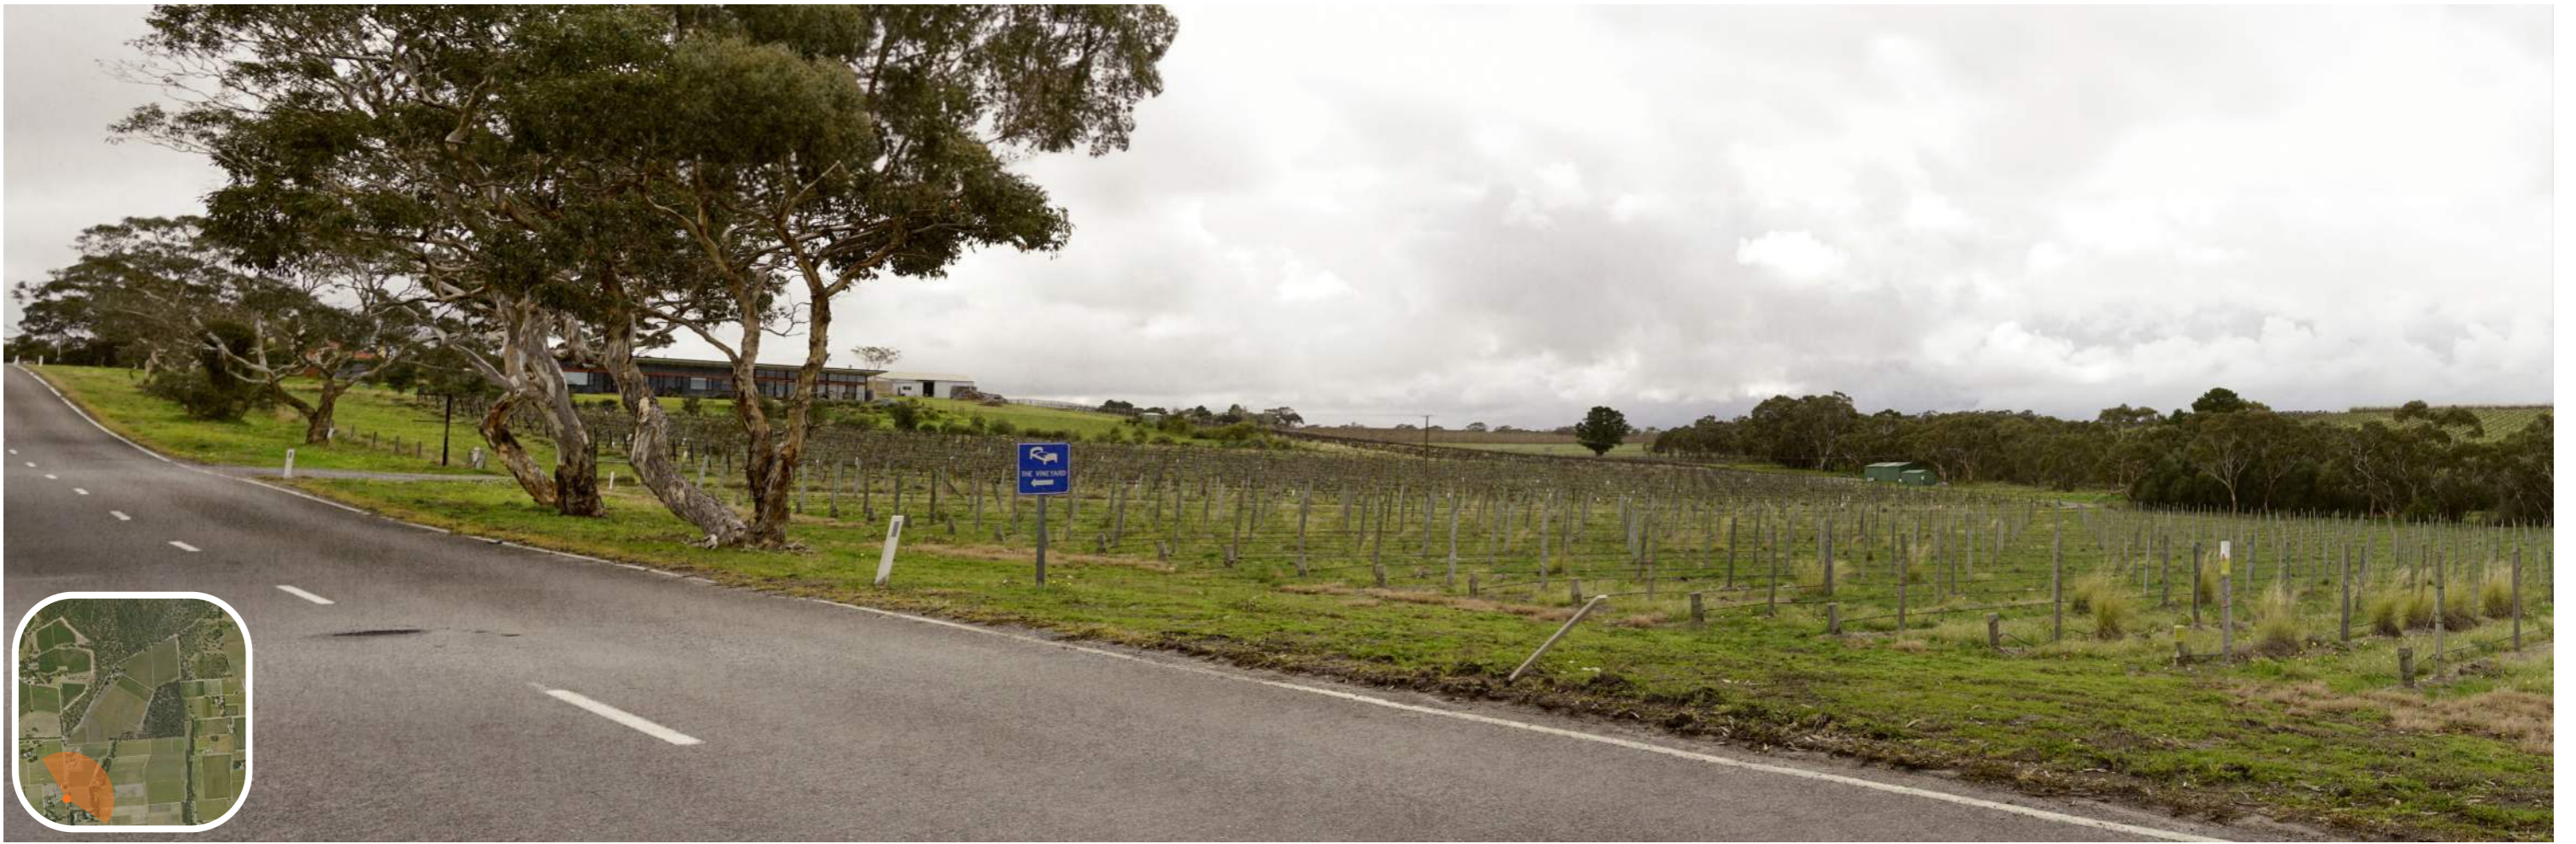
The photomontages illustrate the visual effect of the proposed development 'post-construction' and 'five years after implementation'.

EXISTING VIEW FROM WHITINGS ROAD LOOKING NORTH

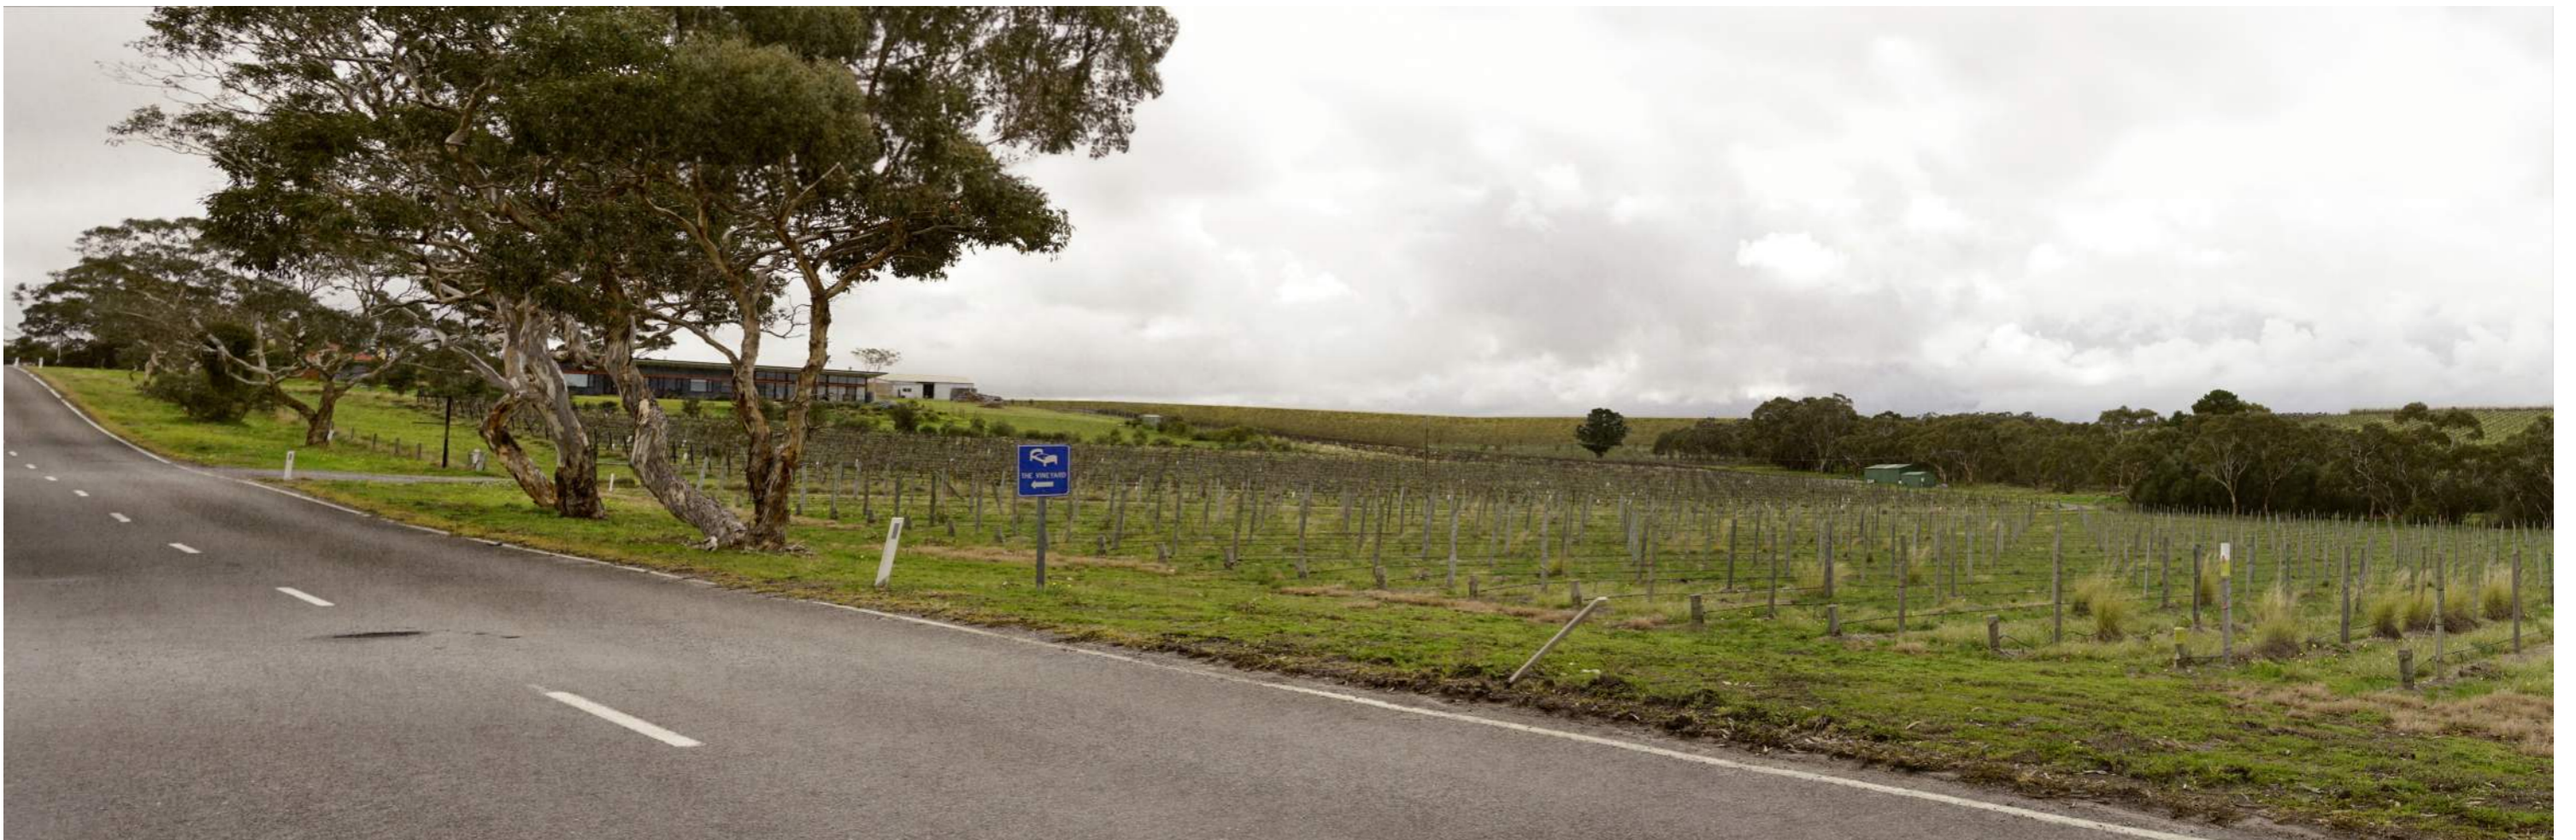
VIEW OF DAM PROJECT POST CONSTRUCTION (1 YEAR)

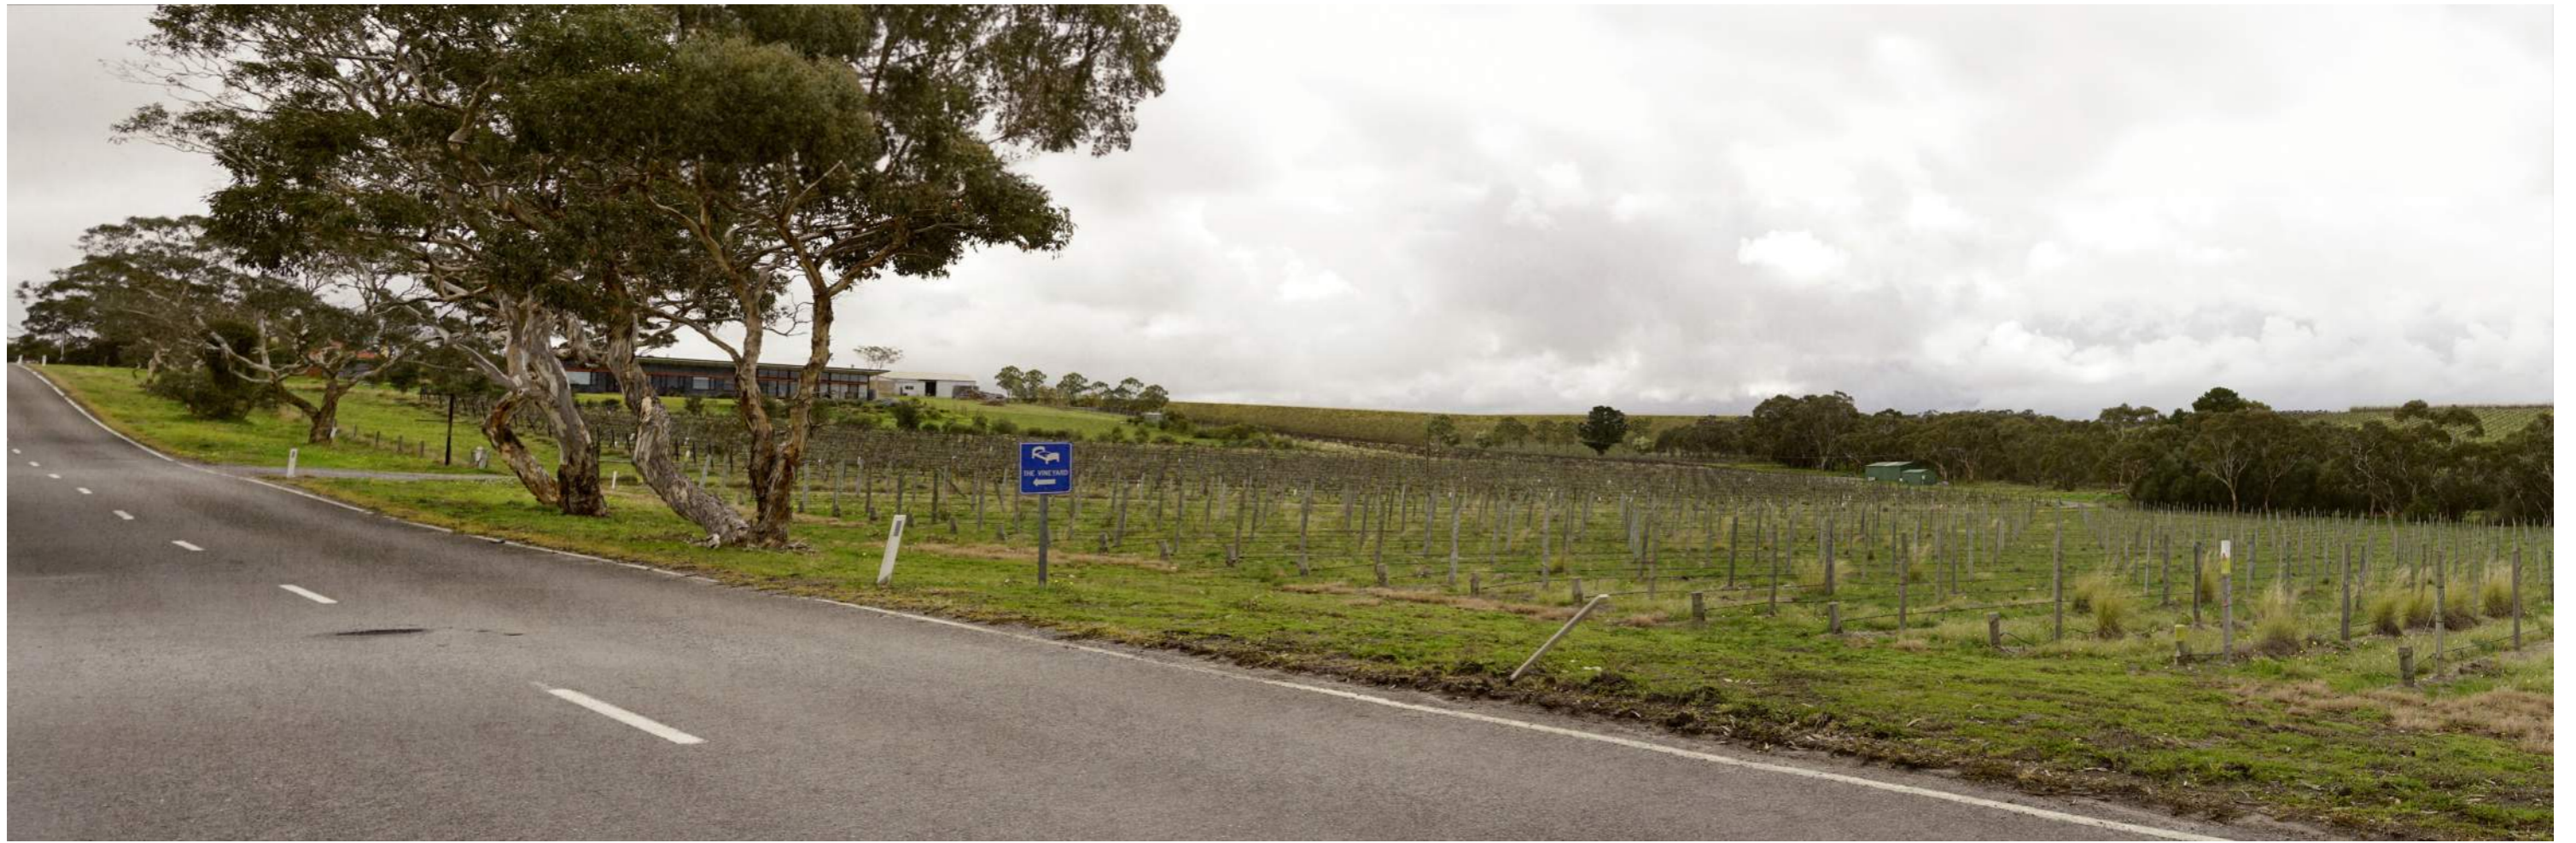
VIEW OF DAM PROJECT 5 YEARS AFTER CONSTRUCTION

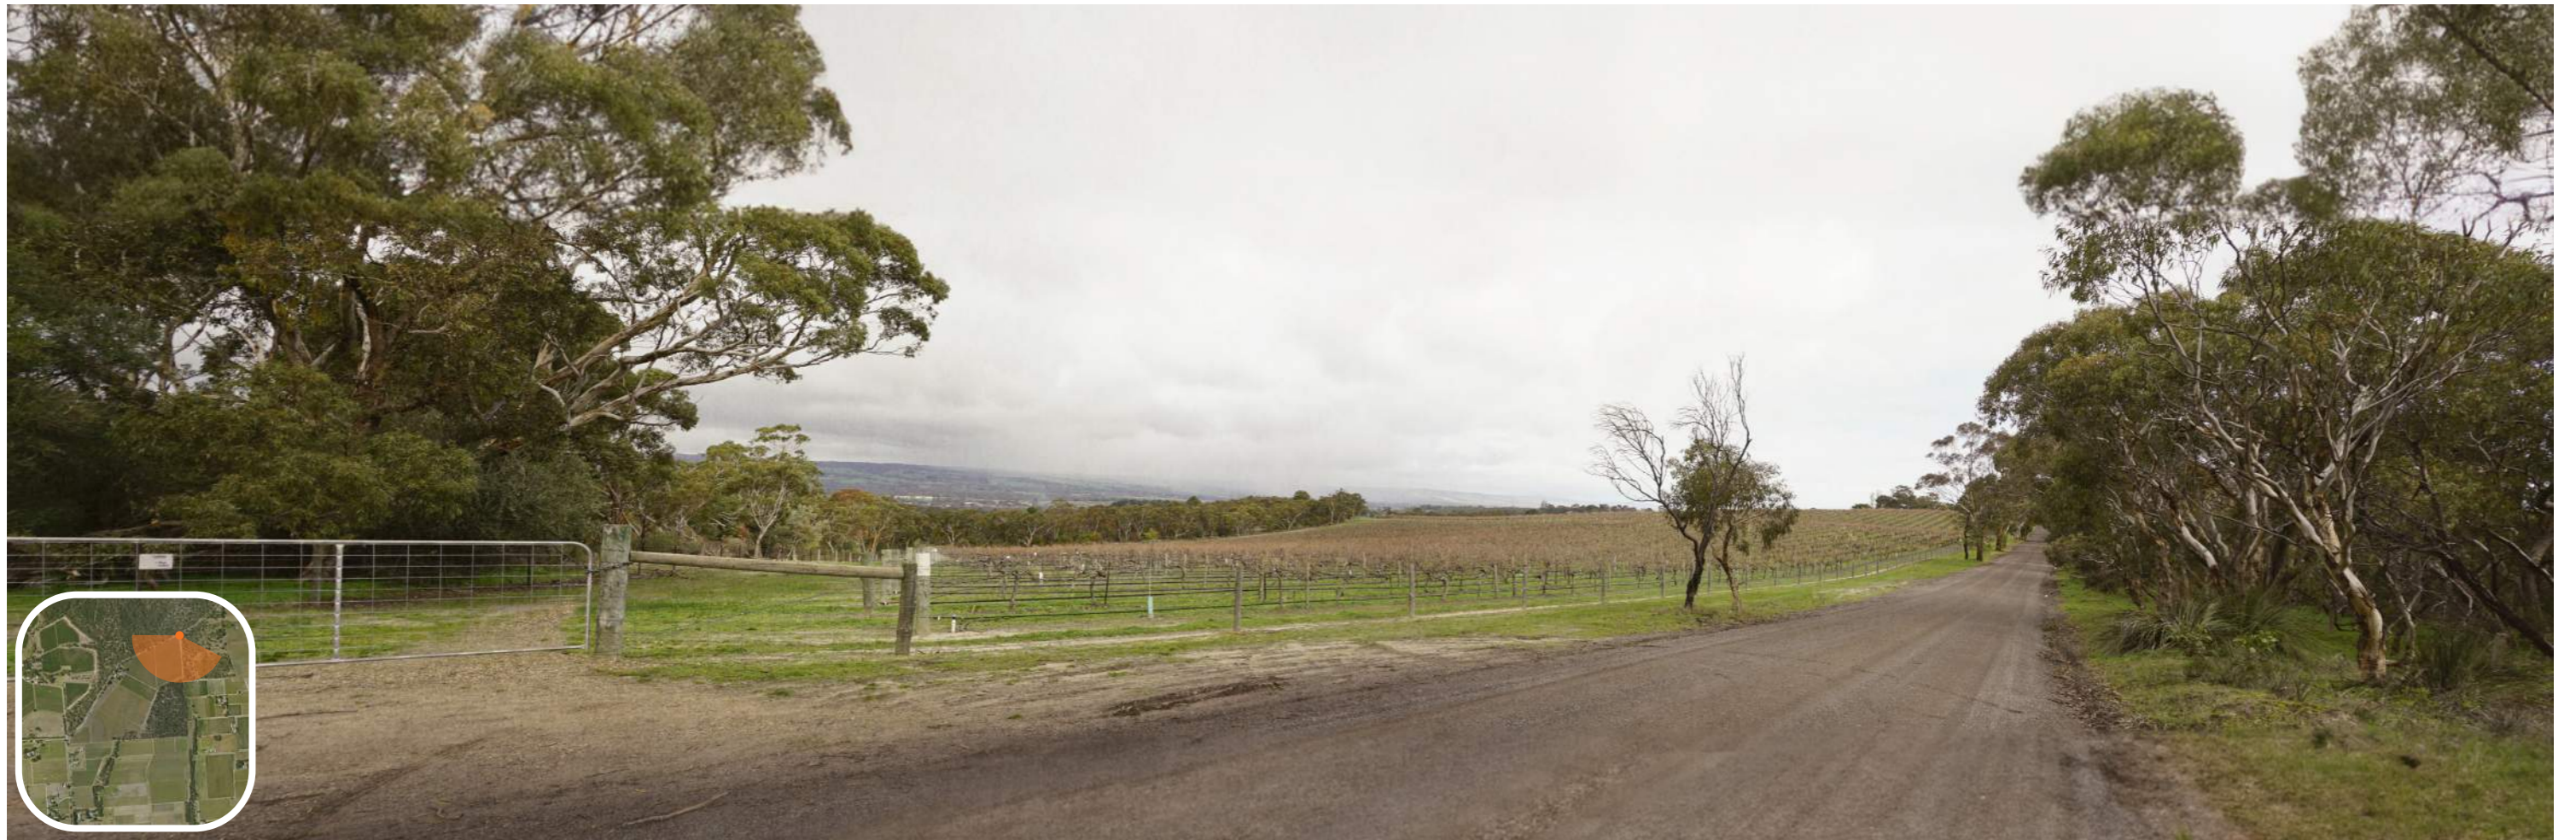
EXISTING VIEW FROM WHITINGS ROAD LOOKING SOUTH

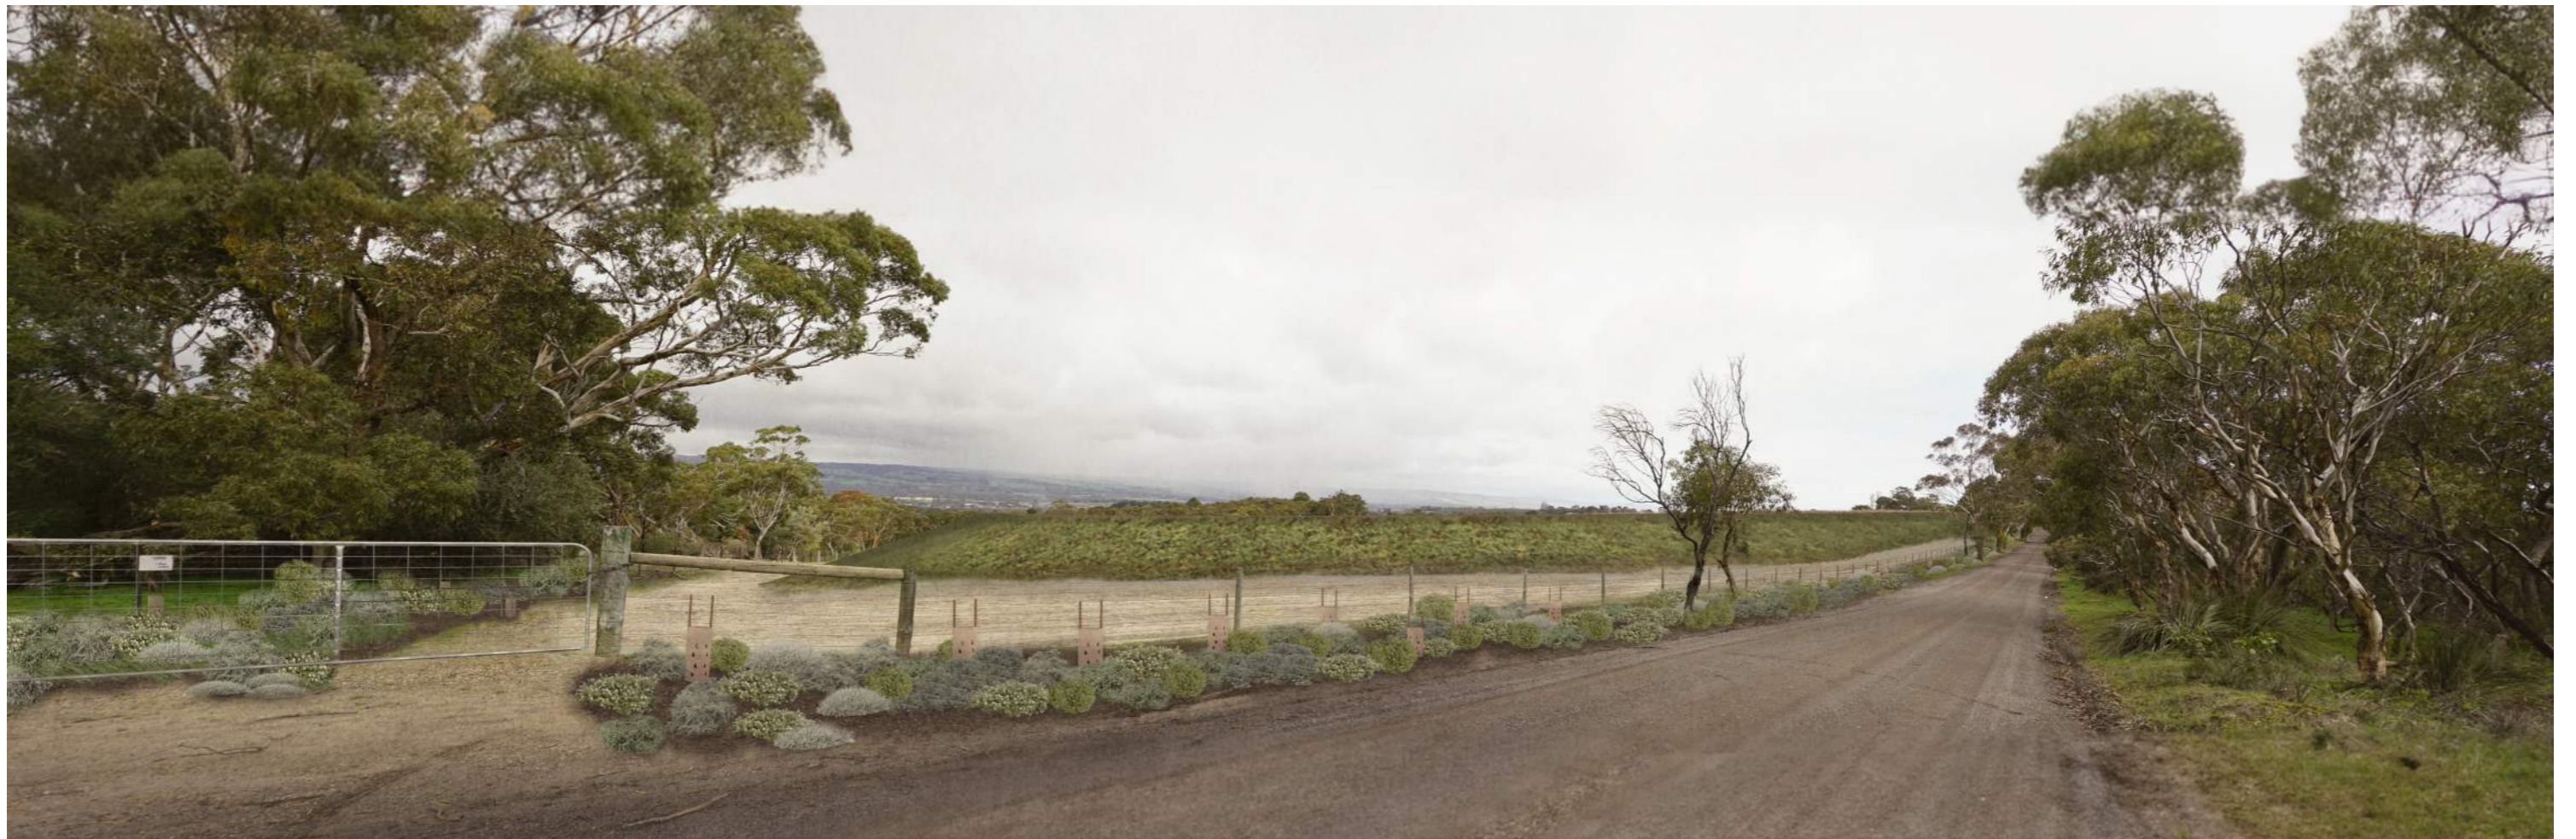
VIEW OF DAM PROJECT POST CONSTRUCTION (1 YEAR)

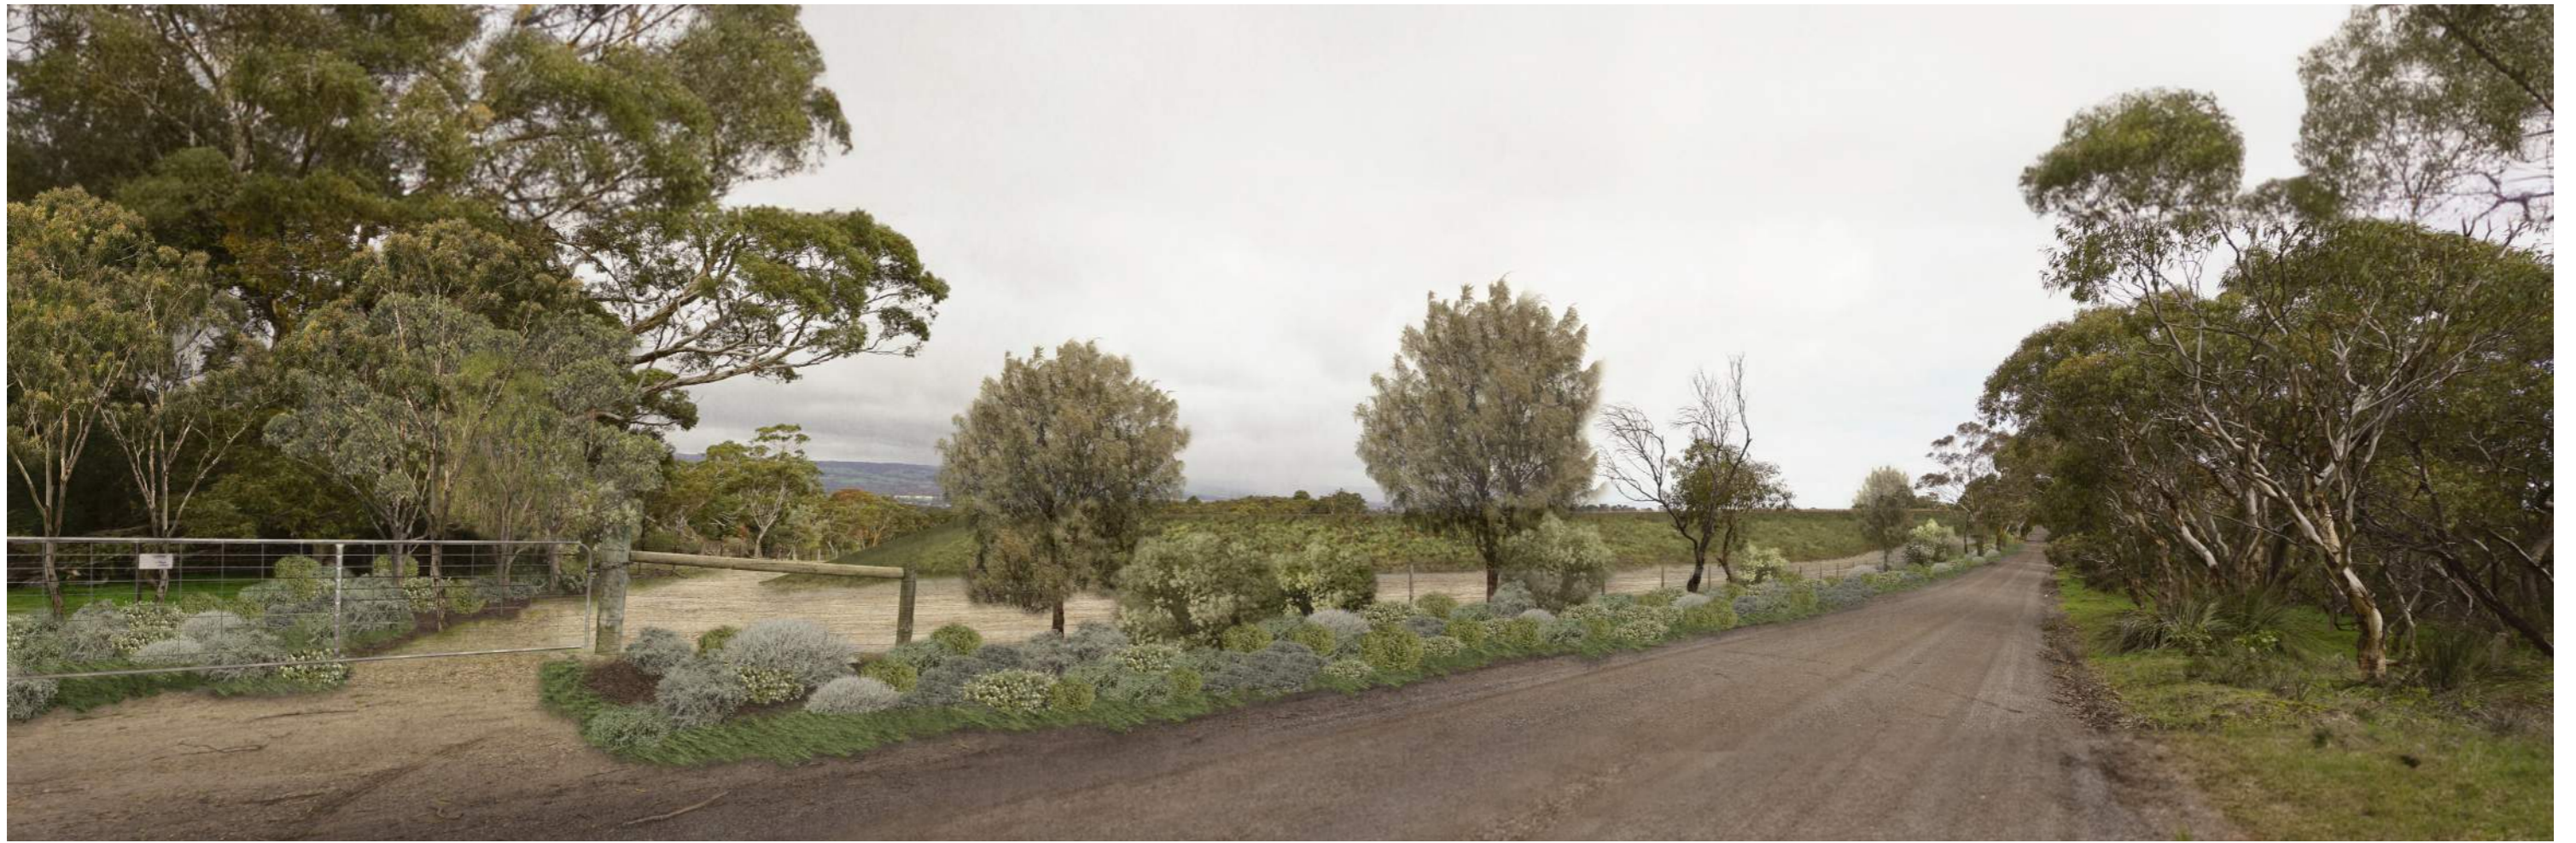
VIEW OF DAM PROJECT 5 YEARS AFTER CONSTRUCTION

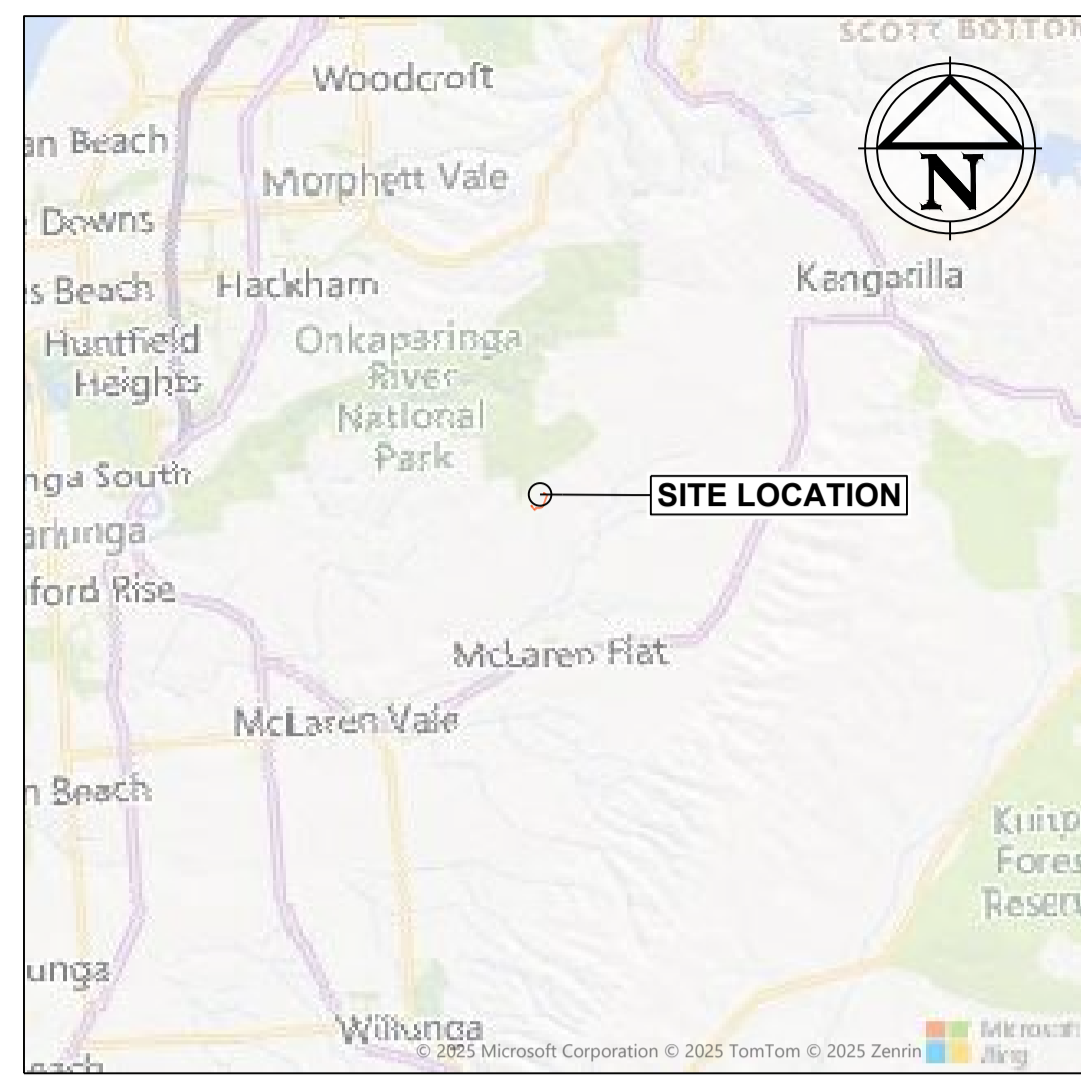
KEY PLAN  
SCALE 1:2000

CONNECTION POINT

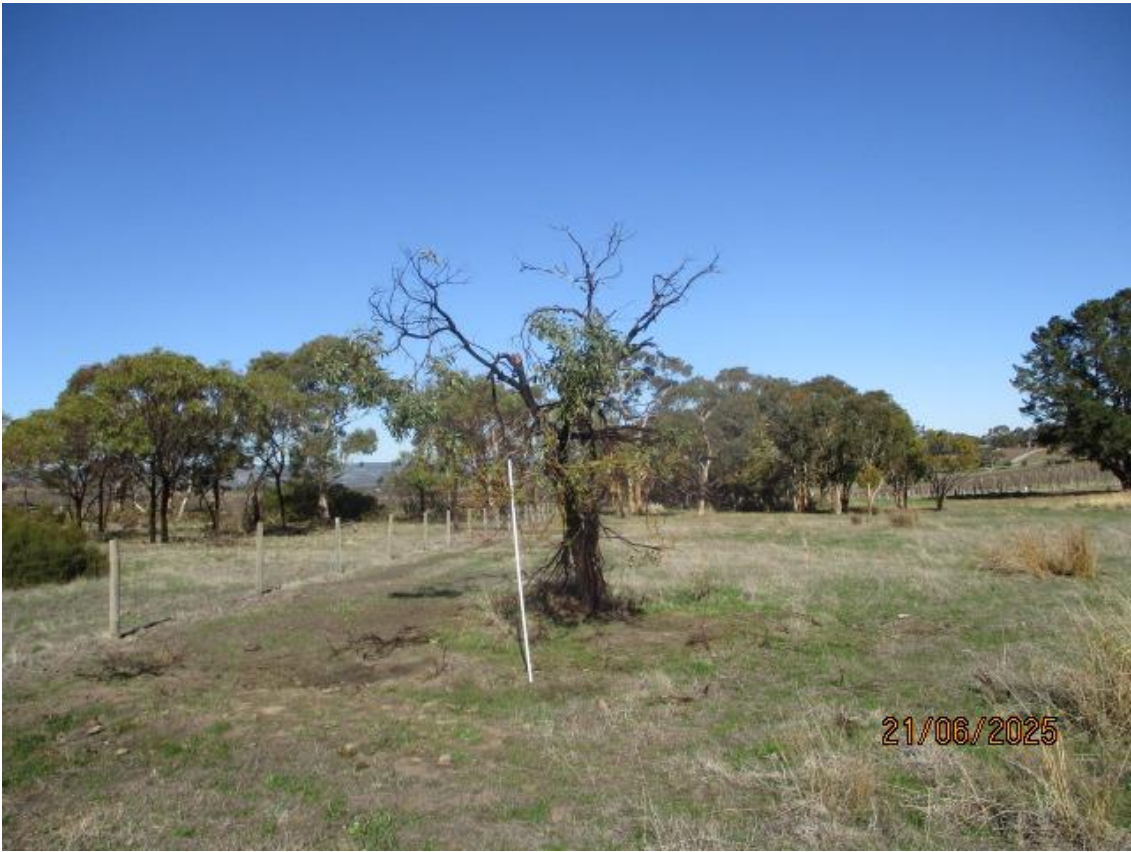
<i>Acacia pycnantha</i>	
Number of trees – 1	
Height (m) – 4	
Hollows – Nil	
Diameter (cm) – 19	
Canopy dieback (%) – 60	
Total Biodiversity Score – 0.30	
<p>Medium <i>Acacia pycnantha</i> (Golden Wattle) in poor health with 60% die-back of canopy. Tree 1 has no hollows. Tree 1 provides suitable habitat for the Elegant Parrot (<i>Neophema elegans elegans</i>) which is listed as rare under the <i>National Parks and Wildlife Act 1972</i>.</p>

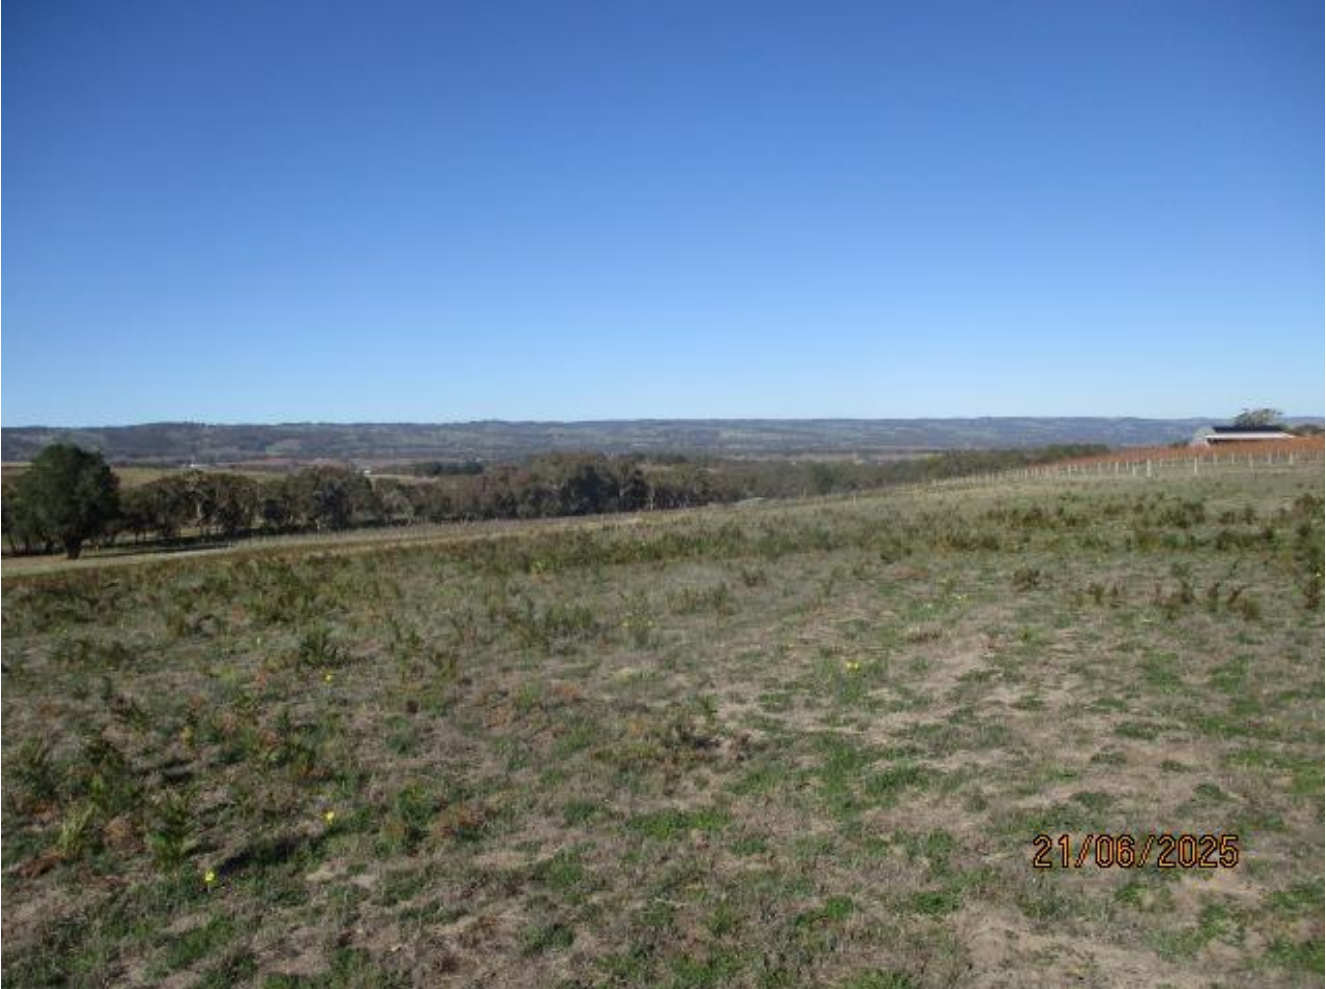
Vegetation Association	Degraded area dominated by introduced pasture with scattered native flora, mainly <i>Pteridium esculentum ssp. esculentum</i> (Bracken Fern)

General description	<p>Site A1 contains a degraded area dominated by introduced pasture with scattered native flora including <i>Pteridium esculentum ssp. esculentum</i> (Bracken Fern), <i>Hibbertia virgata</i> (Twiggy Guinea-Flower), <i>Melaleuca decussata</i> (Totem-poles), <i>Acacia myrtifolia</i> (Myrtle Wattle) and <i>Xanthorrhoea semiplana ssp. semiplana</i> (Yacca).</p> <p>The area is regularly mowed and grazed by cattle which would inhibit the growth and regeneration of native flora. The native vegetation is dominated by <i>Pteridium esculentum ssp. esculentum</i> (Bracken Fern) which covers approximately 20-30% of the area. The other native species recorded are limited in cover and represent less than 1% of the area. The area is regularly grazed by cattle and slashed to maintain fire fuel loads.</p>

Threatened species	Site A1 provides suitable habitat for the Elegant Parrot ( <i>Neophema elegans elegans</i> ) which is listed as rare under the <i>National Parks and Wildlife Act 1972</i> .				
Landscape context score	1.13	Vegetation Condition Score	2.70	Conservation significance score	1.02
Unit biodiversity Score	3.11	Area (ha)	1.48	Total biodiversity Score	4.60
