**APPENDIX 5**  
**Operational Management Plan (Draft)**

**Willunga Basin Water Co Pty Ltd**

**WBWC-IMS-DOC-xxx**  
**Whittings Rd Recycled Water Storage Operations Environmental Management Plan**

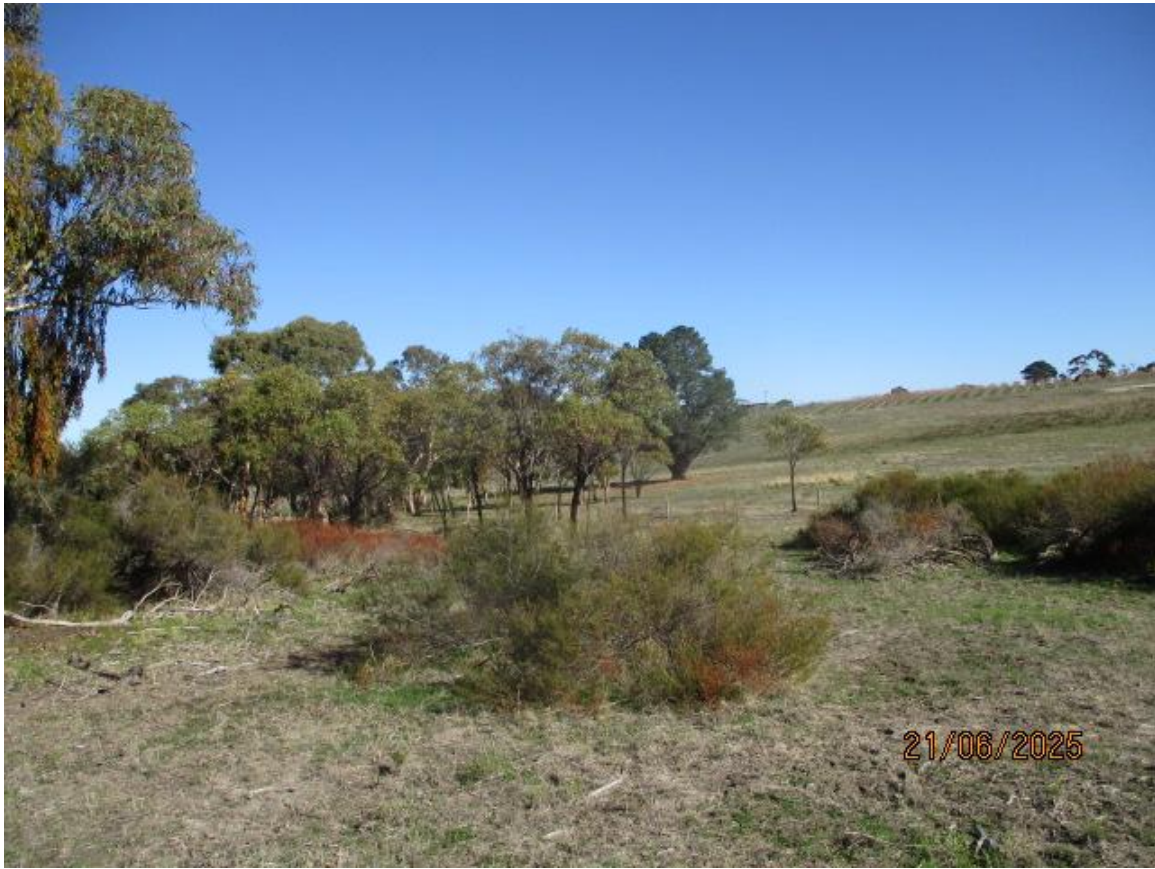
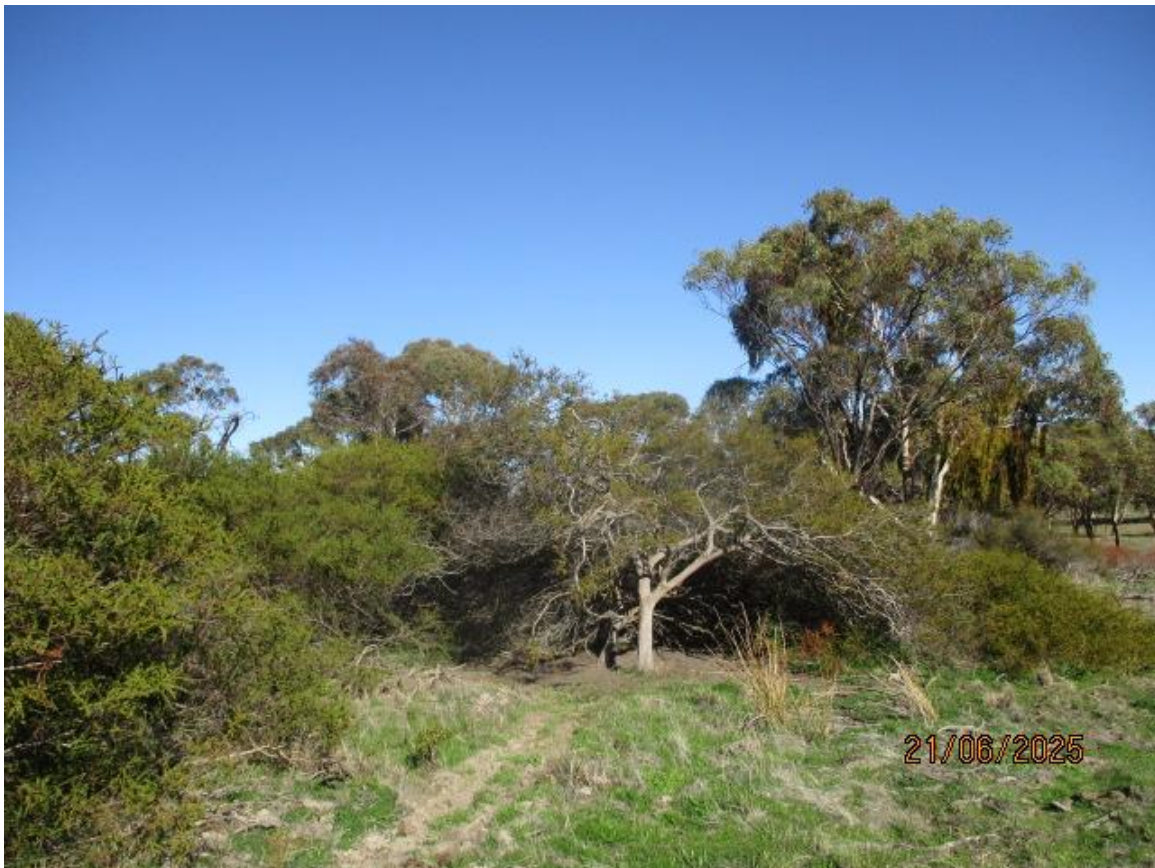
Vegetation Association	Removal of understorey species on the edge of a <i>Eucalyptus fasciculosa</i> (Pink Gum) woodland with an open sclerophyll shrub understorey
------------------------	--

General description	<p>The broader are of the vegetation block containing Site B1 includes a <i>Eucalyptus fasciculosa</i> (Pink Gum) woodland over <i>Acacia pycnantha</i> (Golden Wattle), <i>Acacia paradoxa</i> (Kangaroo Thorn), <i>Acacia acinacea</i> (Wreath Wattle), <i>Acacia myrtifolia</i> (Myrtle Wattle), <i>Hibbertia virgata</i> (Twiggy Guinea-flower), <i>Xanthorrhoea semiplana ssp. semiplana</i> (Yacca), <i>Lomandra fibrata</i> (Mount Lofty Mat-rush) and <i>Rytidosperma caespitosum</i> (Common Wallaby-grass). The overstorey canopy contains <i>Amyema miquelii</i> (Box Mistletoe). Introduced flora species include <i>Crataegus monogyna</i> (Hawthorn), <i>Rhamnus alaternus</i> (Blowfly Bush), <i>Olea europaea</i> (Olive), <i>Pinus radiata</i> (Radiata Pine), <i>Gomphocarpus cancellatus</i> (Broad-leaf Cotton-bush), <i>Sonchus oleraceus</i> (Common Sow-thistle), <i>Sisalix atropurpurea</i> (Pincushion), <i>Plantago lanceolata</i> (Ribwort), <i>Hypericum perforatum ssp. veronense</i> (St John's Wort), <i>Trifolium arvense var. arvense</i> (Hare's-foot Clover), <i>Trifolium cherleri</i> (Cupped Clover), <i>Trifolium scabrum</i> (Rough Clover), <i>Bromus madritensis</i> (Compact Brome) and <i>Avena barbata</i> (Wild Oat). , <i>Asparagus asparagoides</i> (Bridal Creeper), <i>Chrysanthemoides monilifera</i> (Boneseed) and <i>Olea europaea</i> (Olive) are declared plant species listed under the <i>Landscape South Australia Act 2019</i>.</p> <p>The vegetation block is currently grazed by cattle. No regeneration of native flora was observed. The area contains patchy leaf litter with numerous branch and trunk sized logs. The percentage of native and introduced understorey biomass is approximately 50% each. Trees are in good health with no hollows observed. <i>Eucalyptus fasciculosa</i> (Pink Gum) is listed as a rare plant species within South Australia. However, no Pink Gums are proposed to be impacted as only a small section along the northern edge is under application. Native species to be impacted includes <i>Acacia paradoxa</i> (Kangaroo Thorn), <i>Acacia acinacea</i> (Wreath Wattle), <i>Acacia myrtifolia</i> (Myrtle Wattle), <i>Hibbertia virgata</i> (Twiggy Guinea-flower), <i>Lomandra fibrata</i> (Mount Lofty Mat-rush) and <i>Rytidosperma caespitosum</i> (Common Wallaby-grass).</p>

Threatened species	Site B1 provides suitable habitat for the Elegant Parrot ( <i>Neophema elegans elegans</i> ) which is listed as rare under the <i>National Parks and Wildlife Act 1972</i> .				
Landscape context score	1.13	Vegetation Condition Score	25.12	Conservation significance score	1.06
Unit biodiversity Score	30.09	Area (ha)	0.012	Total biodiversity Score	0.36
