# PRELIMINARY ACID SULPHATE SOIL INVESTIGATION, BUCKLAND PARK, SOUTH AUSTRALIA

**Submitted to:**  
Walker Corporation  
Level 50, Governor Phillip Tower  
1 Farrer Place  
SYDNEY NSW 2000

**Report Number:** 077662060 008 Rev4

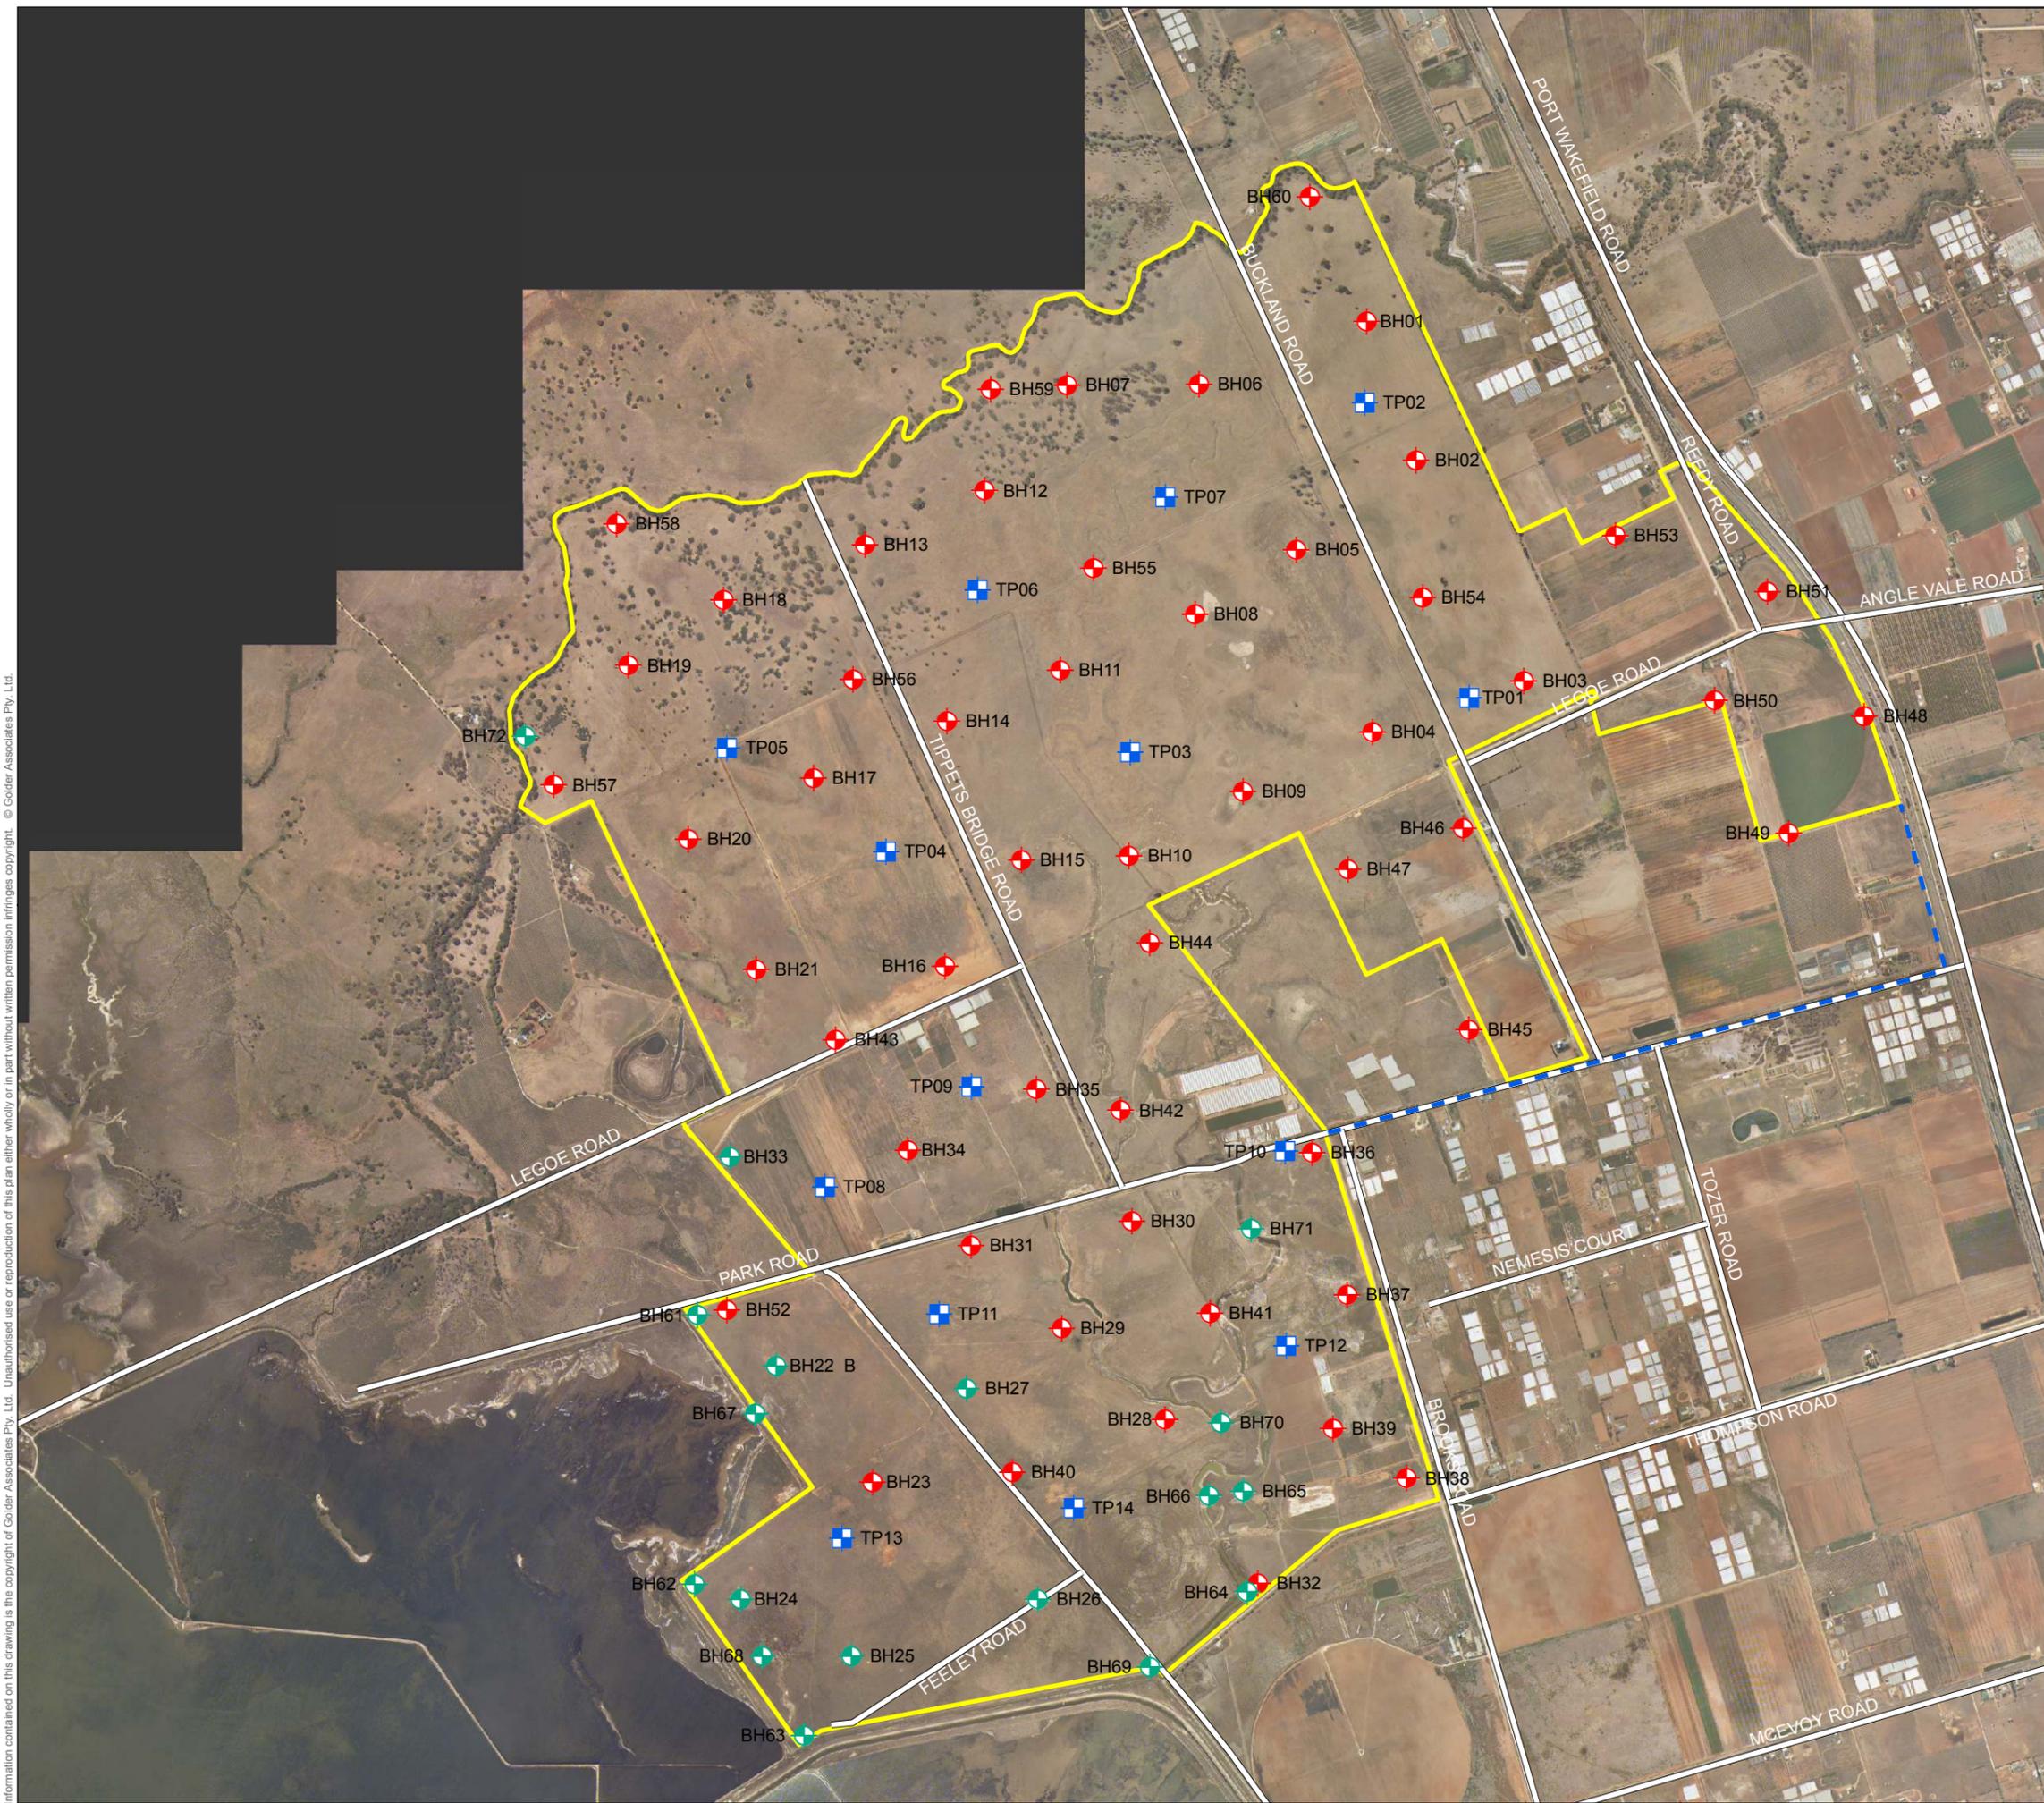
**FIGURE 1a**

- Figure 1 - Geotechnical & ASS Testing Locations
- Figure 2 - 5 mAHD Boundary
- Figure 3 - Sectors Indicating Risk of Encountering ASS
- Figure 4 - Distribution of ASS Overlaying Expected Geology Formations

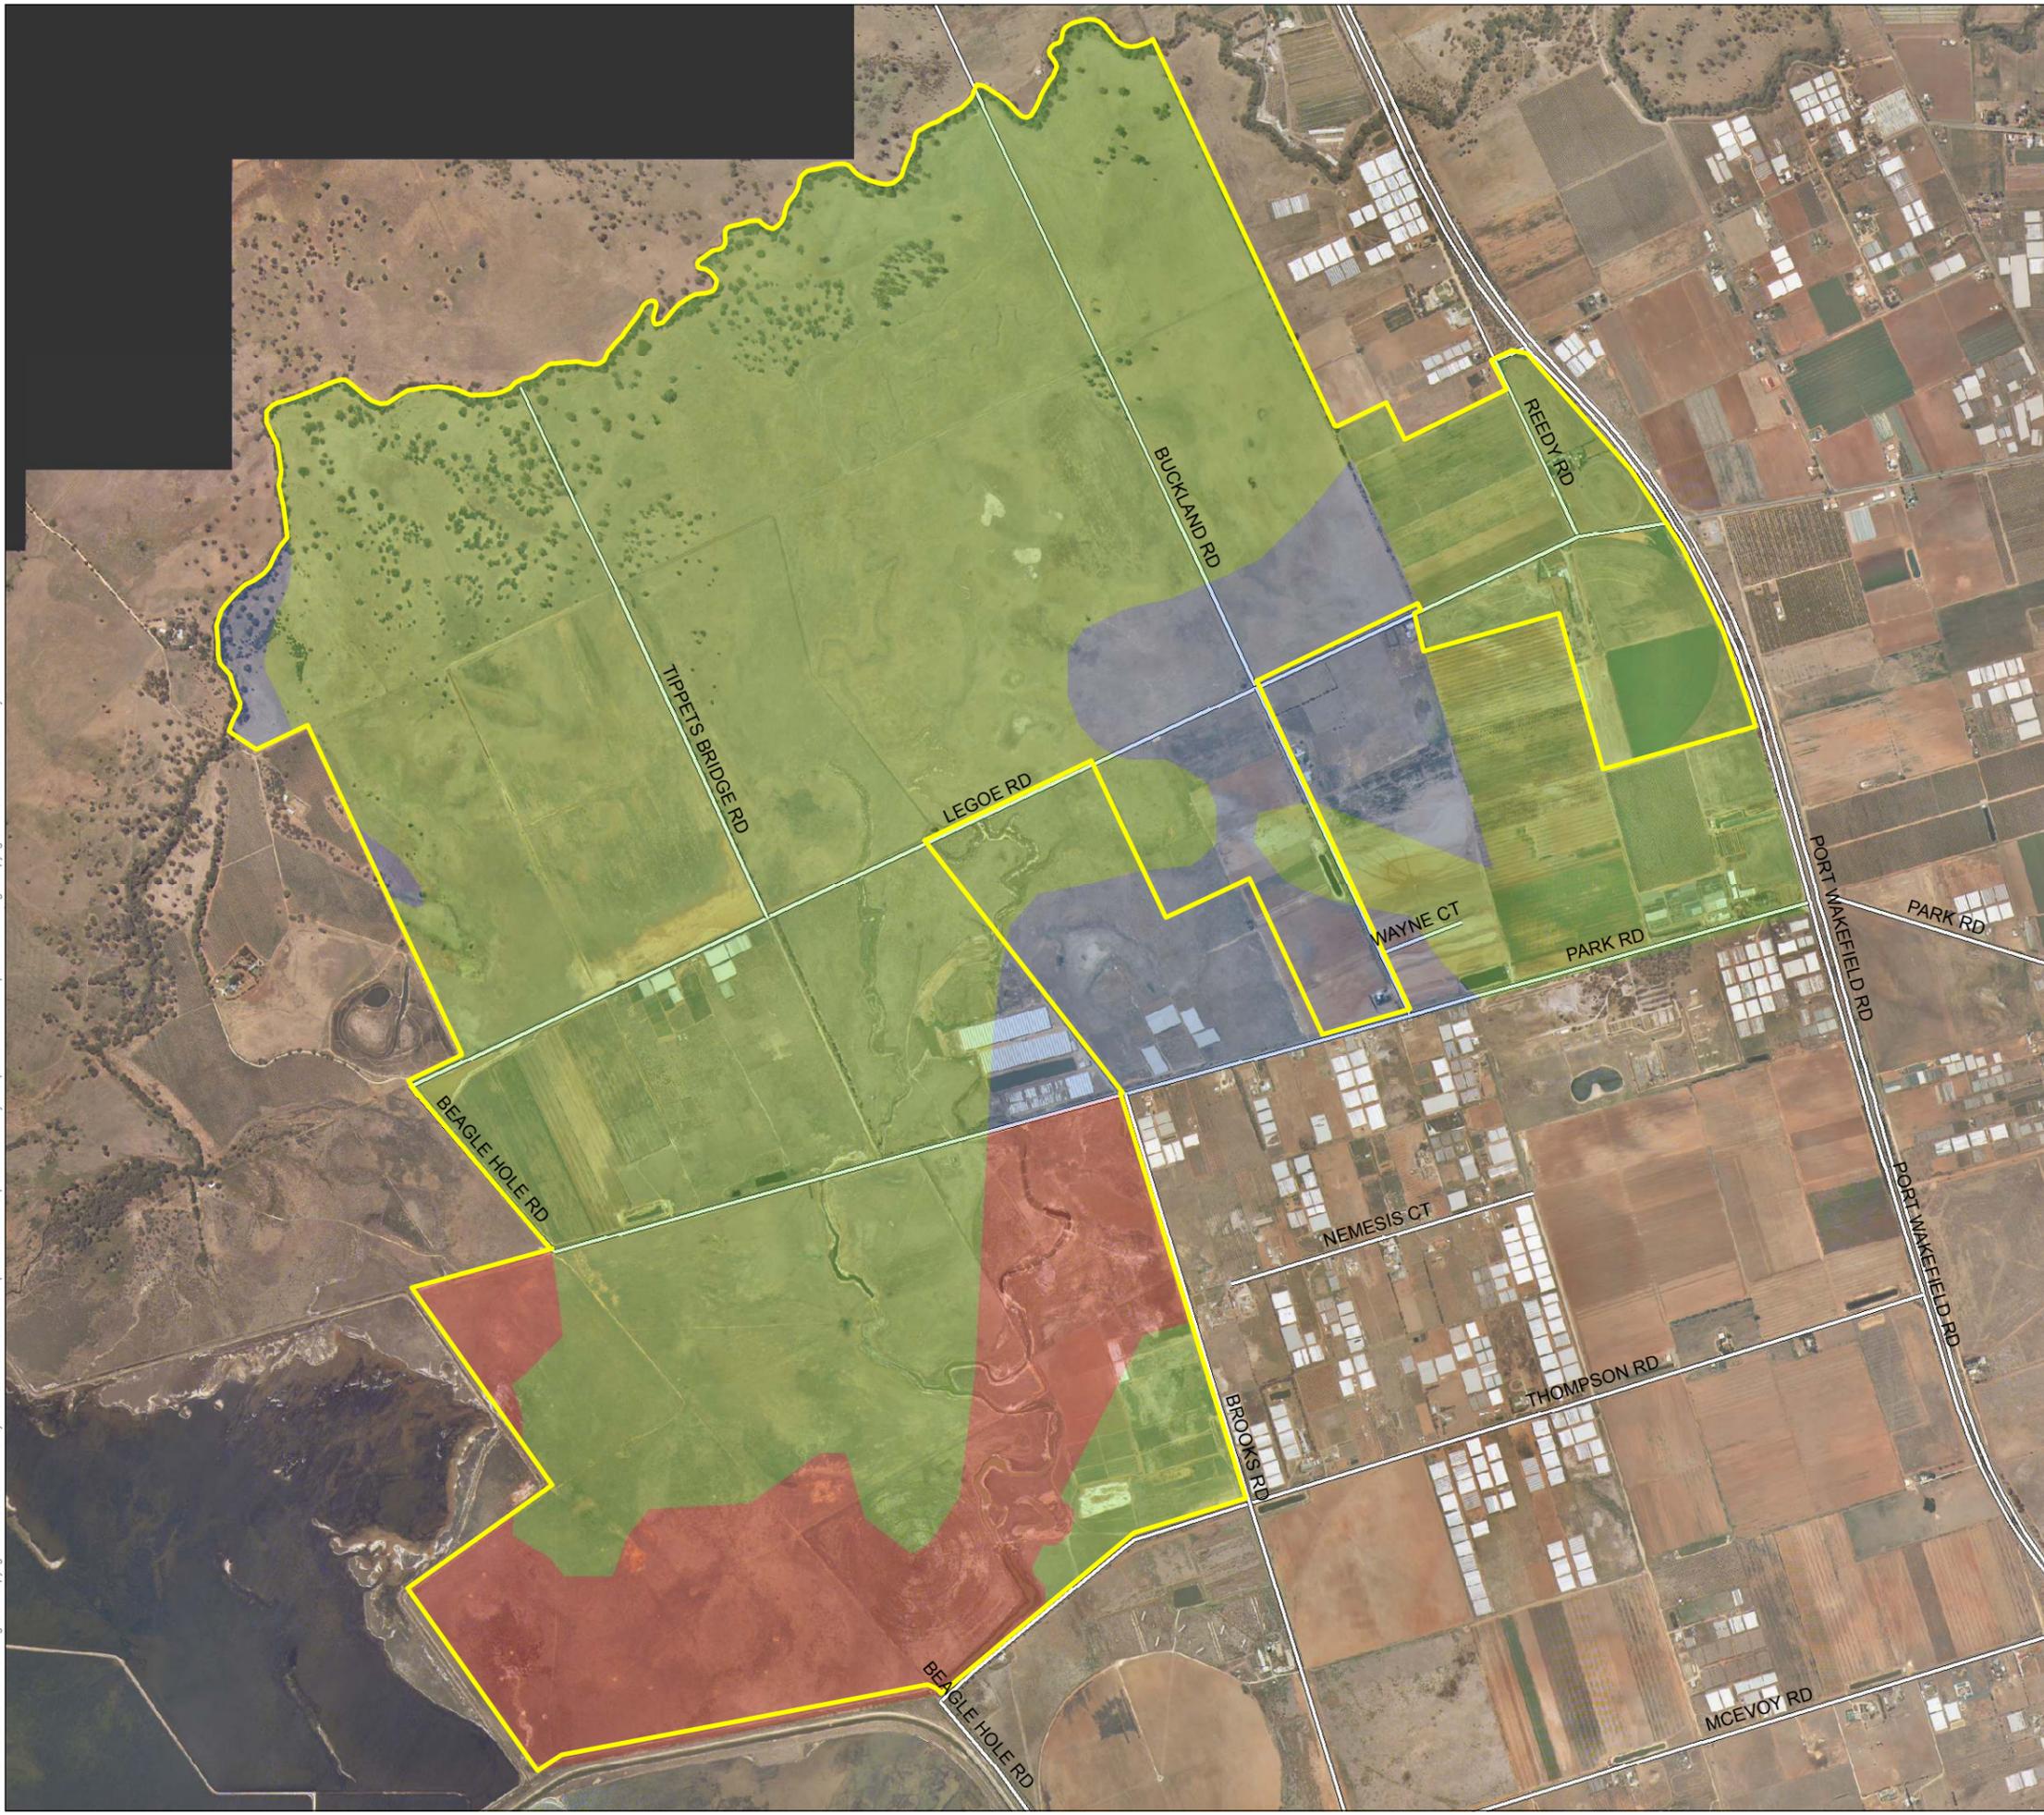
## RISK OF ENCOUNTERING ACID SULPHATE SOILS SECTORS
