SMITH BAY WHARF

DRAFT ENVIRONMENTAL IMPACT STATEMENT

APPENDIX B – ALTERNATIVE LOCATIONS FOR KI SEAPORT

Appendix B – Desktop Visual Assessment of Locations

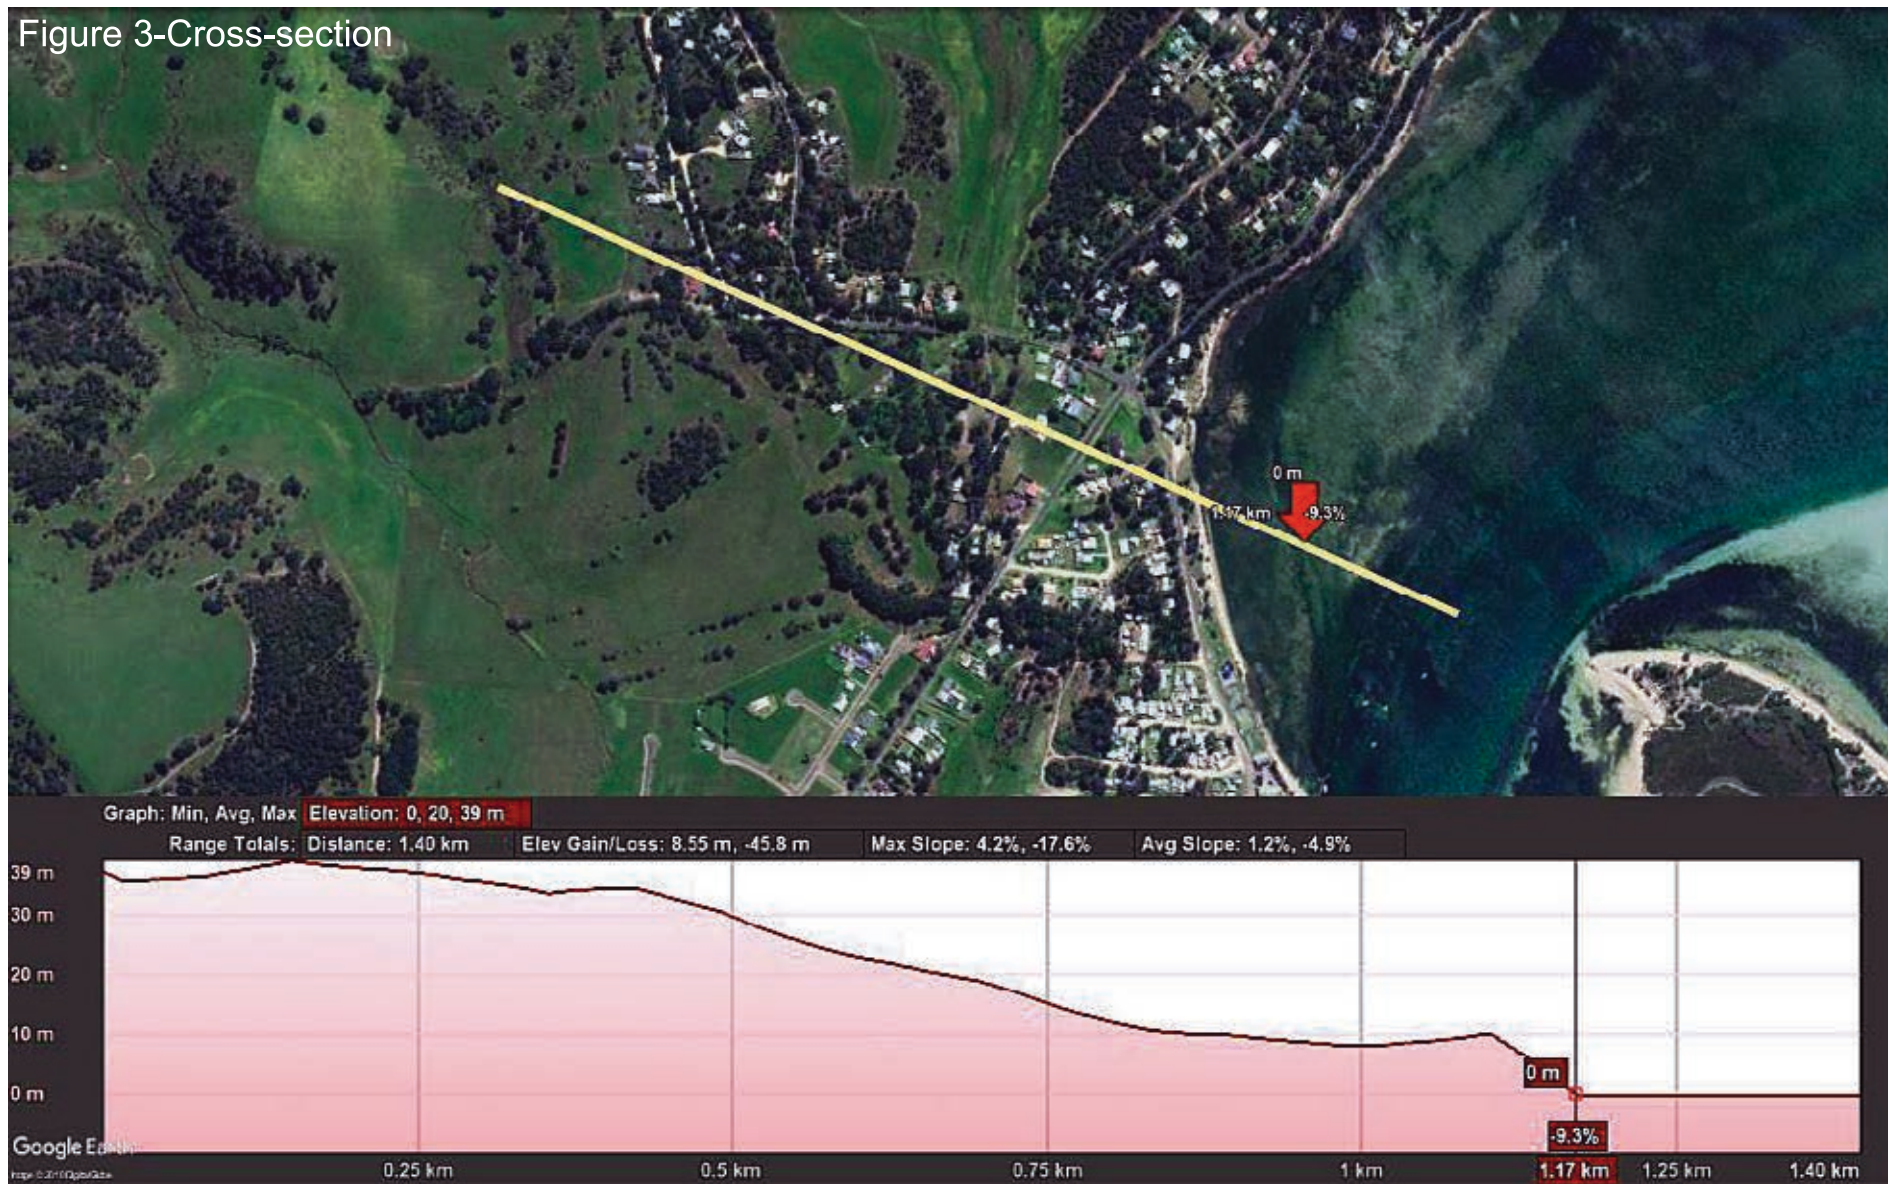
Figure 3-Cross-section

- a significant town community is established at American River (**Figure 2**, Appendix A)
- private vessels moor off this location (**Figure 6**, Appendix A)
- cleared land, potentially agricultural, exists a distance away from the location
- unconnected stands of vegetation exist adjacent to the location
- maximum bathymetry depth is 6.9 m
- **Figure 3**, Appendix A, shows a staggered decline with a small bench at 375 m, followed by slight incline, before a steep decline of 10 m in the last 170 m before the water, with a maximum slope of -17.6%, and elevation loss of 39 m.

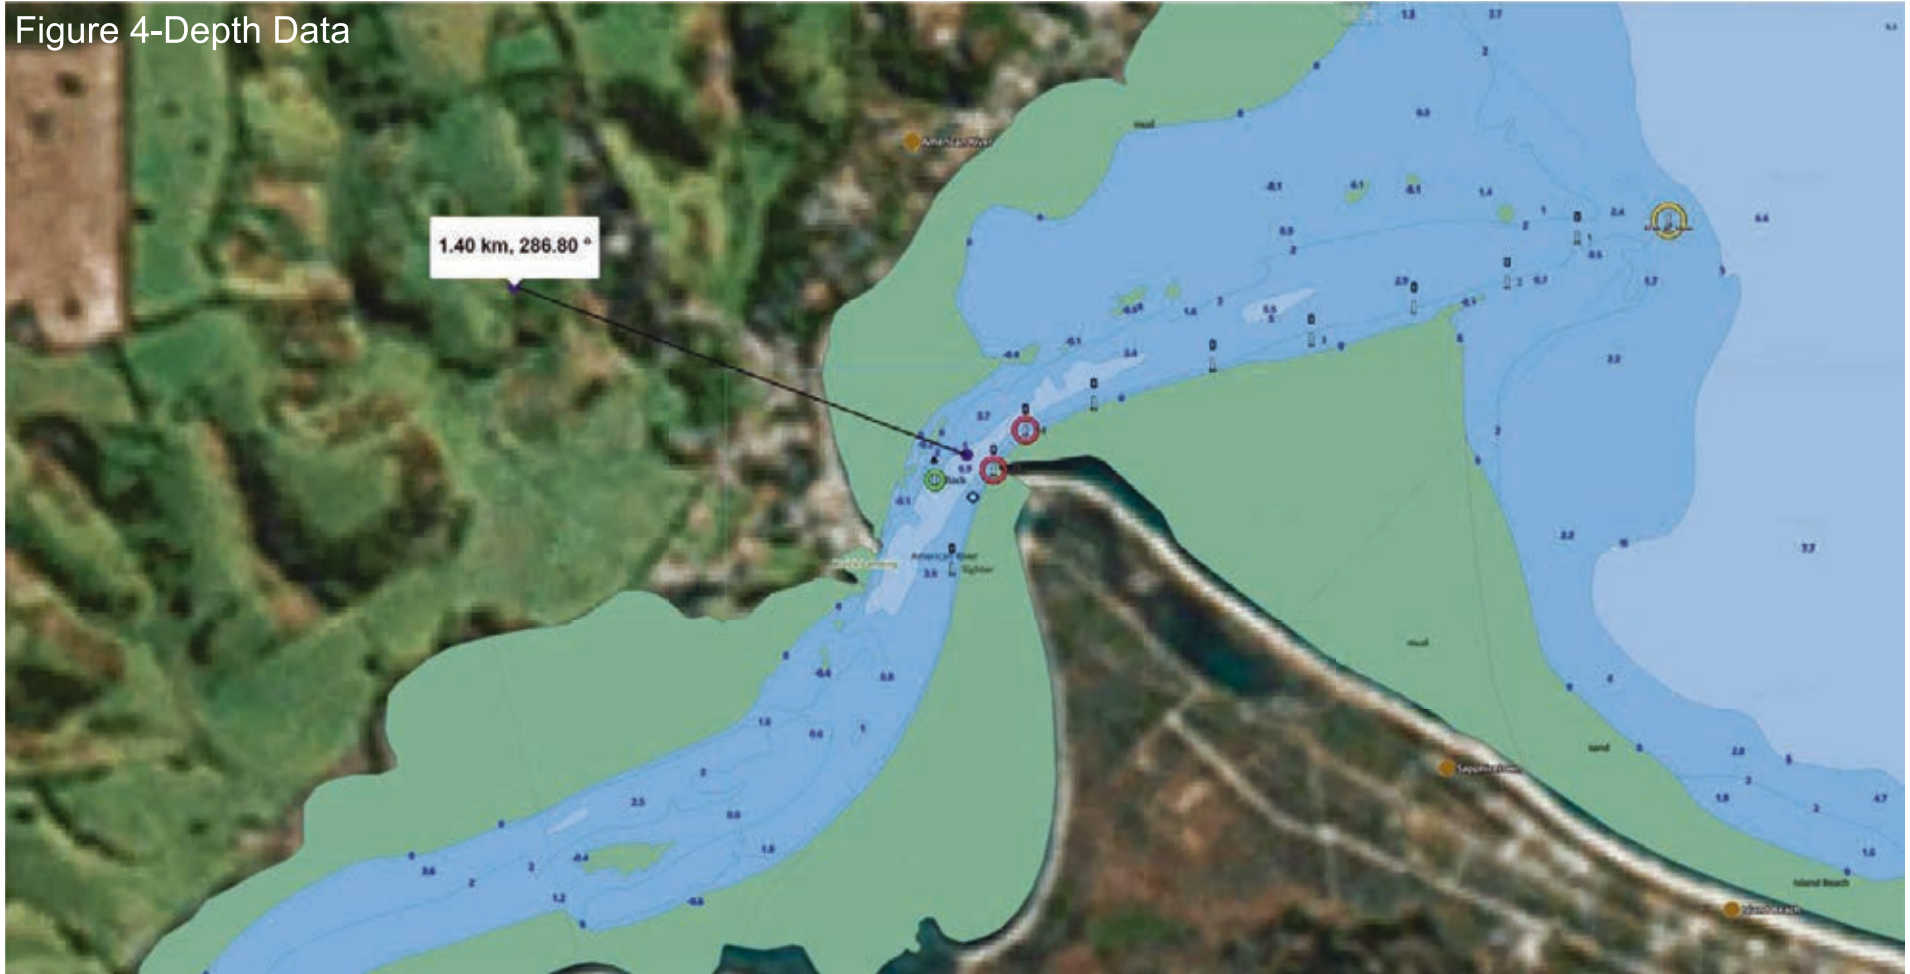
Figure 5-Coastline-01

- location of an old gypsum export facility
- historic clearing (still visible)
- vegetation abuts the site
- cleared (potentially agricultural) land and interconnected pockets of vegetation exists a distance away from the location
- private vessels moor within the protected waters south-west of the location (**Figure 5**, Appendix B)
- cross-section shows a steep decline from the top of the site, with a maximum slope of -28% and an elevation loss of 69 m (**Figure 3**, Appendix B)
- nearby oyster lease/s can be seen in shallow (3.6 m) waters just south of Ballast Head (**Figure 4**, Appendix B)
- significant amount of residential development (American River) exists to the south-west in the region, see **Figure 5**, Appendix B.

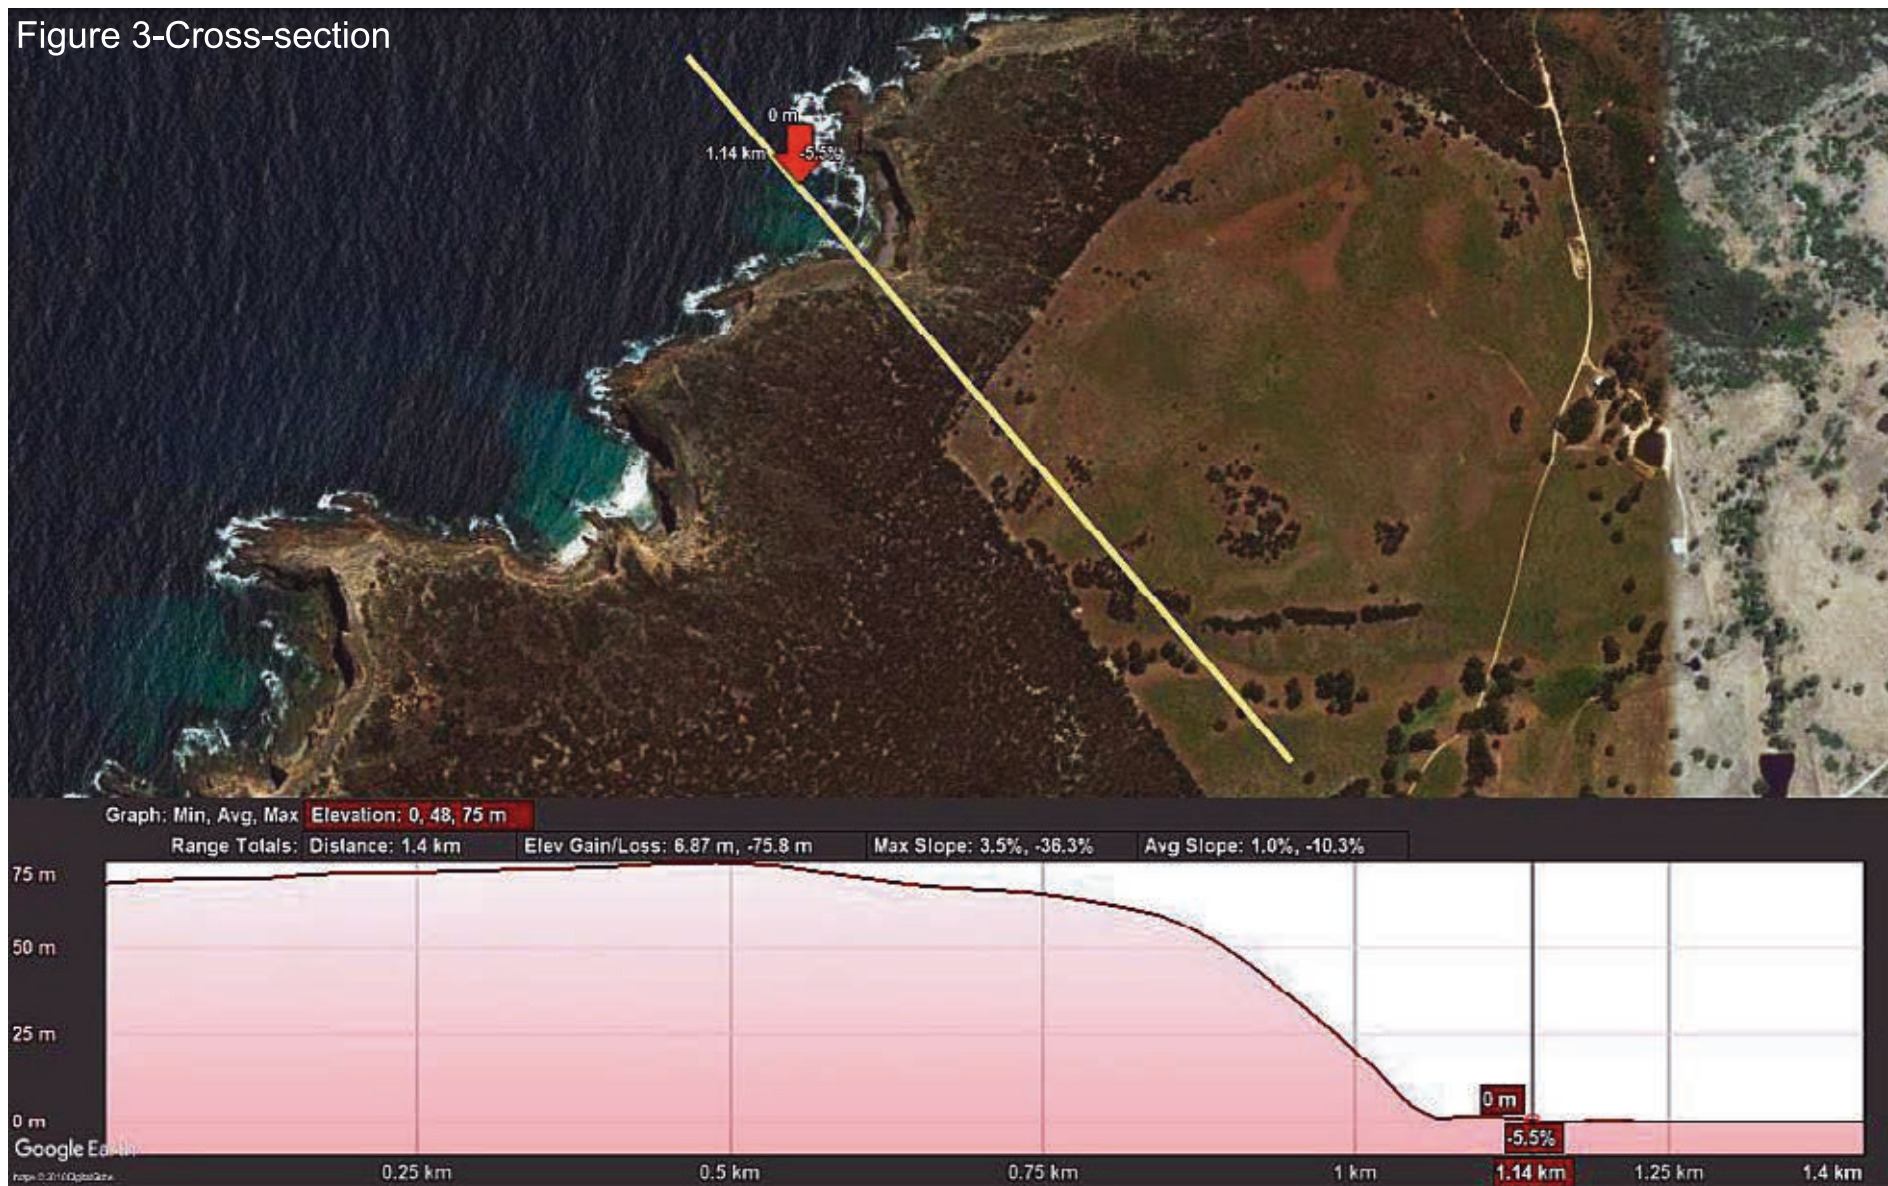
Figure 3-Cross-section

- the coastline is banded by a strip of vegetation, with agricultural land directly behind it (**Figure 1**, Appendix C)
- consists of very steep cliffs, dropping from a height of almost 75 m down to the water's surface in just over 250 m with a maximum slope of -36.3% (**Figure 3**, Appendix C)

- a significant decline to the water's surface exists, with a maximum slope of -36.3% and elevation loss of 75 m in just over 350 m
- majority of the coastline in this area is steeply sloping to the ocean floor, as shown in **Figure 5** and **Figure 6** (Appendix C)

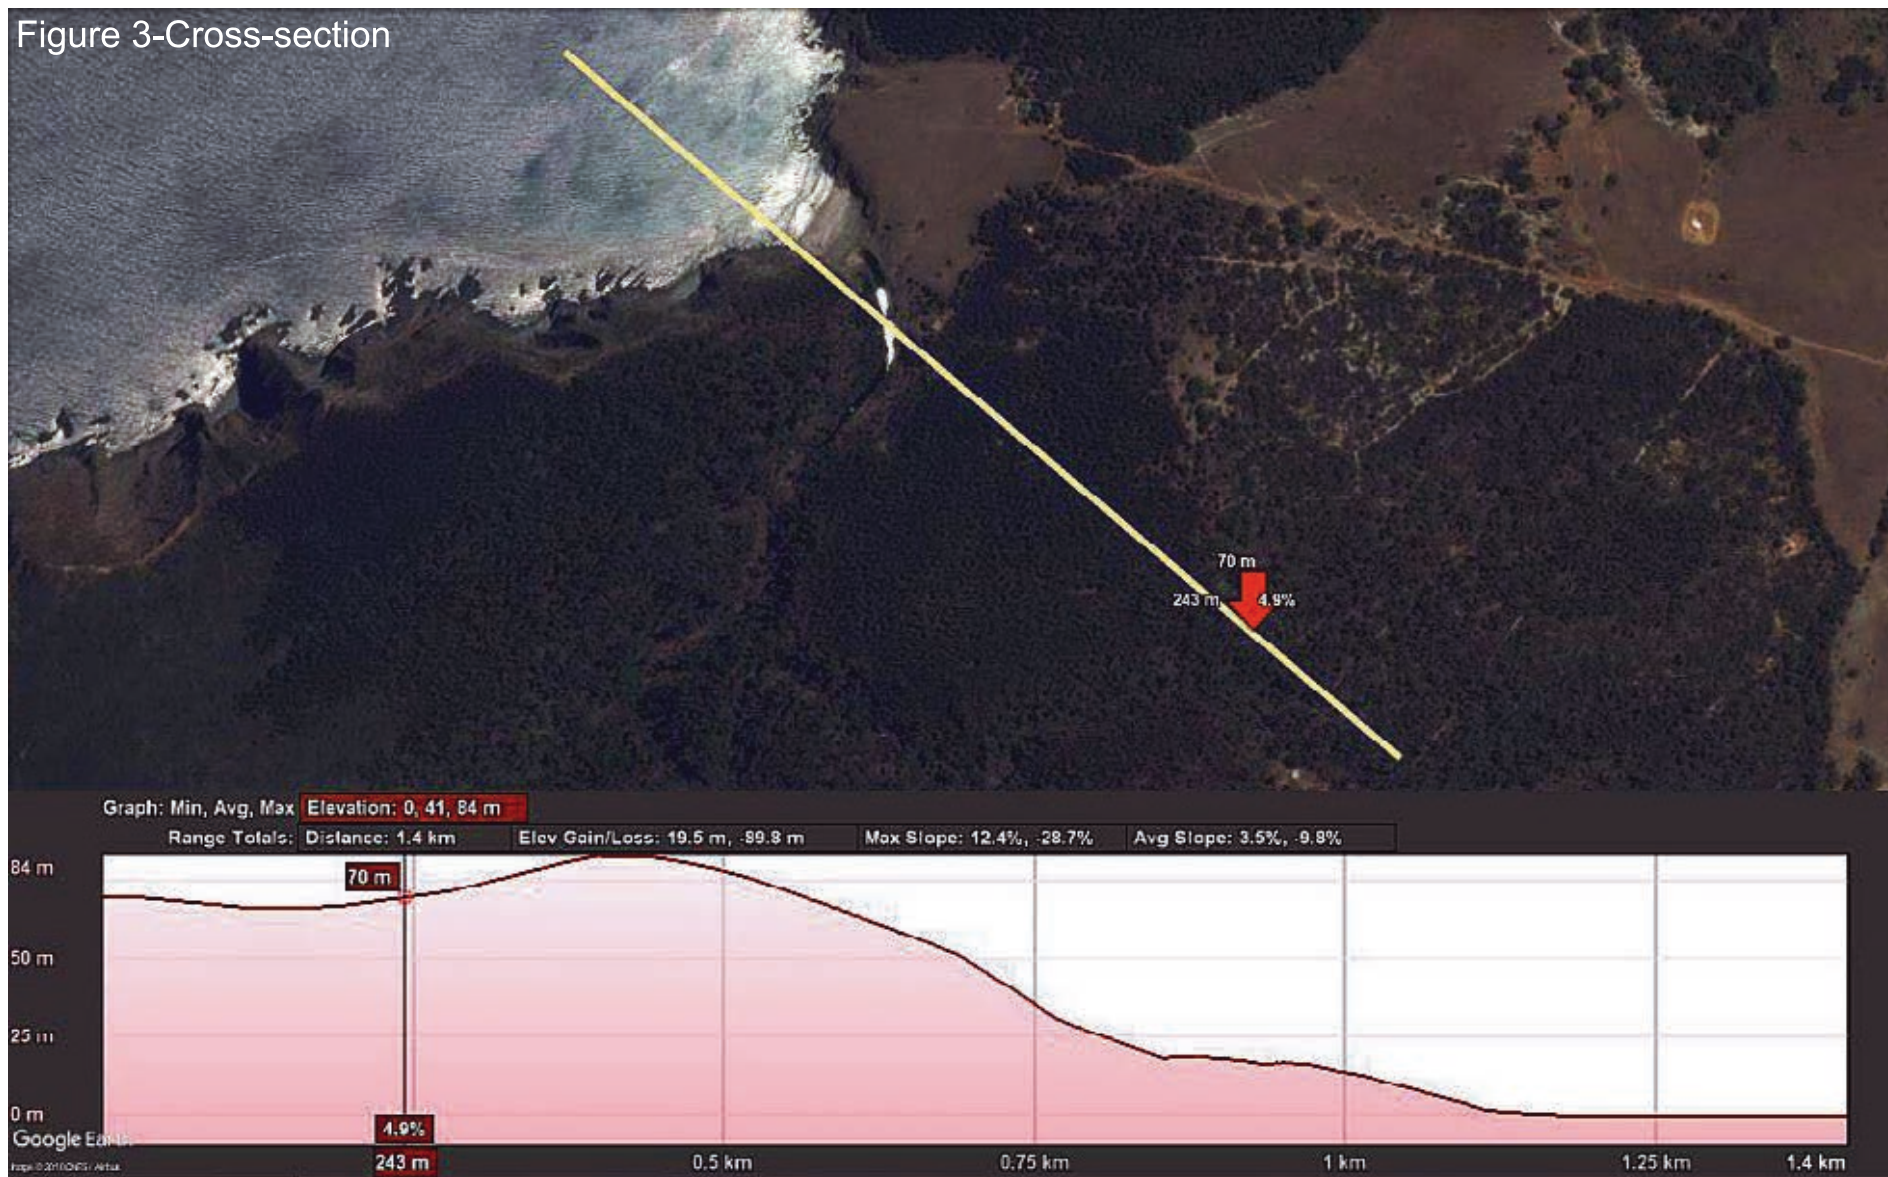
Figure 3-Cross-section

- isolated location that has no visible infrastructure
- two possible residential dwellings in close proximity to the location
- a cleared area, with possible dam and shack dwellings to the south south-east of it, exists near the river mouth with potential access road leading towards it (**Figure 1**, Appendix D)
- cross-section data shows maximum elevation loss of 85 m and a maximum slope of -28.7%, with a steep decline beginning around 450 m and extending to approximately 850 m, before flattening out for a short distance and a final dip to the water (**Figure 3**, Appendix D)
- depth data shows direct access to deep water (18.5 m), with marine vegetation visible on both sides of the river mouth (**Figure 4**, Appendix D).

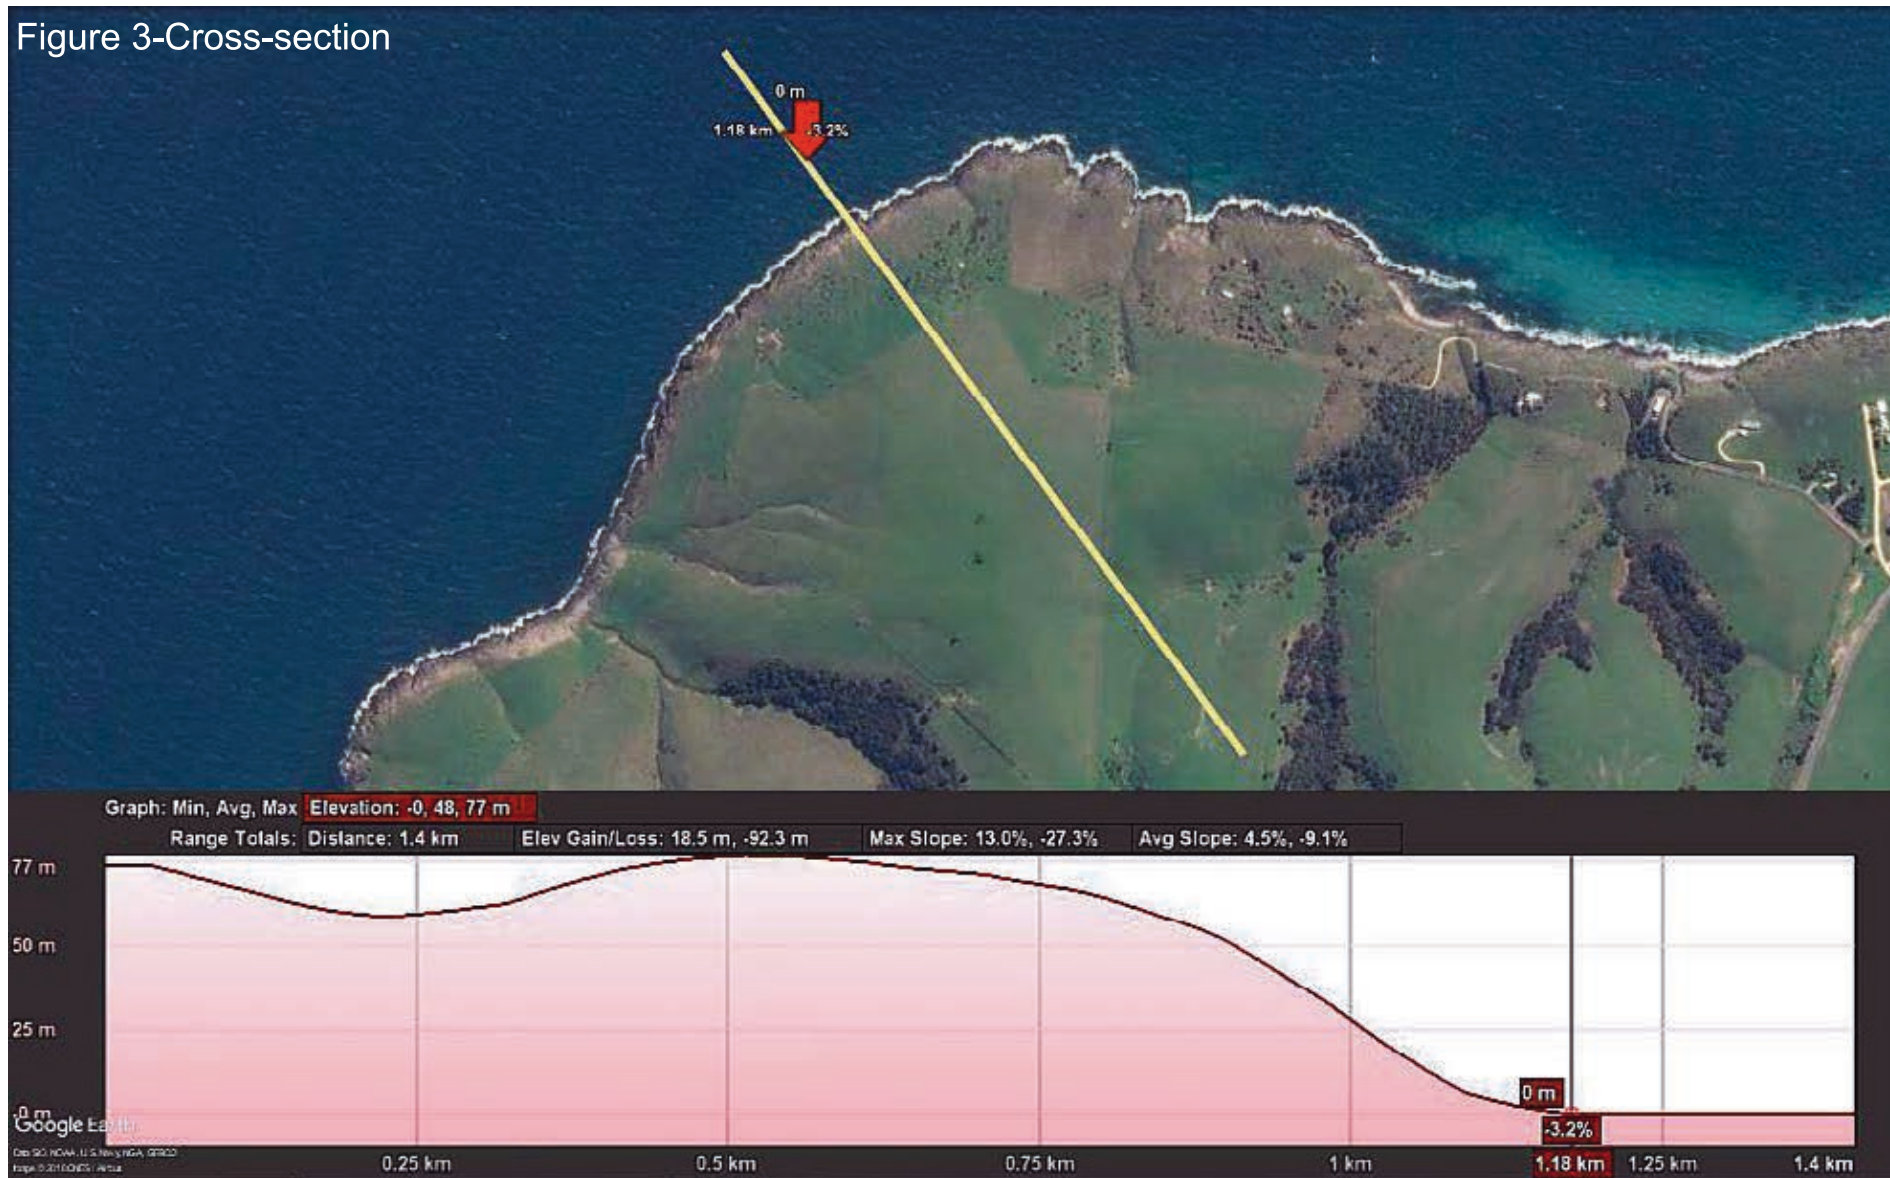
Figure 3-Cross-section

- almost completely cleared for agriculture, with some pockets of vegetation
- approximately seven private residences/structures along the northern coastline (**Figure 1**, Appendix E)
- regional view (**Figure 2**, Appendix E) shows consistent cleared agricultural lands interspersed with pockets (interconnected and unconnected) of vegetation
- area seems to be interspersed with vegetated and unvegetated gullies, with an eroded rocky entry to the water (**Figure 6**, Appendix E)
- a town community (Penneshaw) is visible to the east of the location (**Figure 2**, Appendix E)
- bathymetry depth data show almost an instant depth of 9 m (**Figure 4**, Appendix E)
- cross-section shows a swale shape in the first 0.5 km, that proceeds to a decline with a maximum slope of -27.3% and a total elevation loss of 77 m (**Figure 3**, Appendix E).

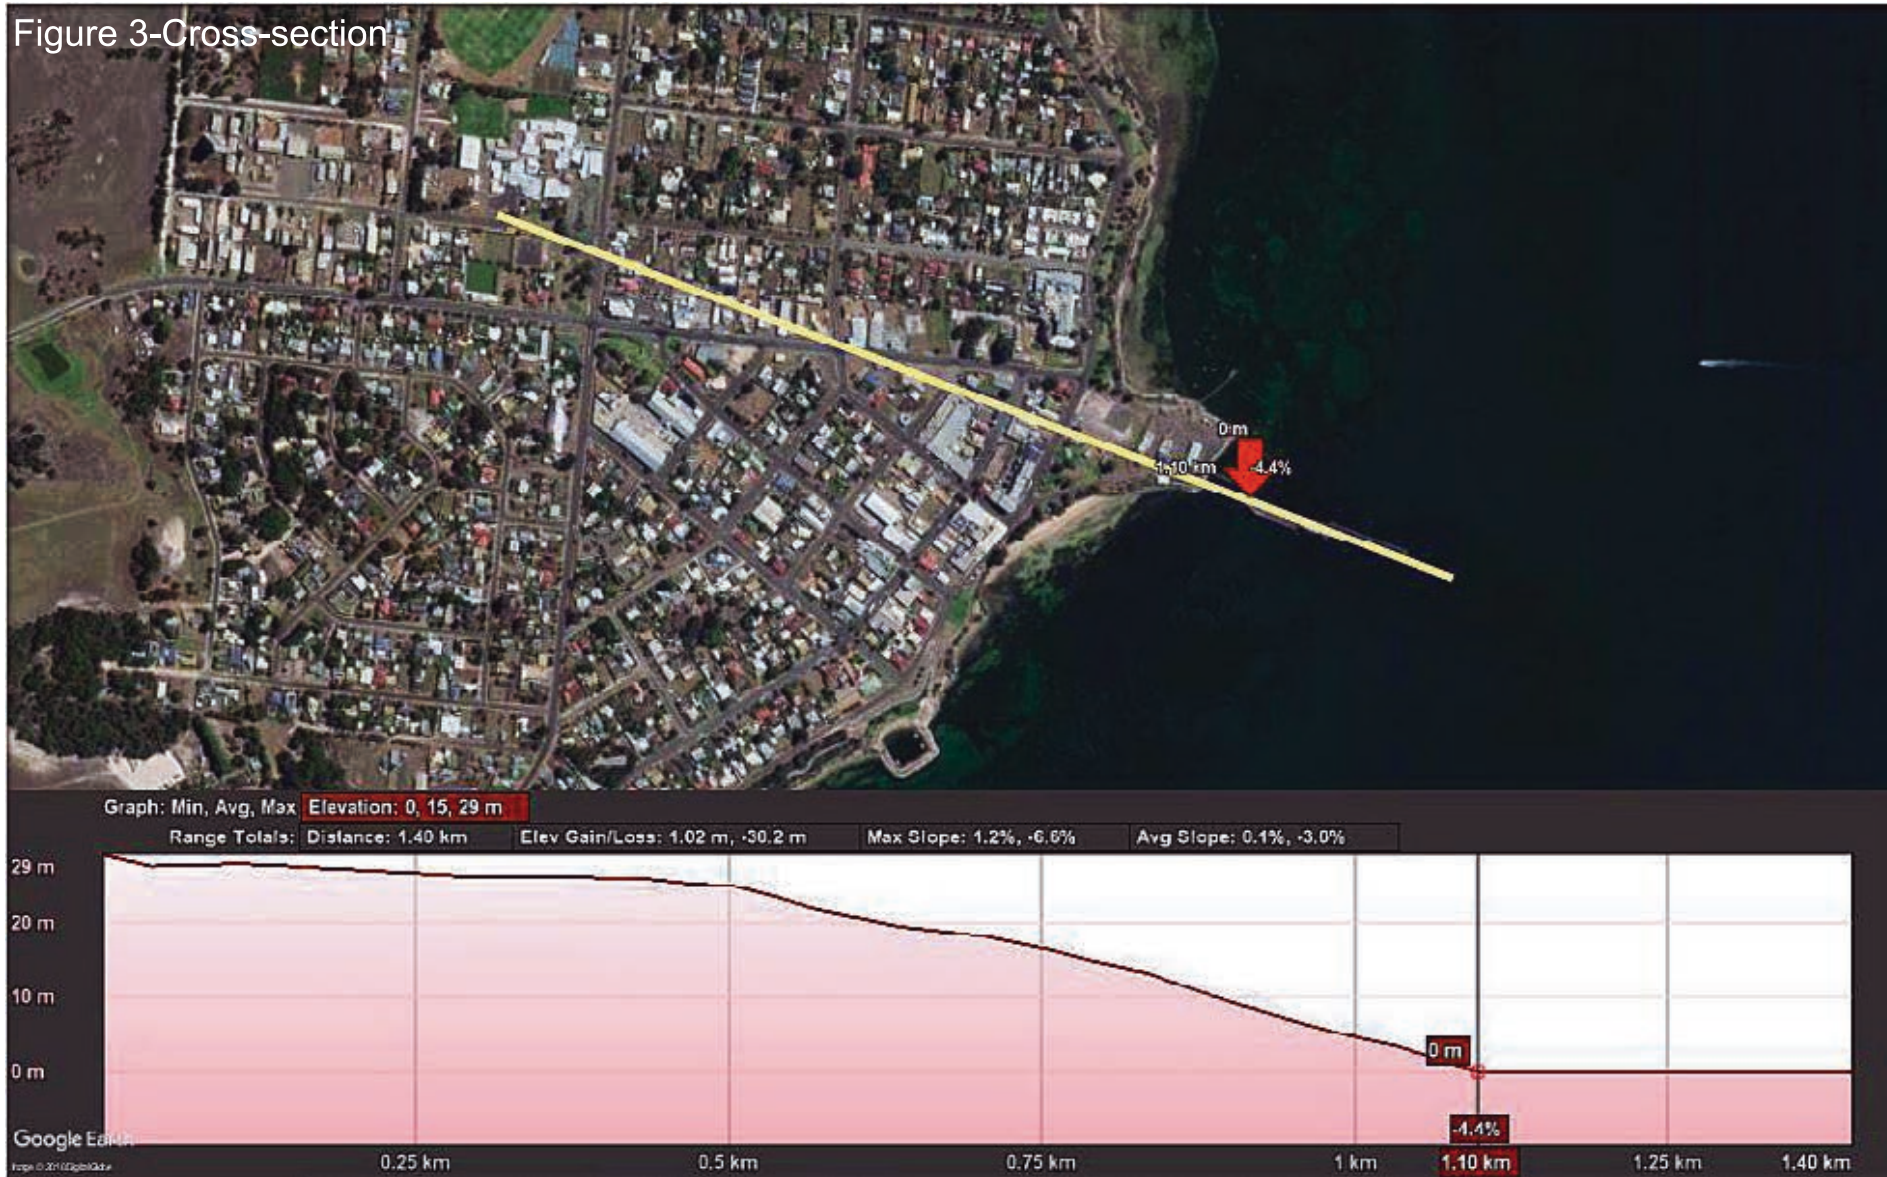
- significant residential and commercial development and a jetty and associated infrastructure exists (**Figure 1**, Appendix F)
- slightly sloping with a total elevation loss of 29 m and a maximum slope of -6.6%, that presents as a consistent decline from about 250 m to the 1.1km point (**Figure 3**, Appendix F)
- on a regional scale, the location is at the end of a low headland on the southern side of Bay of Shoals, with a large sand bar providing protection from ocean swell and agricultural land extending a distance away from the coast (**Figure 2**, Appendix F)
- public foreshore infrastructure such as walking tracks, ocean pool and parkland visible along the coastline.

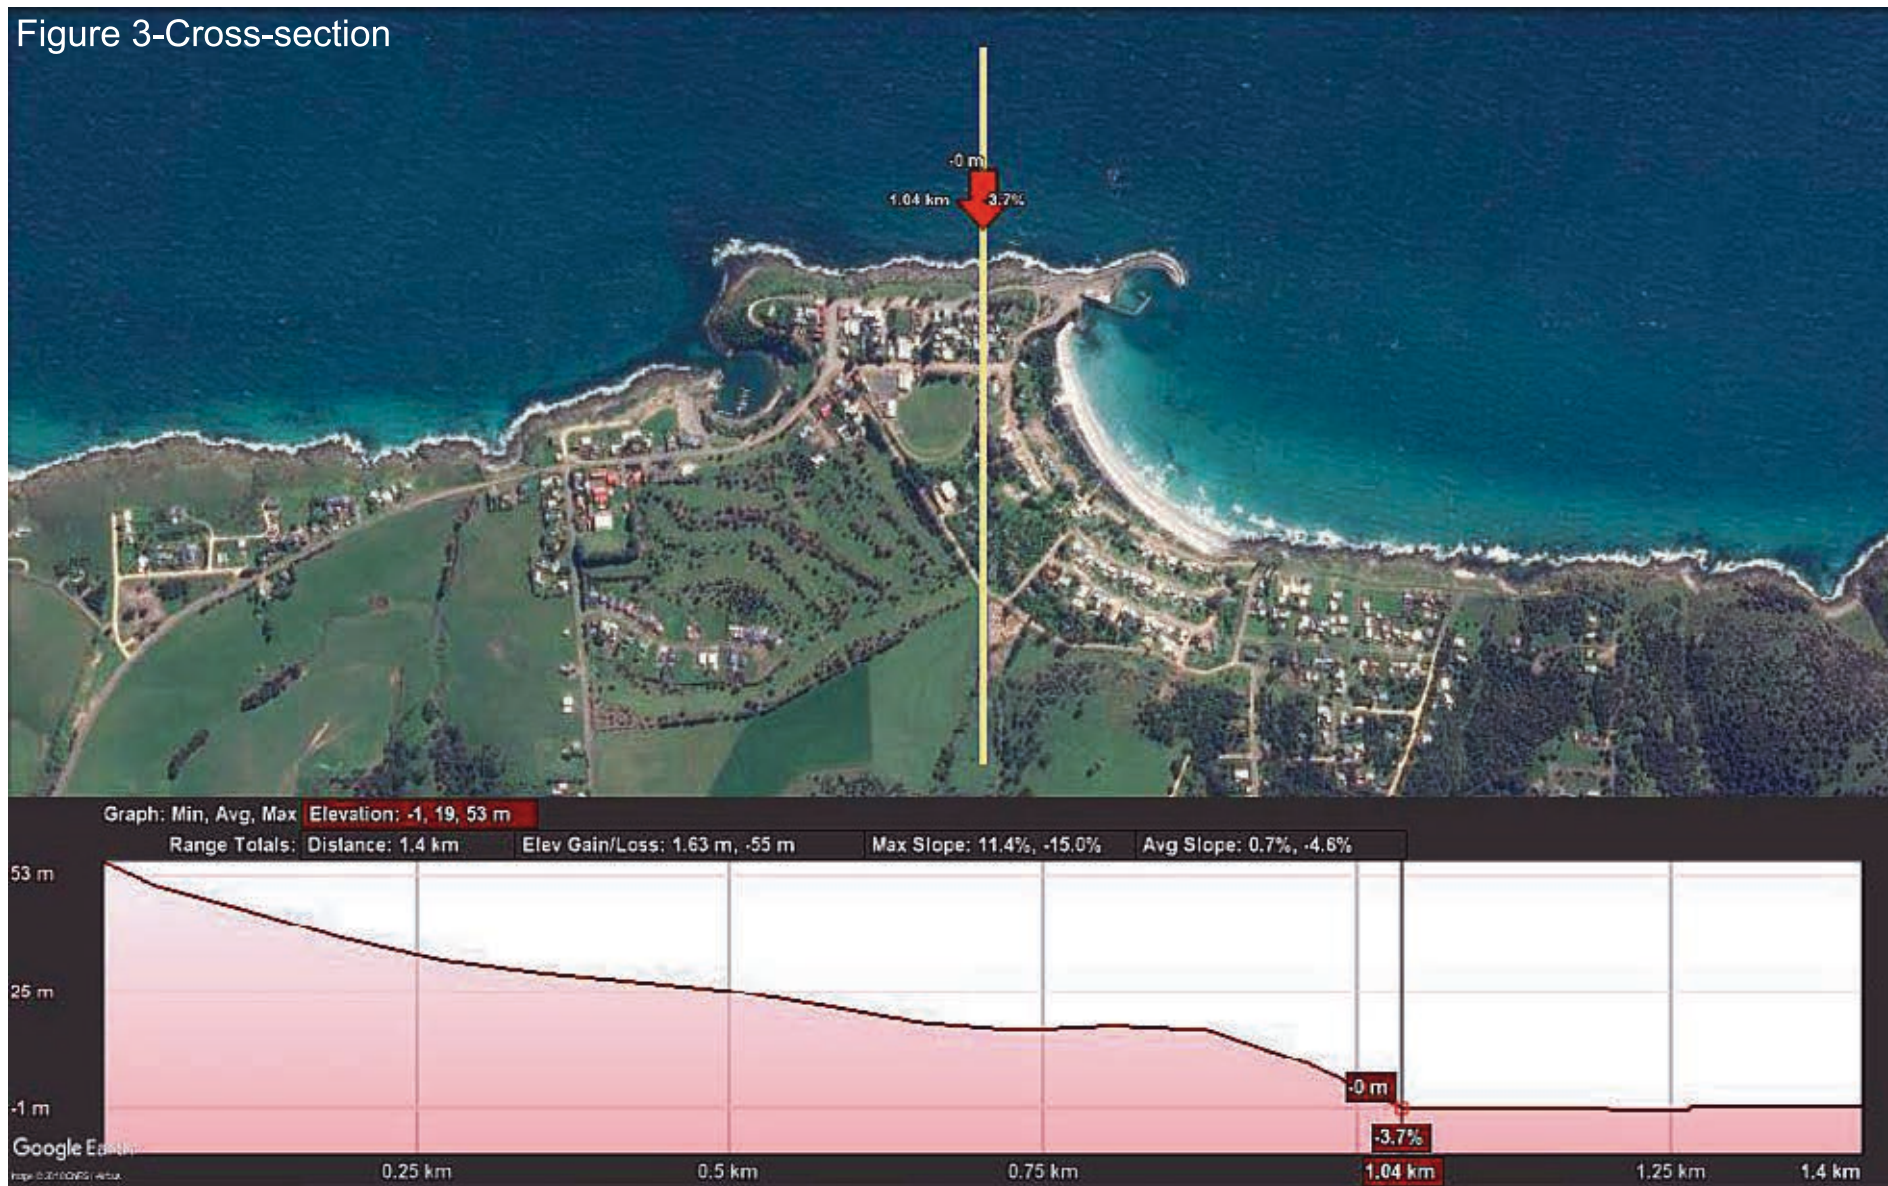
Figure 3-Cross-section

- location of the island's ferry terminal for passenger and freight movement to/from Kangaroo Island
- significant amount of residential development
- some land, assumed to be for agricultural purposes, on the outskirts of the residential area
- some vegetated areas to the east of the location that appears to be hummocky in nature (**Figure 6**, Appendix G)
- a golf course (or similar) on the outskirts of the residential area (**Figure 2**, Appendix G)
- elevation cross-section shows a steady decline from 53 m down to just below 25 m where it levels off slightly before a final slope down to the water, with a maximum slope of -15% (**Figure 3**, Appendix G)
- depth data shows it remains below 10 m deep for approximately 350 m from shore (**Figure 4**, Appendix G).

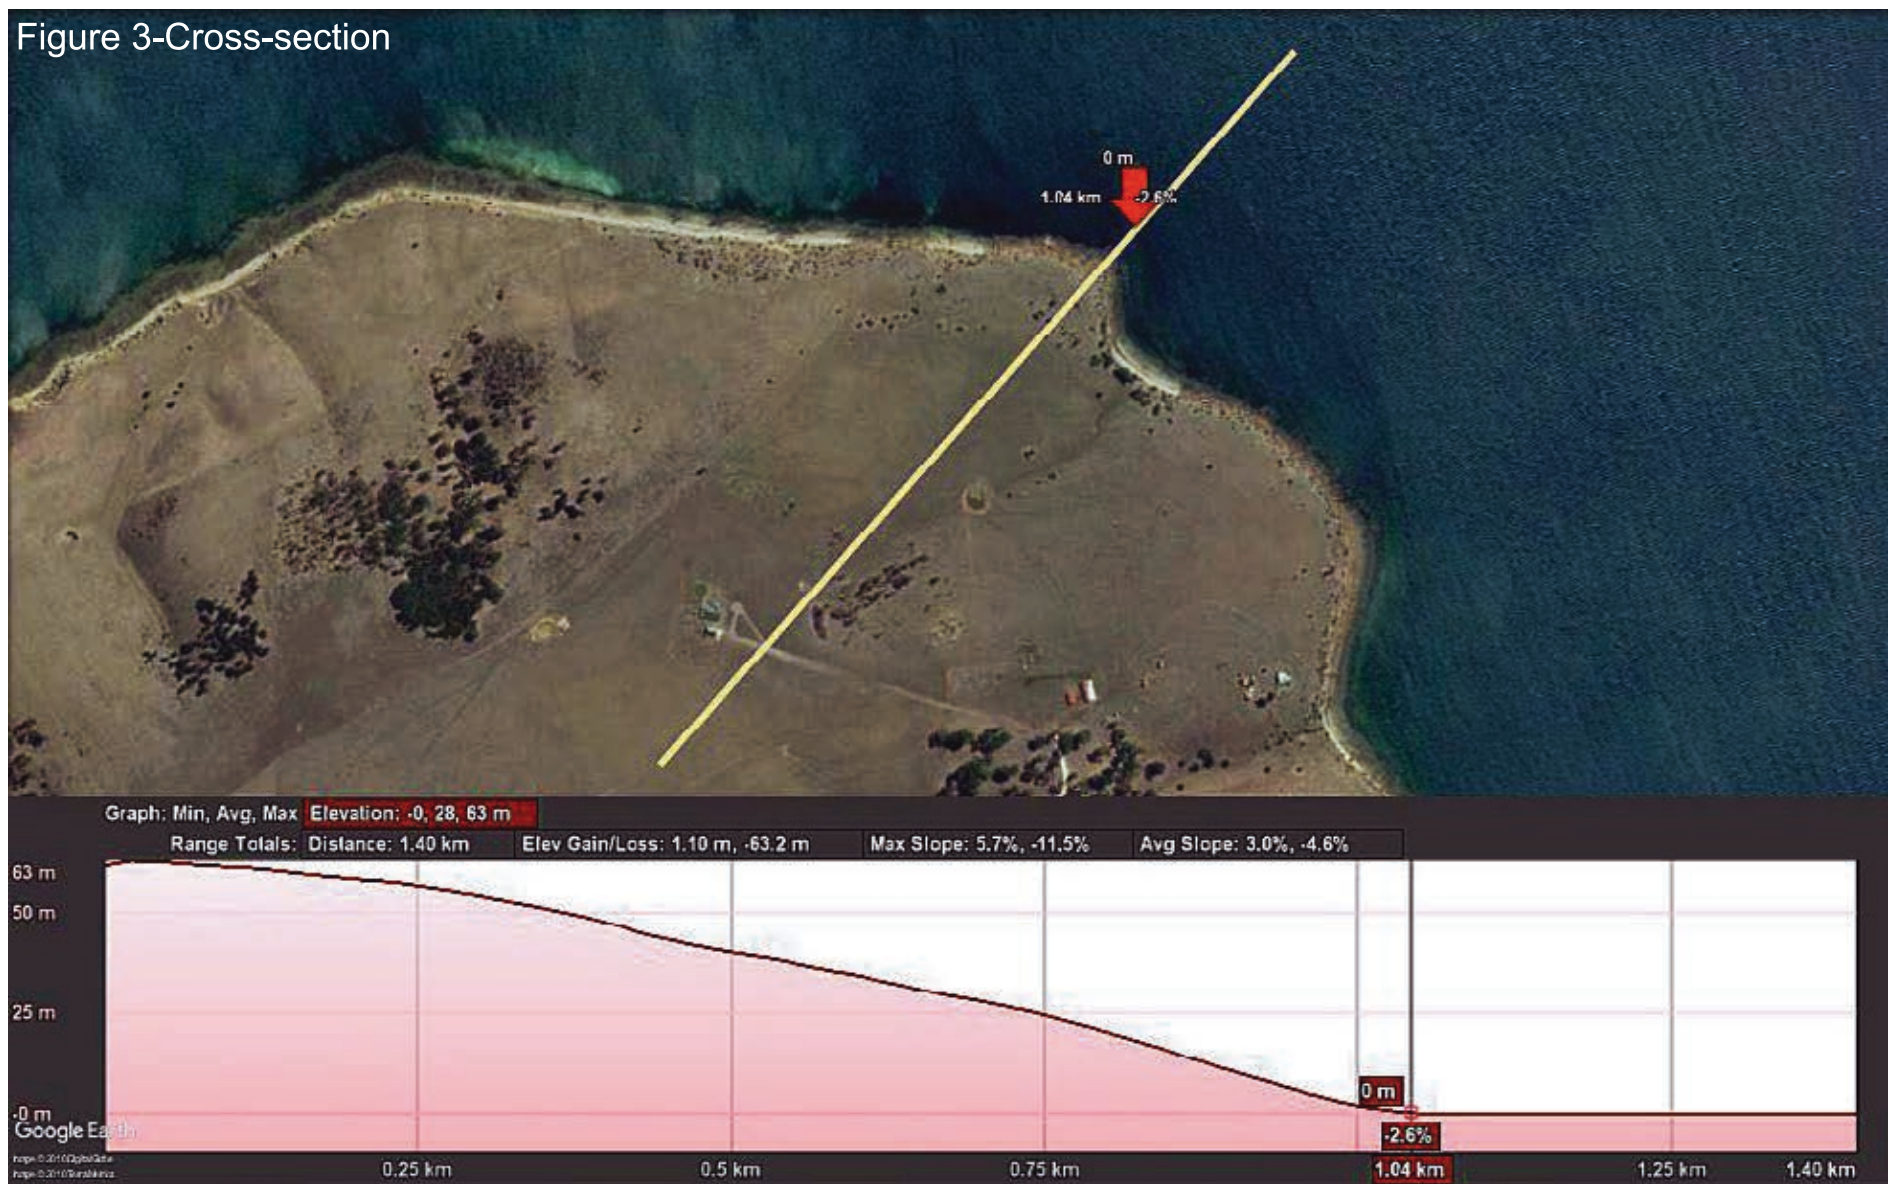
Figure 3-Cross-section

- surrounded by agricultural land, disconnected stand of vegetation (to the south-east) and vegetation can be seen adjacent to the coastline and throughout agricultural areas (**Figure 2**, Appendix H)
- cross-sectional data shows a steady decline of 63 m and a maximum slope of -11.5%, from approximately 100 m through to the 1.04 km point, where the water's surface is encountered (**Figure 3**, Appendix H)
- coastal imagery confirms the slight decline to the water's edge, with depth data showing a gradual decline in water depth to the 9.9 m mark and sand pockets marked close to the central location marker (**Figure 4**, Appendix H).

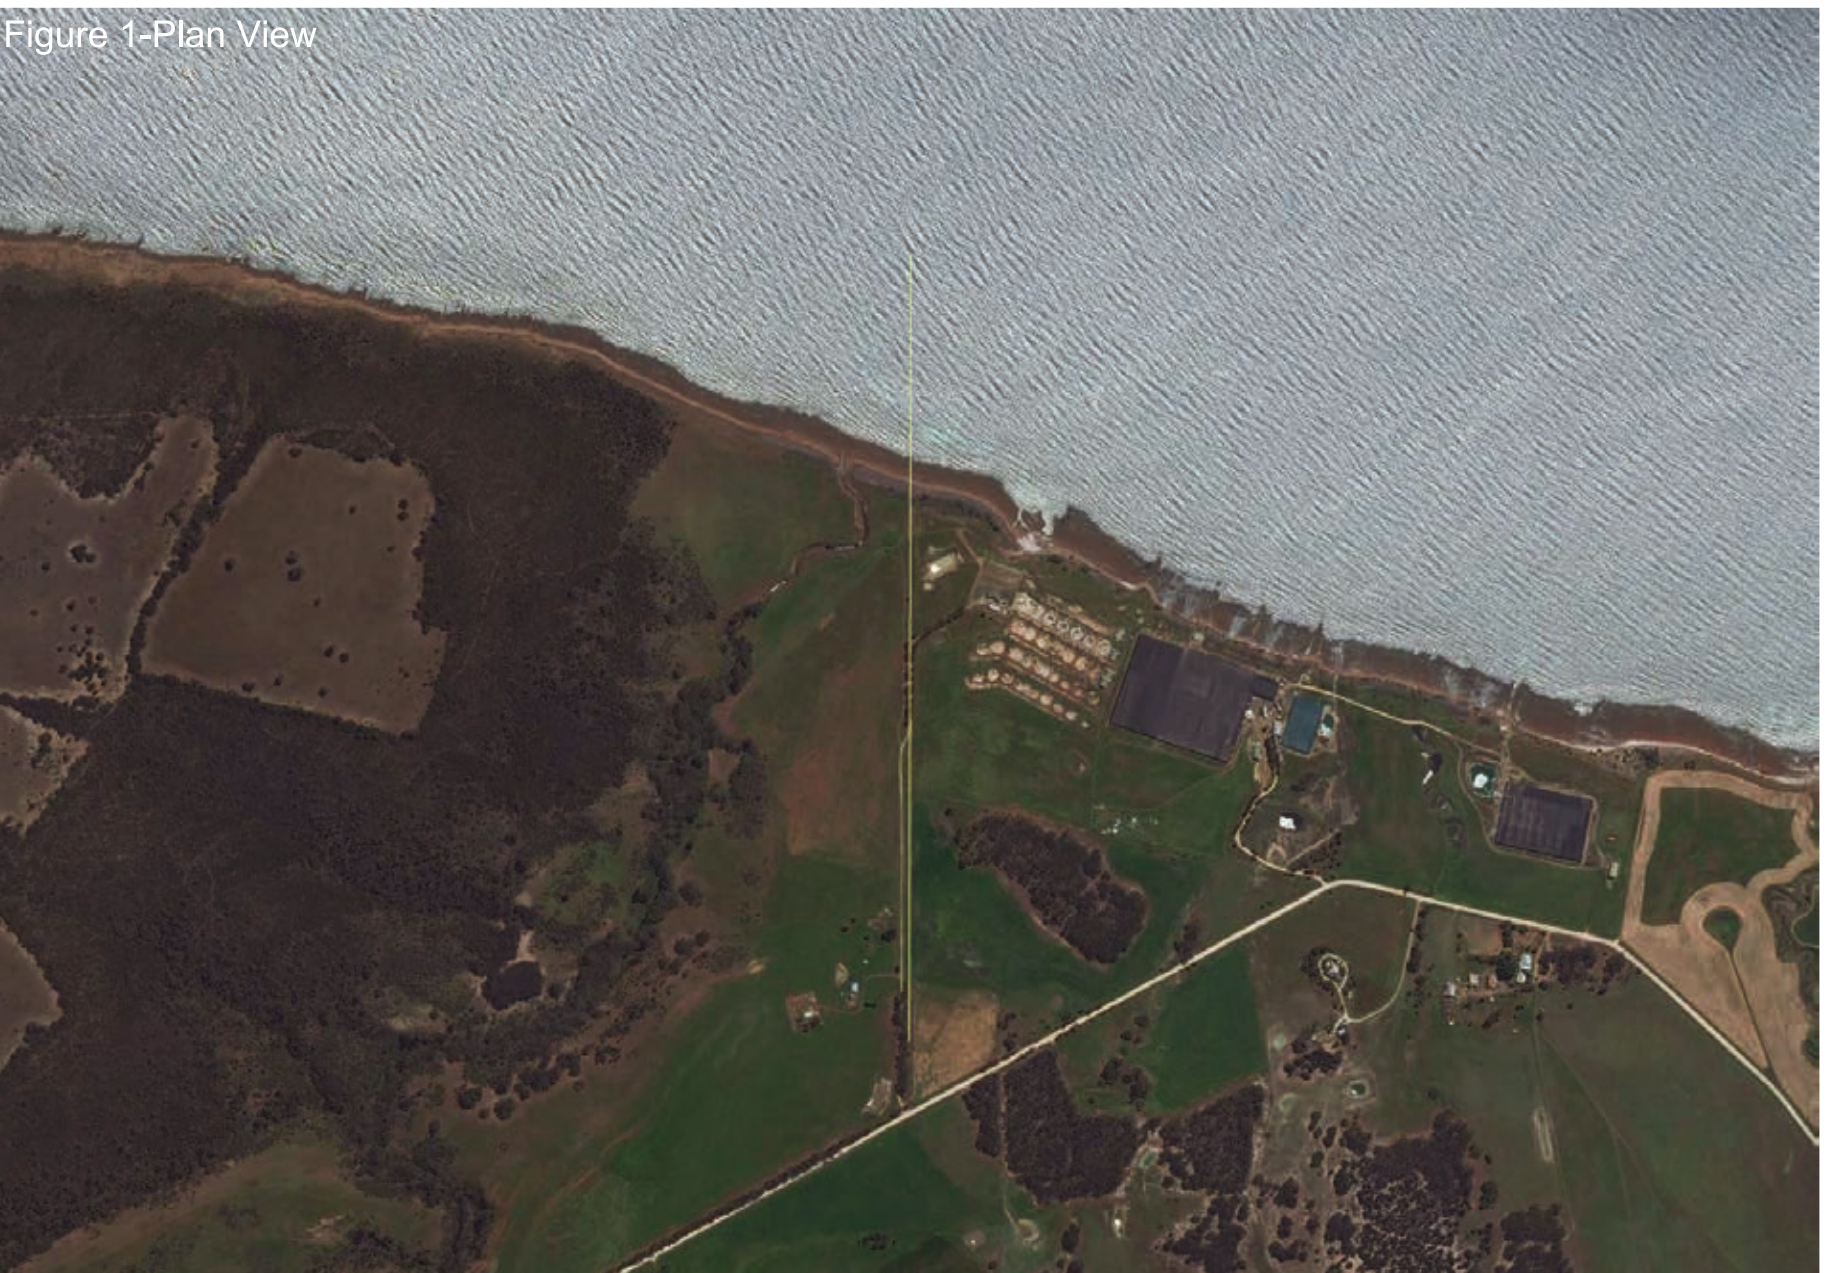
- the coastline looks to be of a rocky nature, between 40 m and 50 m wide, remnant aquaculture infrastructure, directly bounding the proposed site to the east and agricultural farmland extending away from the site in an arc, south south-west to the east (Figure 1, Appendix I)

- there is an onshore tank-based aquaculture facility established at Smith Bay to the east of the proposed site, whilst to the west there is a large interconnected stand of native vegetation and to the south is an isolated small stand of remnant native vegetation (Figure 1, Appendix I)
