SMITH BAY WHARF

DRAFT ENVIRONMENTAL IMPACT STATEMENT

APPENDIX B – ALTERNATIVE LOCATIONS FOR KI SEAPORT

Appendix B – Desktop Visual Assessment of Locations

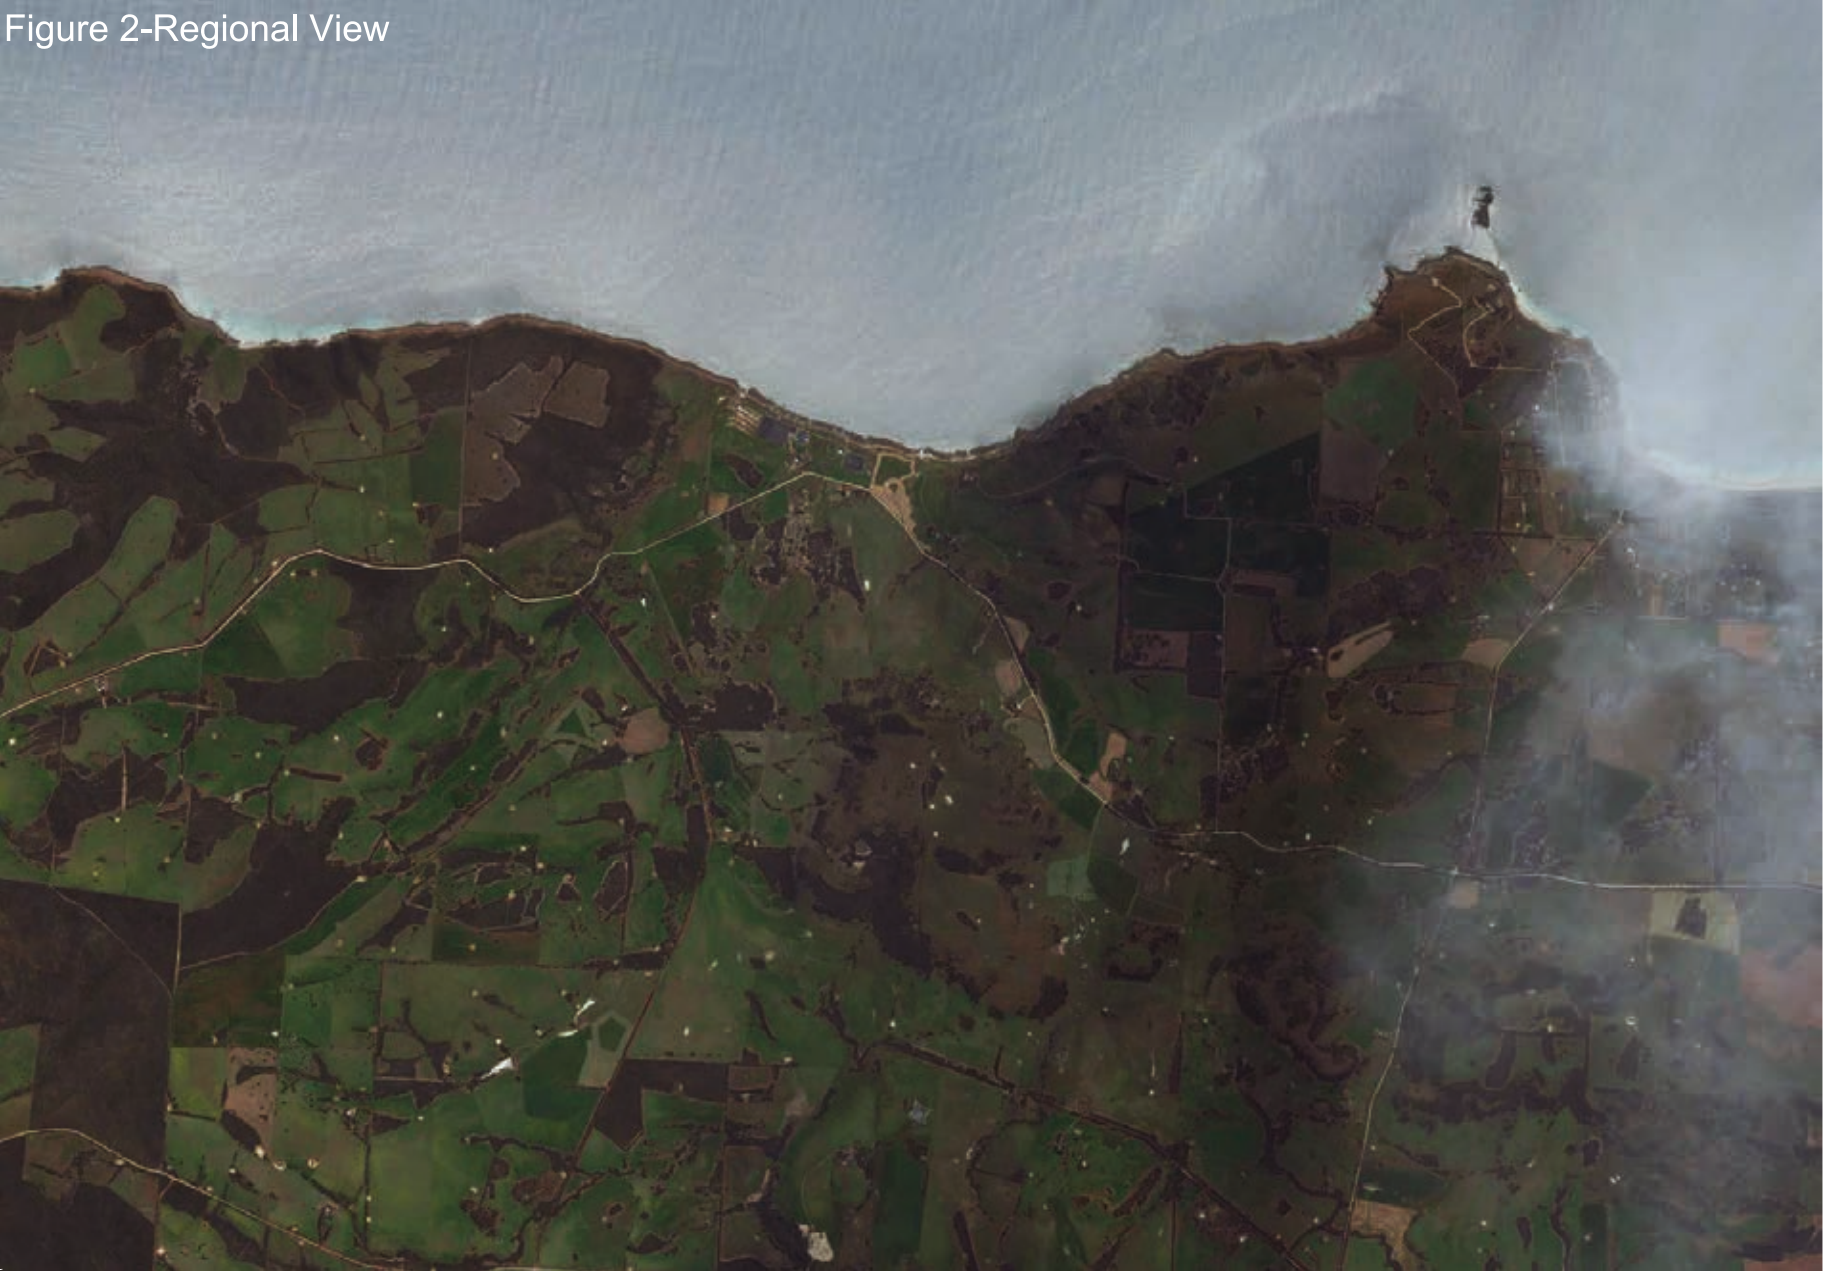
Figure 2-Regional View

- regionally, there is clear evidence of farm land interspersed with unconnected stands of vegetation and a major road (North Coast Rd) running through the area from east to west (Figure 2, Appendix I)

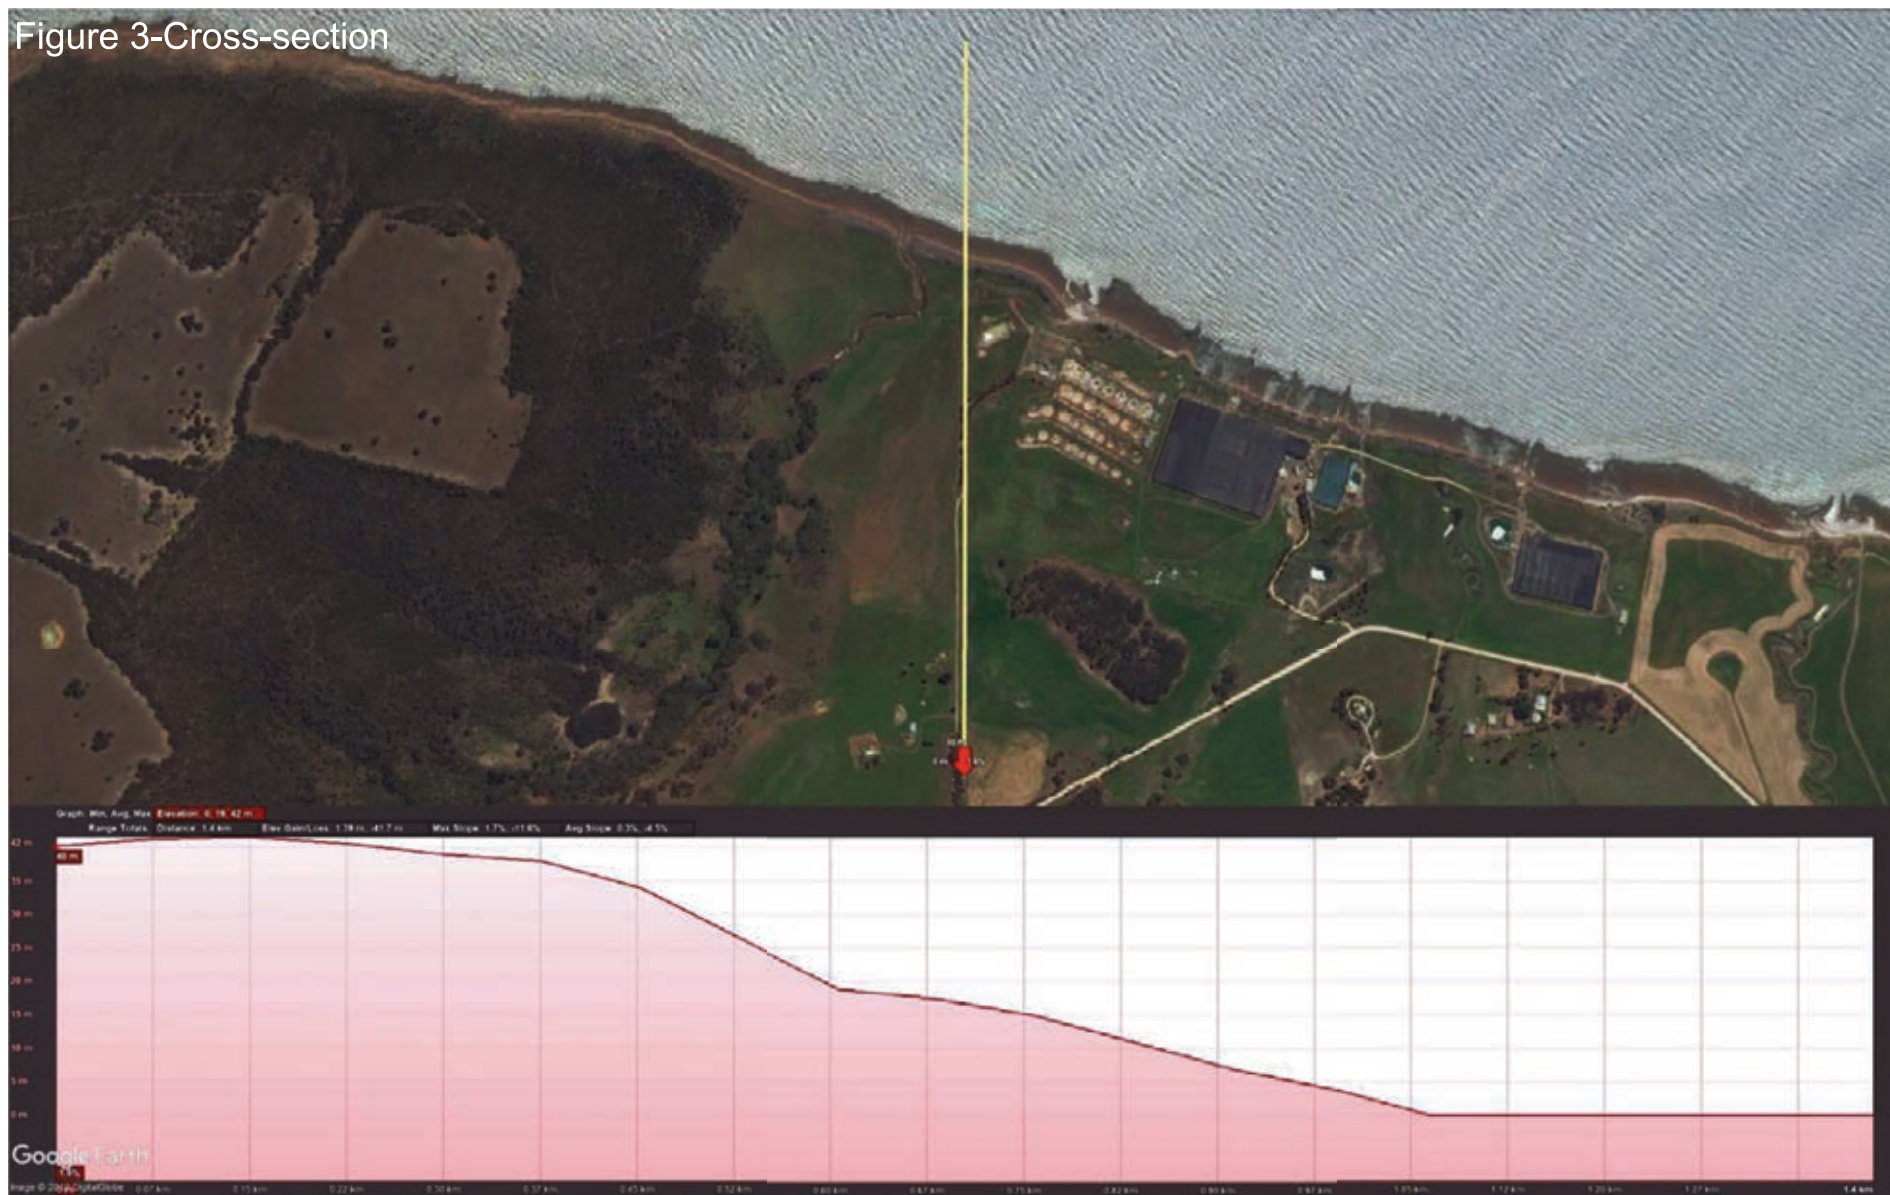
Figure 3-Cross-section

- the cross-section shows a total loss of 42 m in elevation, over two steps, with the first, steeper step ending at 0.6km, followed by a shallower decline through to approximately the 1.07km mark with a maximum decline of -11.6% over the profile (Figure 3, Appendix I)

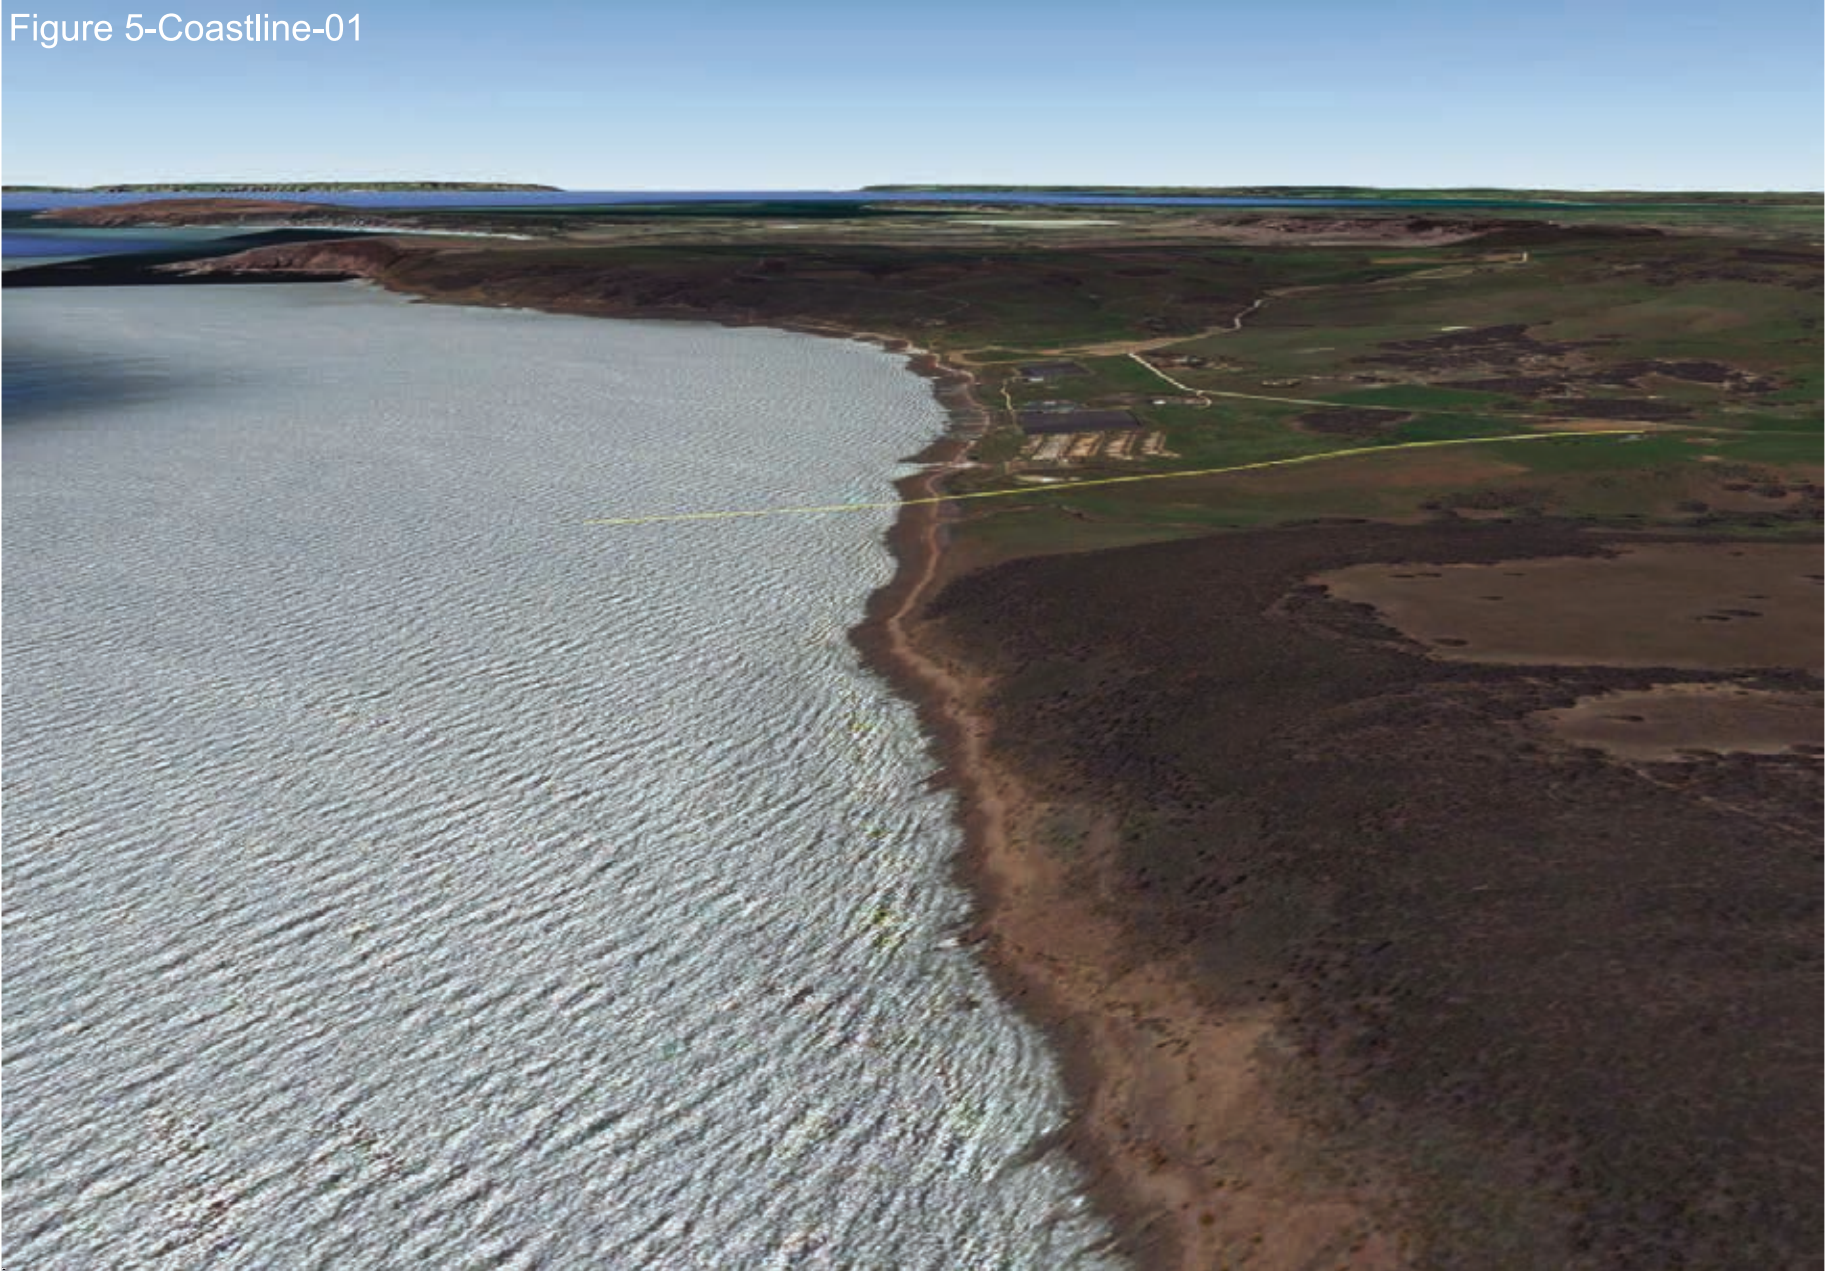
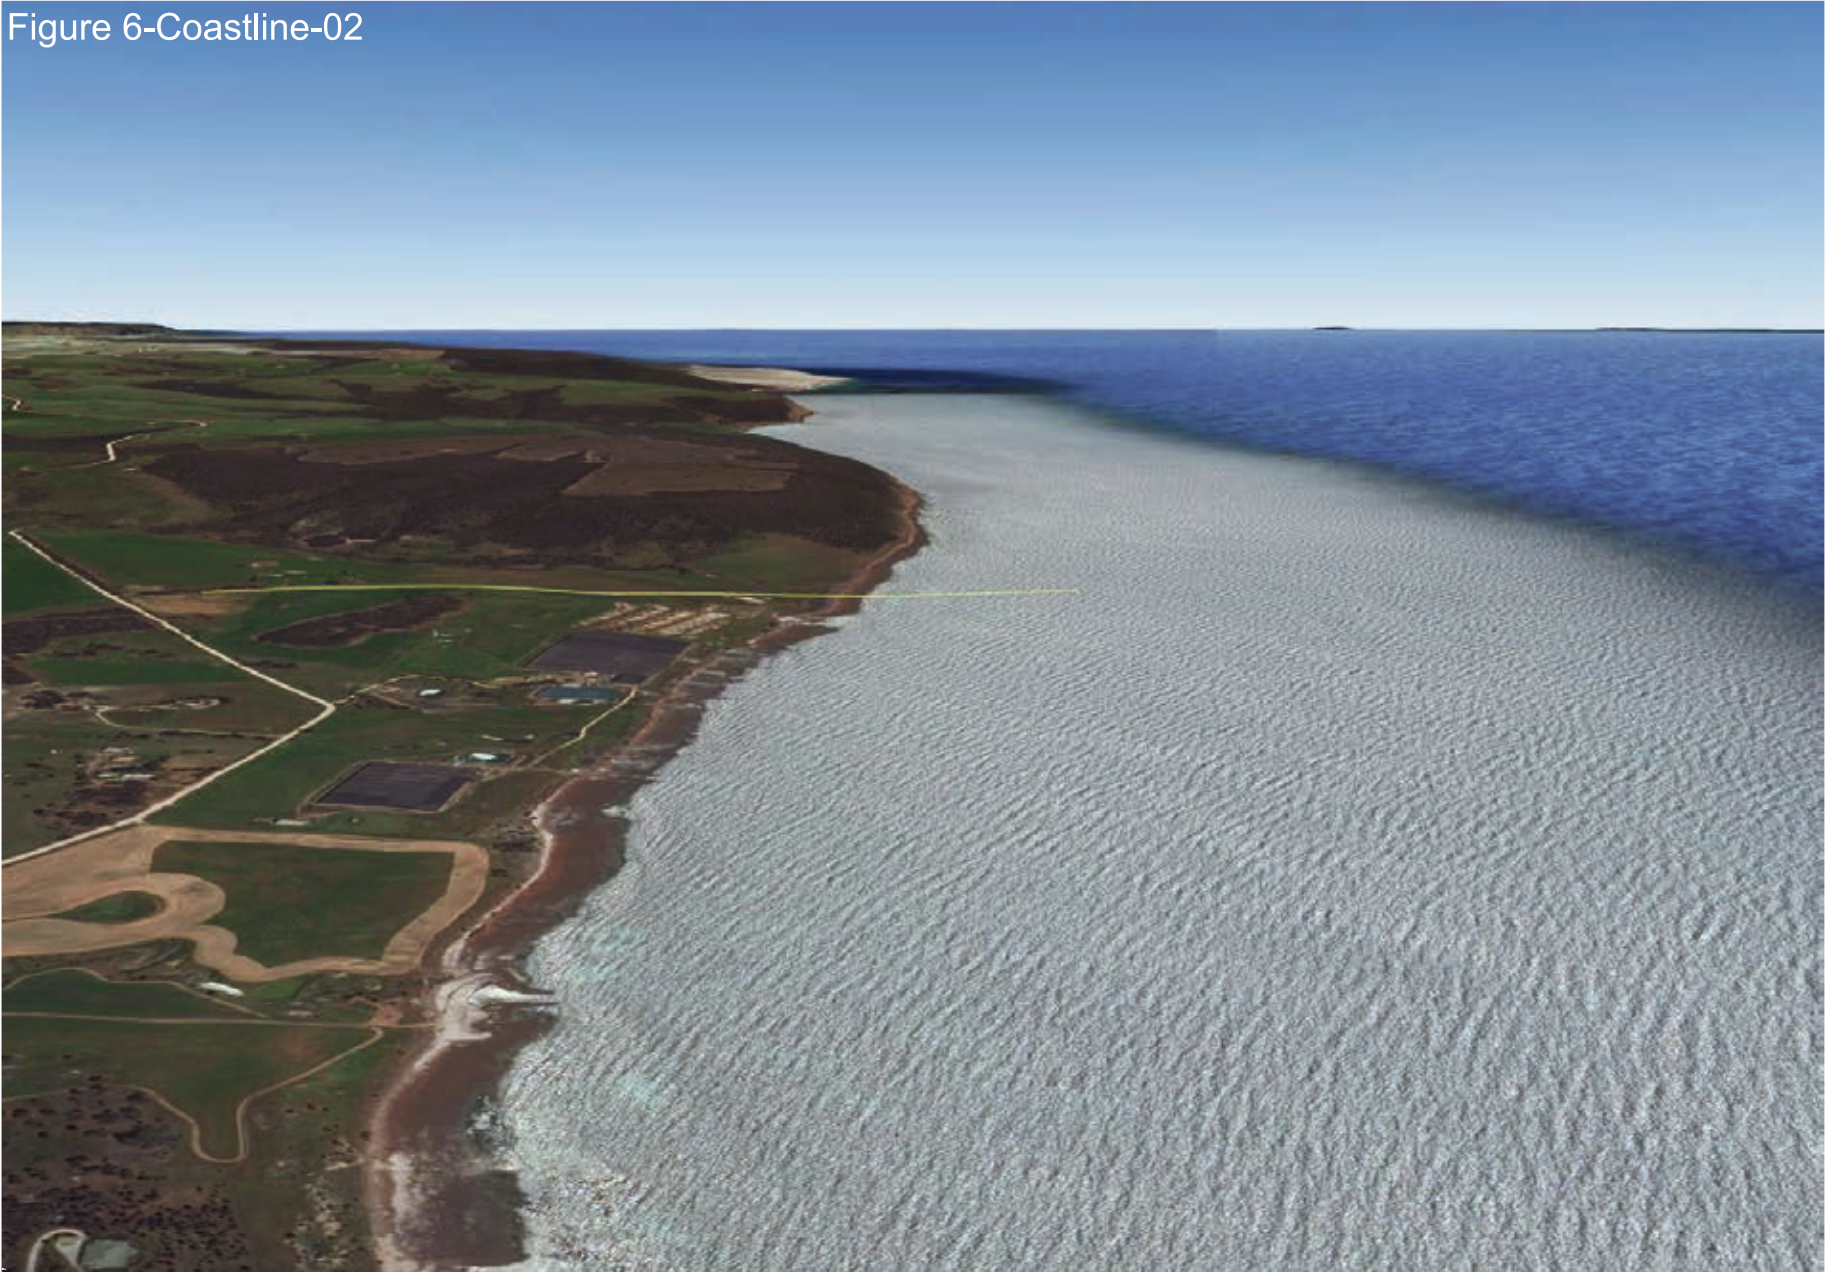
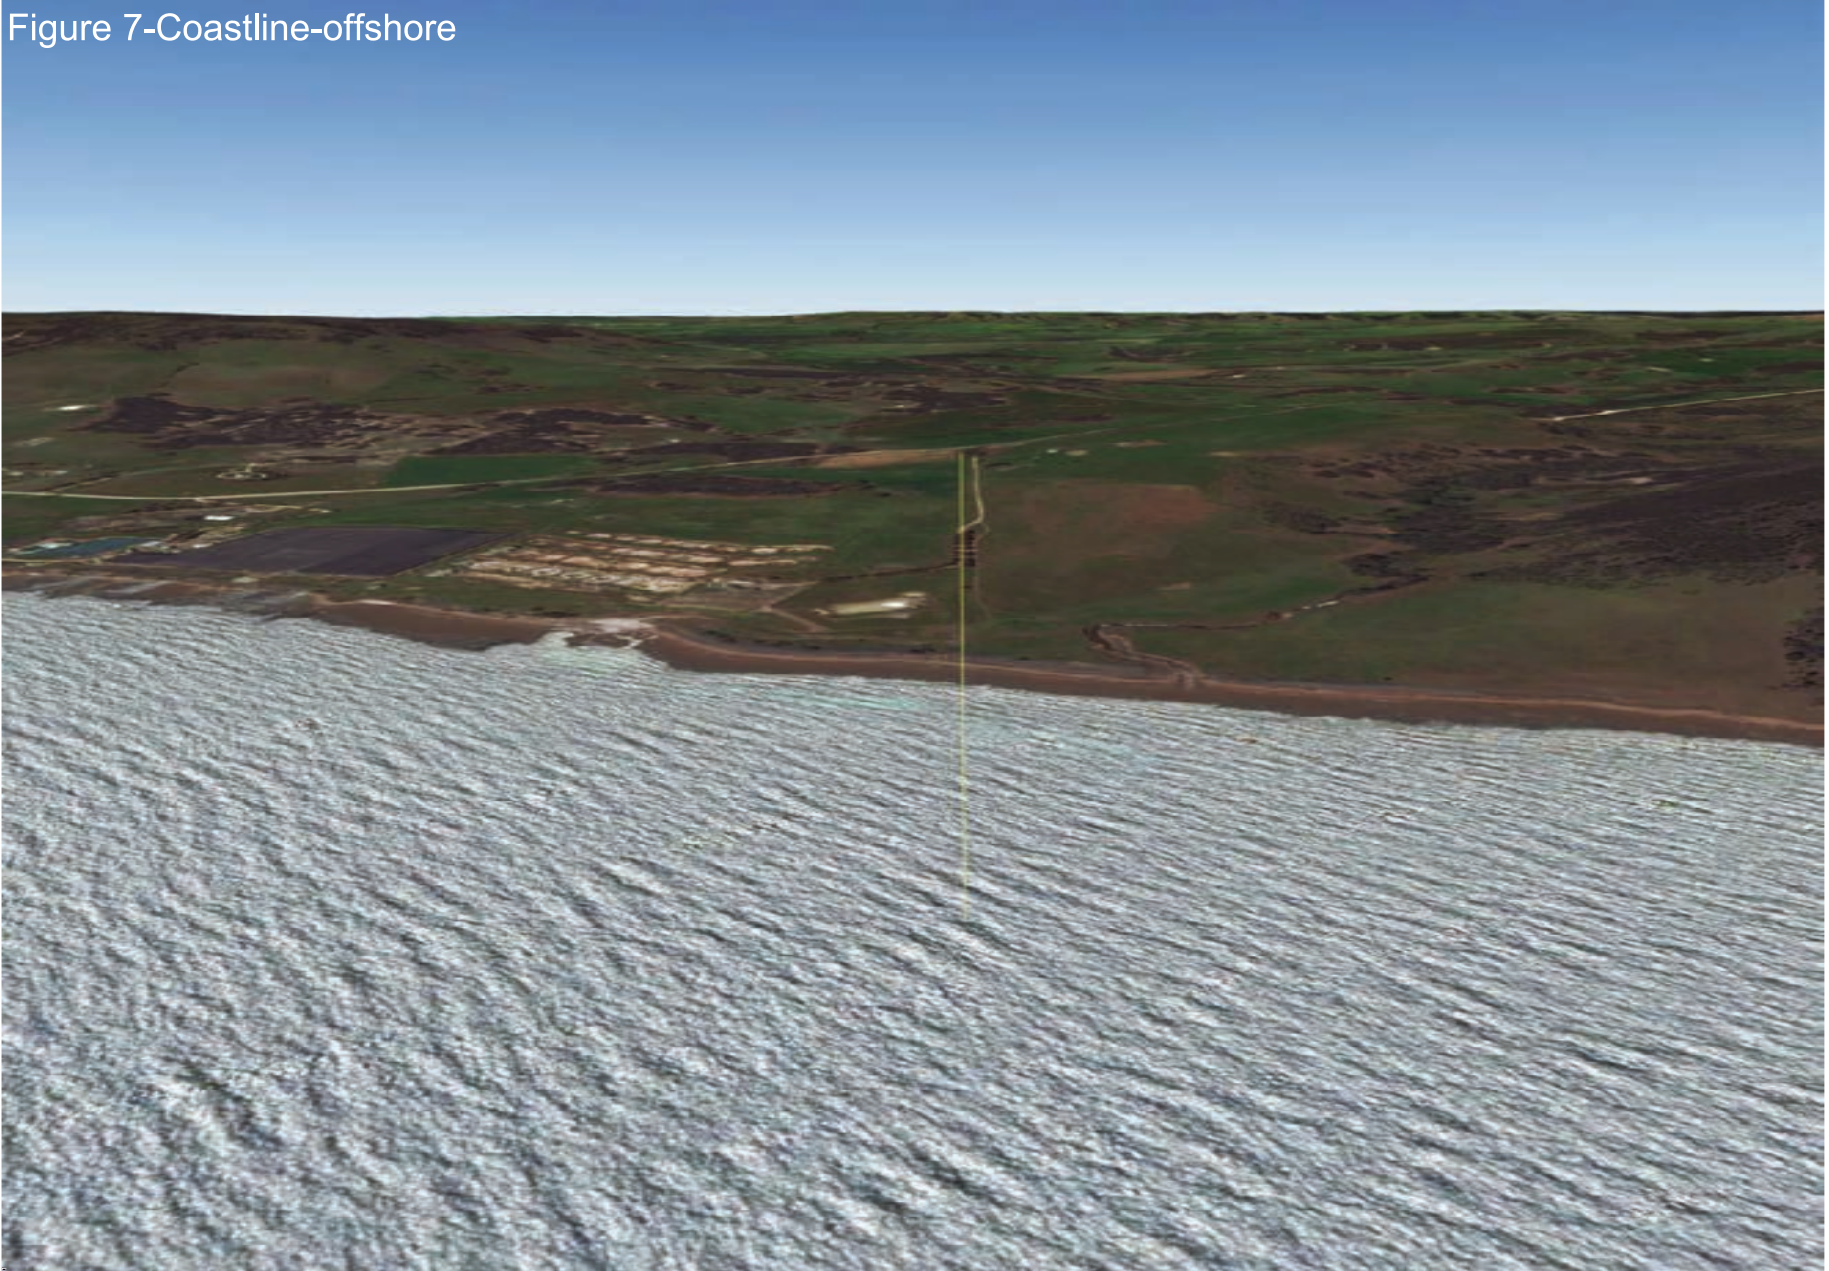
- Figure 5, Figure 6 and Figure 7 (Appendix I) show a shallower gradient towards the coastline at Smith Bay, than what is visible both east and west; areas of higher elevation are visible with steeper declines to the oceans edge in both directions, along with higher elevations further back from the coast

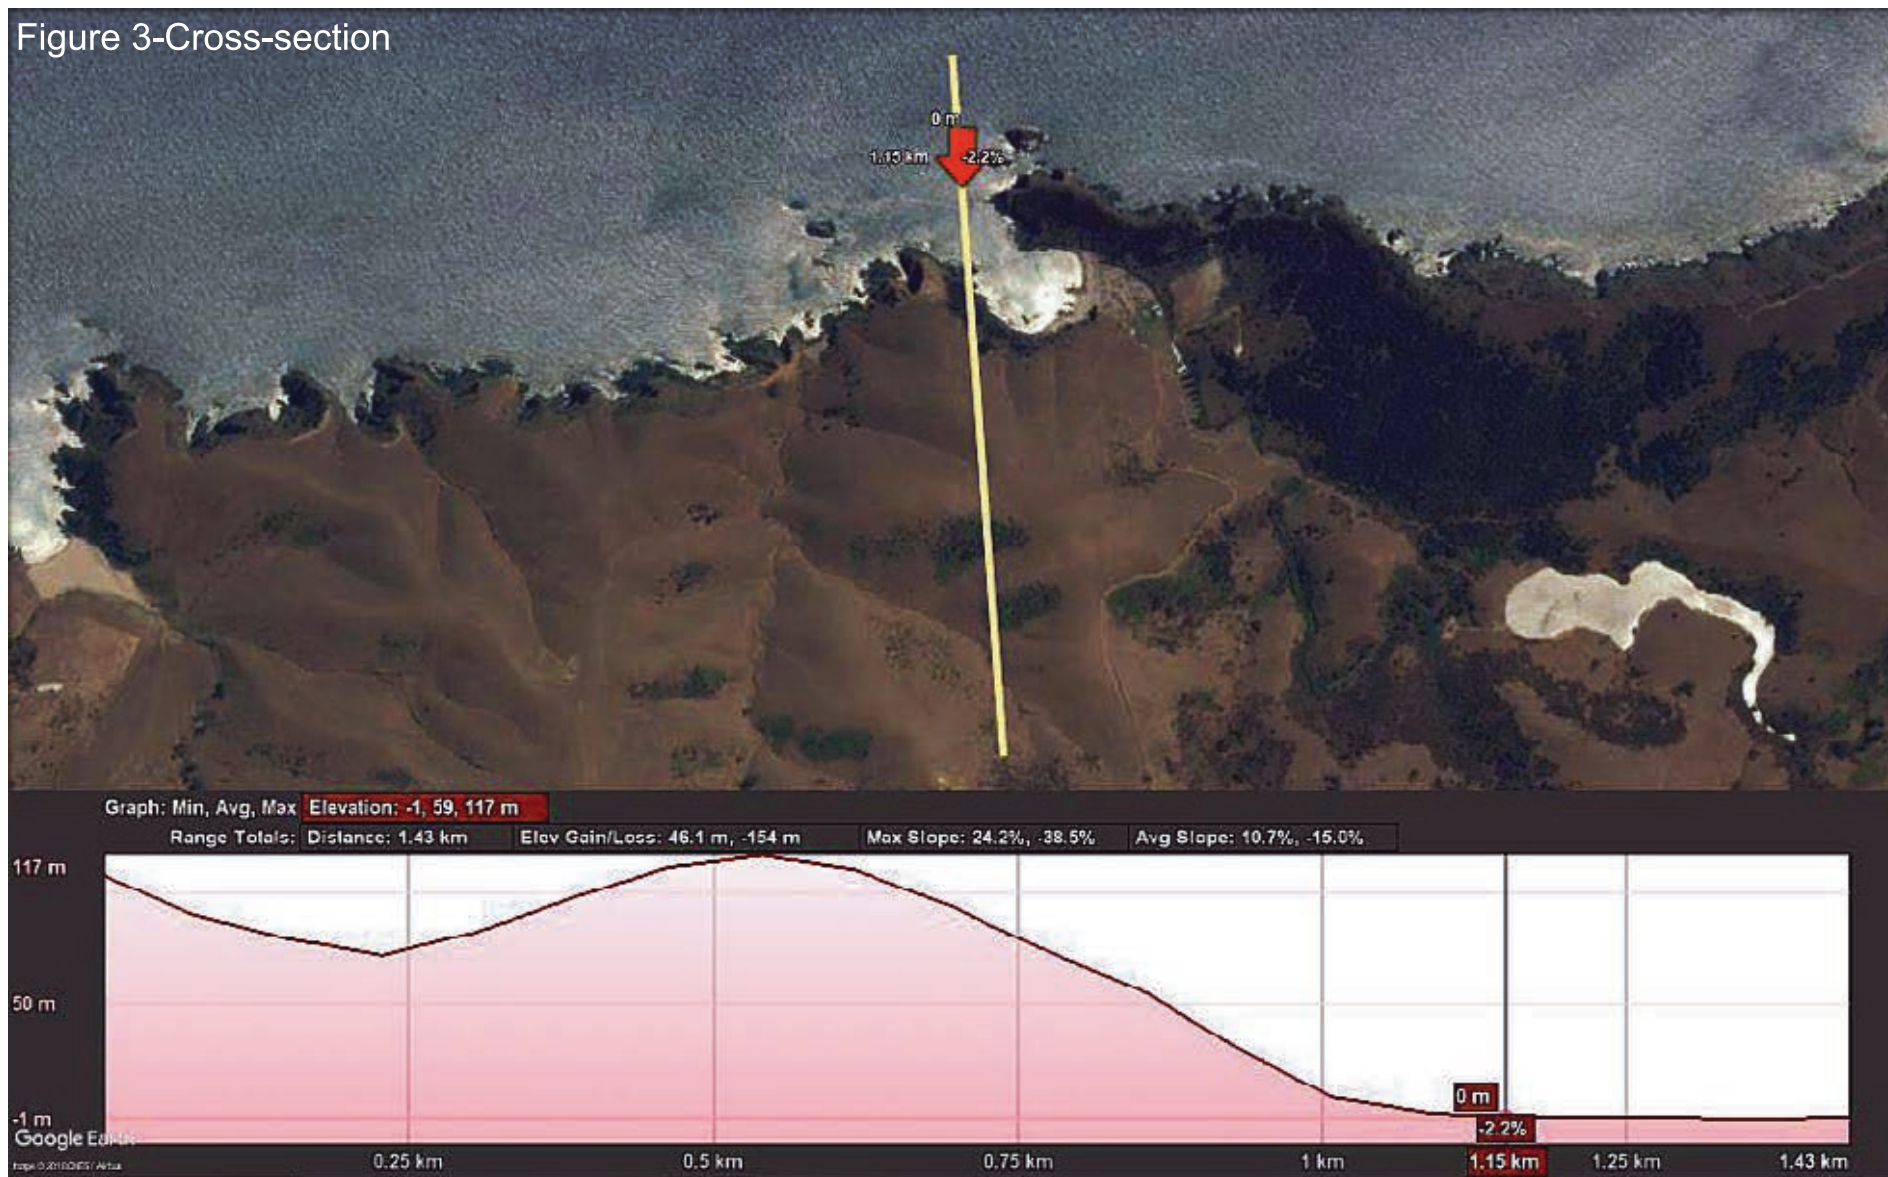
Figure 3-Cross-section

- cross-section indicates that there is a total elevation loss of 117 m and a maximum slope of -38.5%, with two clear ridgelines followed by a steep descent into the cove (**Figure 3**, Appendix J)

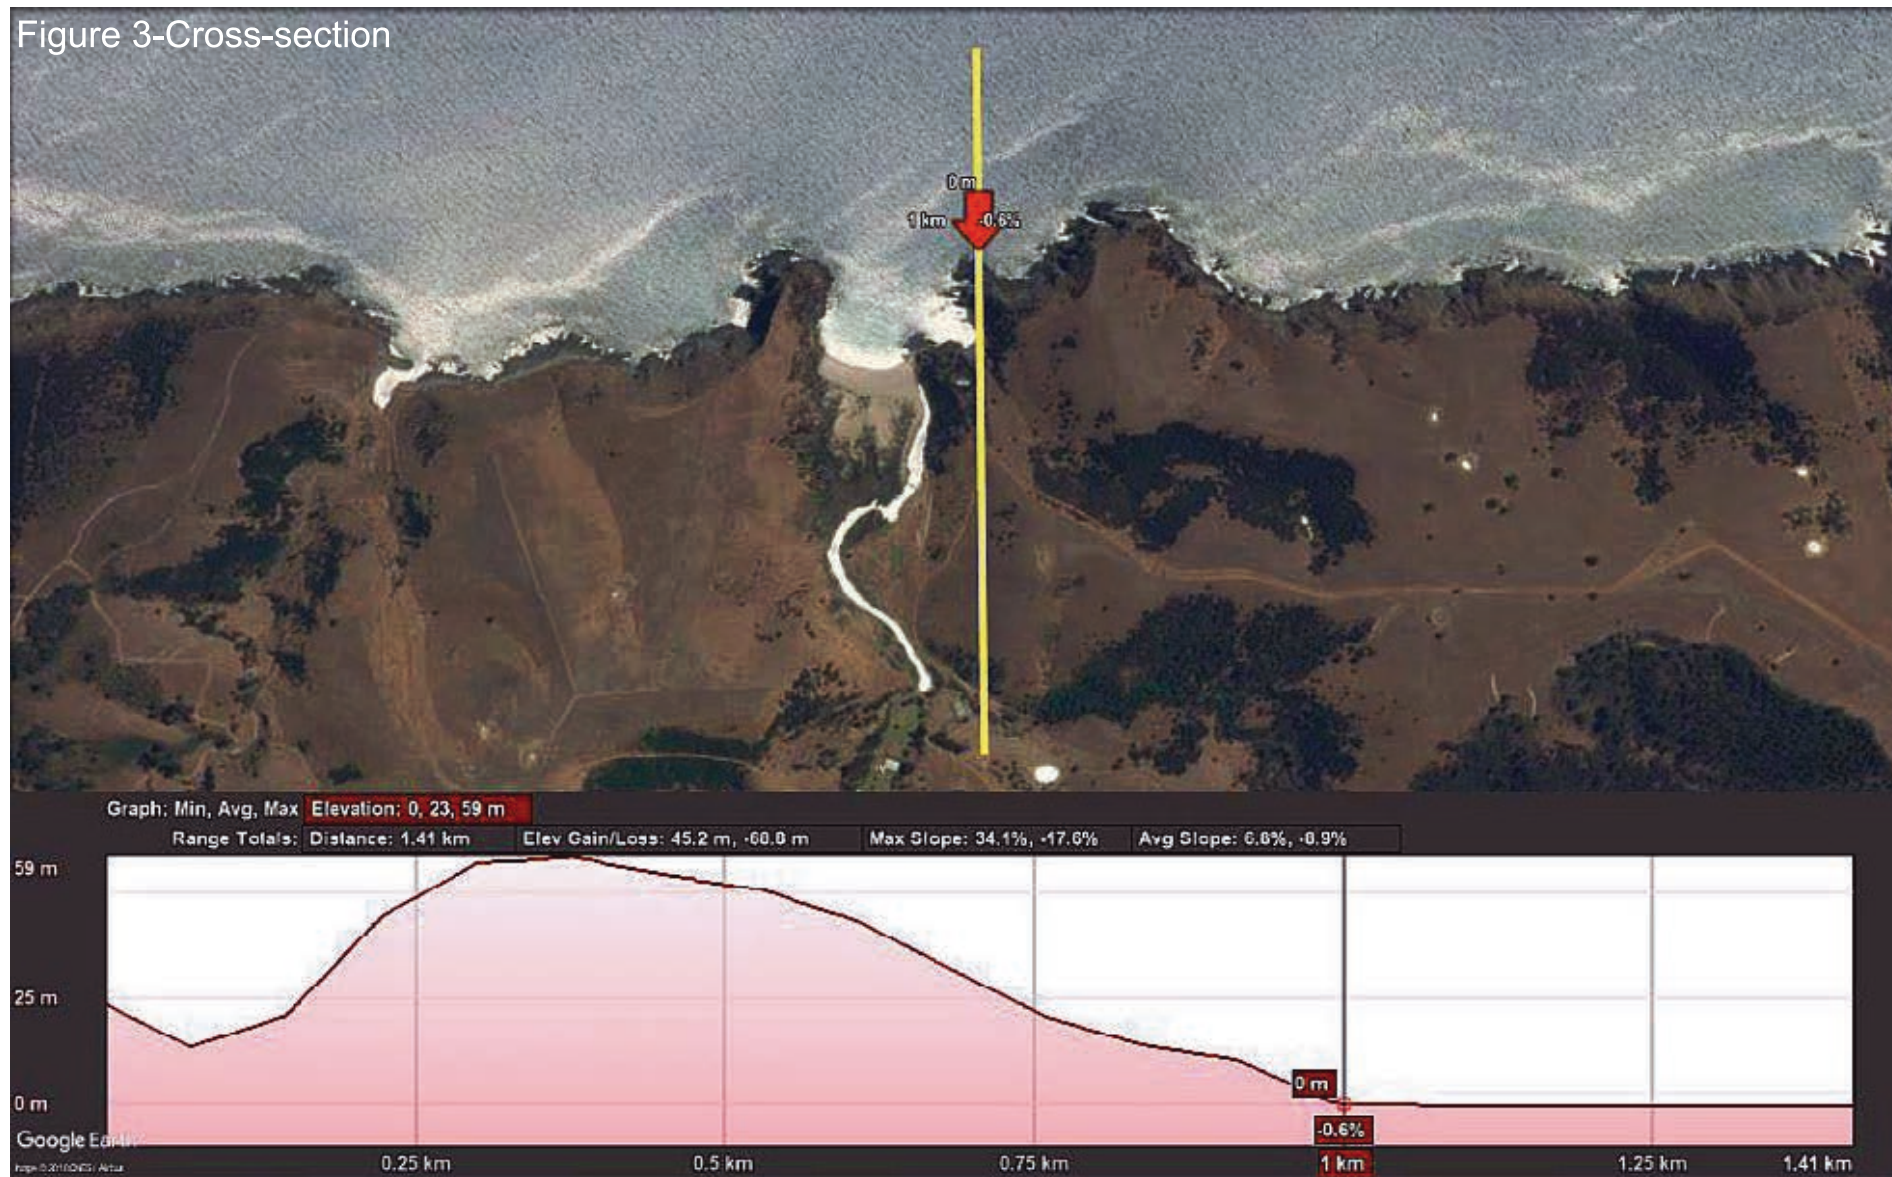
Figure 3-Cross-section

- one visible residential dwelling exists, with two located on a ridgeline further inland (**Figure 1**, Appendix L)
- some isolated pockets of vegetation surrounding the location, with the majority of adjacent land cleared
- cross-section shows two ridgelines, with a total elevation loss of 59 m and a maximum slope of -17.6% (**Figure 3**, Appendix L)
- depth data indicates that the cove enters directly into 20-metre deep water (**Figure 4**, Appendix L)
- a small river enters the cove
- a significant amount of vegetation surrounds the location at a regional scale (**Figure 3**, Appendix L)
- coastline images clearly show that the cove sits within an eroded gully formation with a small sandy beach, river mouth and rock outcroppings at one side (**Figure 5**, **Figure 6** and **Figure 7**, Appendix K).
