# Concordia Growth Area, Concordia SA

## SUPPLEMENTARY GEOTECHNICAL INVESTIGATION

WGA241280-RP-GE-0001\_A

12 September 2024

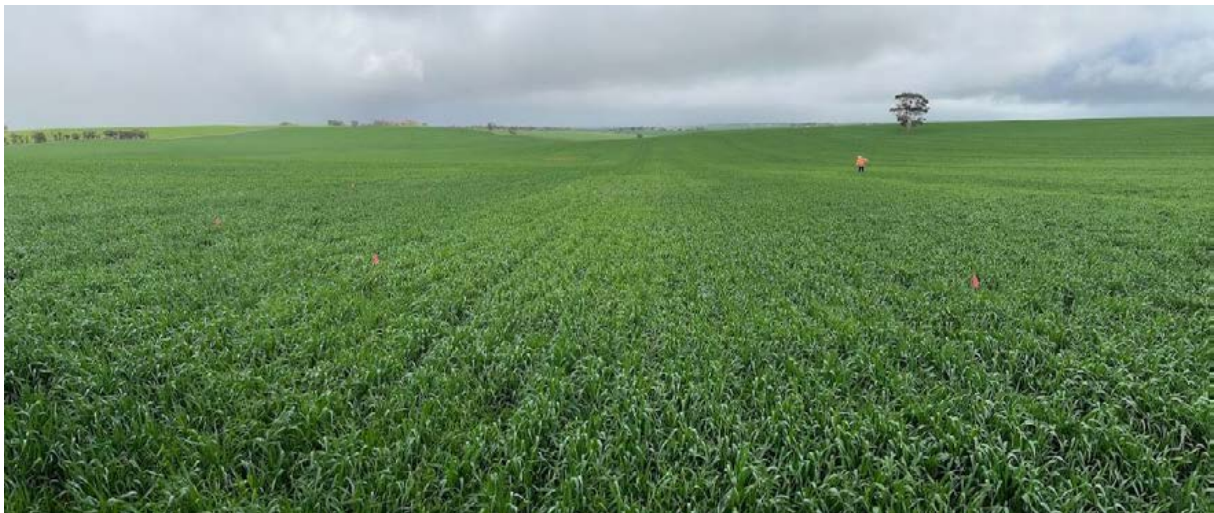
**Figure 2: Typical Site Conditions**

At the time of the investigation a large portion of the site was covered with juvenile crops. A photograph of the typical site conditions is shown in Figure 2.

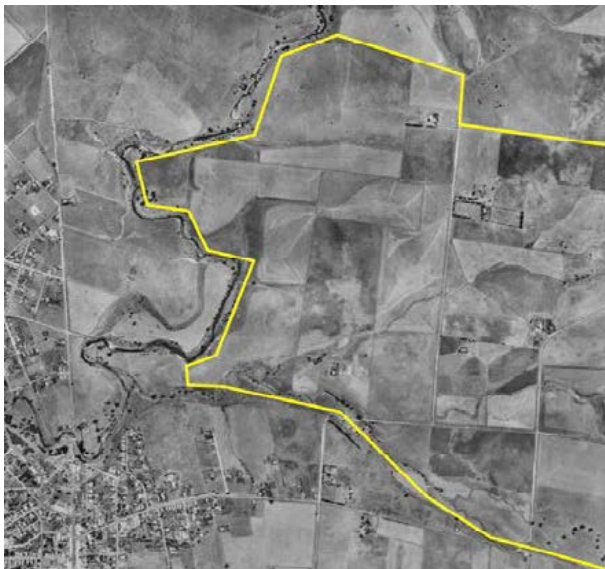
**Figure 5: Historical Aerial Imagery**

Aerial photography is publicly available over the western portion of the site from 1949 and is presented in Figure 5.

The imagery shows no significant development has occurred over the site when compared to the current conditions, with the exception of some additional farmhouses, local residential allotments and more mature trees around the watercourses and residences.

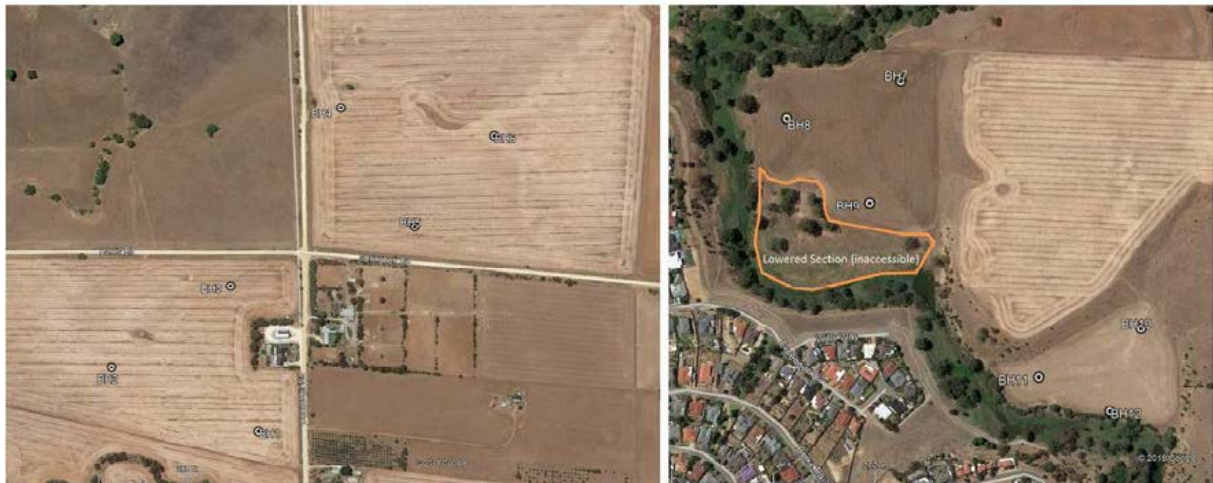
**Figure 6: Historical Borehole Locations**

The locations of the boreholes are shown approximately on Figure 6 and included in Figure A1 of Appendix A.

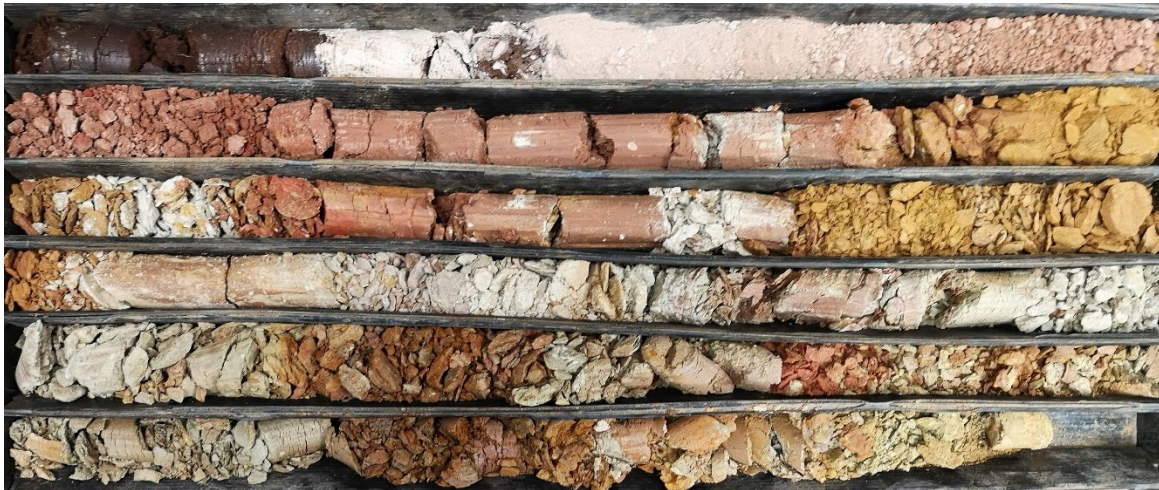
BH3

Note: Core trays are 750 mm in length
