## Appendix 08    Geotechnical Investigation

Geotechnical Investigation - Factual and  
Interpretative Report

*Bolivar, South Australia*

*Renascor Resources Limited*

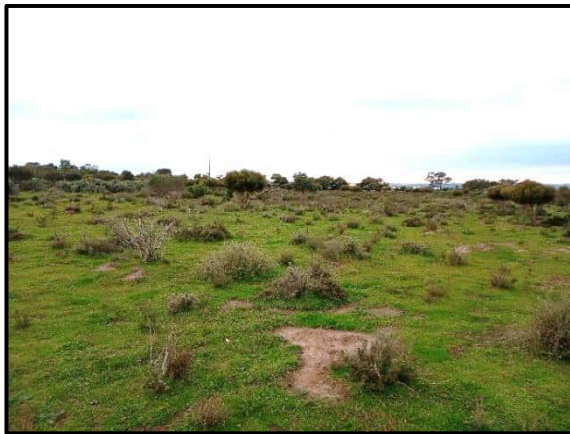
Photo 1: General Site Conditions – view across site looking east.

The site geotechnical investigation location plan is attached in Appendix 1 of this report. Photographs depicting general site conditions are presented in Figure 5.

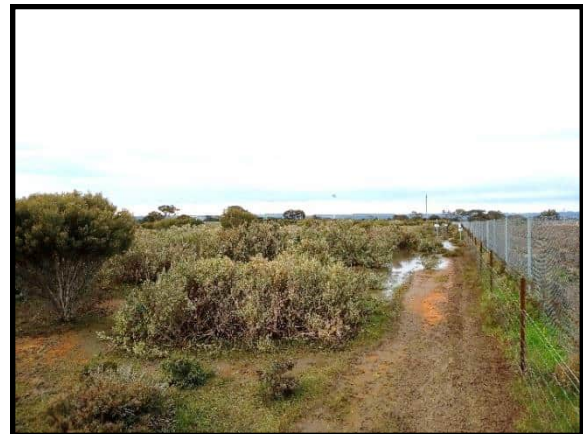
Photo 2: Boggy Southeast portion of the site.

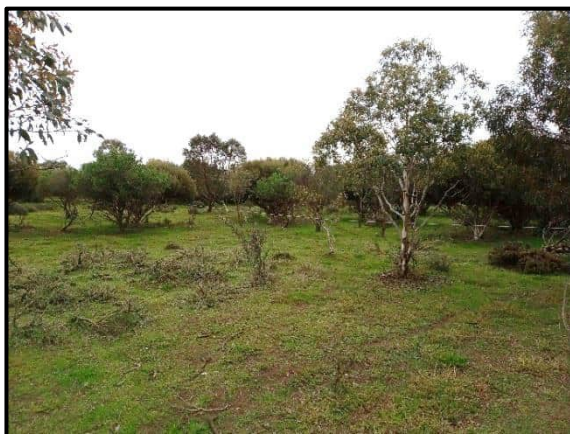
Photo 3: Northeast portion of the site.

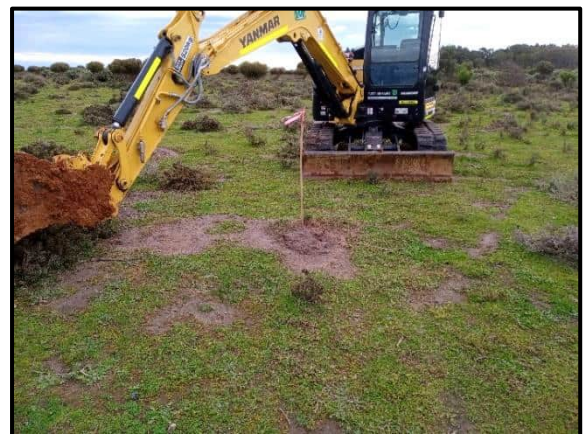
Photo 4: Excavator setting up at TP06.

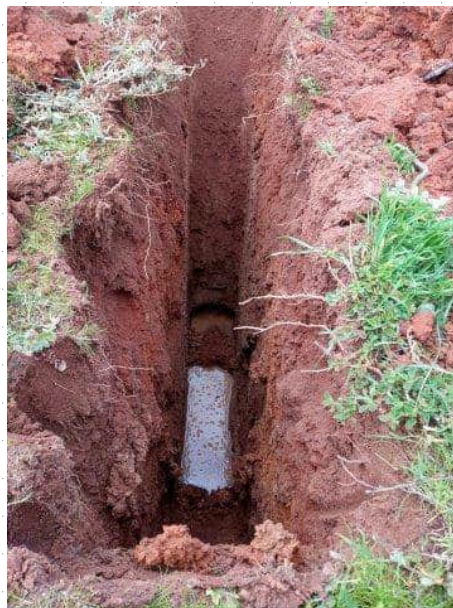
### Photographs

2.0						w > PL			
			2.5					TEST PIT DISCONTINUED @ 2.00 m PRACTICAL REFUSAL GROUNDWATER ENCOUNTERED @ 1.70 m DEPTH BACKFILLED				
			3.0

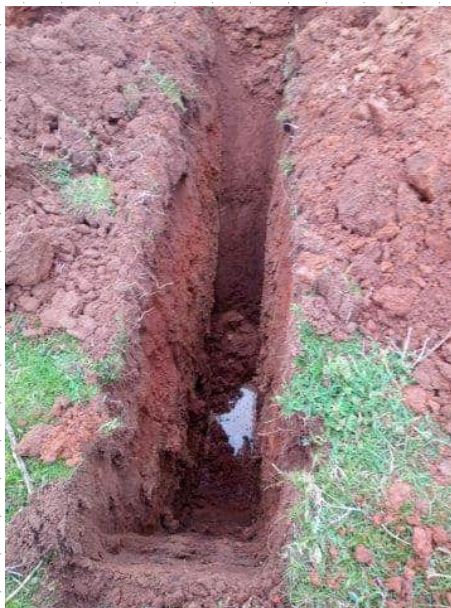
### Photographs

2.0						TEST PIT DISCONTINUED @ 2.00 m PRACTICAL REFUSAL GROUNDWATER ENCOUNTERED @ 1.70 m DEPTH BACKFILLED									
			2.5															
			3.0

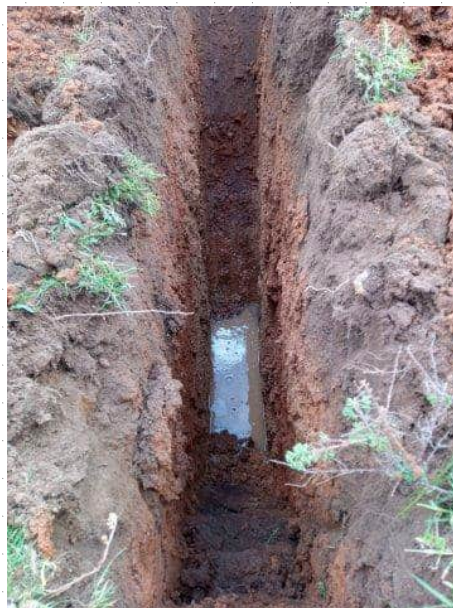
### Photographs

2.0						TEST PIT DISCONTINUED @ 2.00 m PRACTICAL REFUSAL GROUNDWATER ENCOUNTERED @ 1.20 m DEPTH BACKFILLED										
			2.5																
			3.0

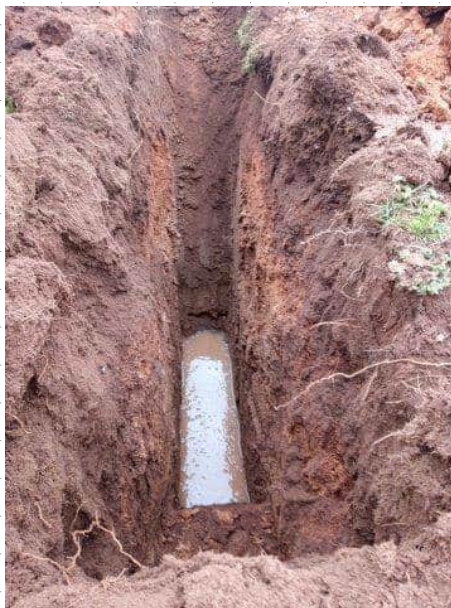
### Photographs

Excavation				Sampling		Field Material Description						
METHOD / SUPPORT	EXCAVATION RESISTANCE	WATER	DEPTH (metres)	DEPTH RL	SAMPLE OR FIELD TEST	RECOVERED GRAPHIC LOG	GROUP SYMBOL	MATERIAL DESCRIPTION	MOISTURE CONDITION	CONSISTENCY DENSITY	STRUCTURE AND ADDITIONAL OBSERVATIONS	DCP TEST (AS1289.6.3.2) Blows per 100 mm
												0 3 6 9 12 15
TB	EP	10/08/22 13:30d	0.0				SM	TOPSOIL: Silty SAND fine to coarse grained, brown, trace rootlets	M

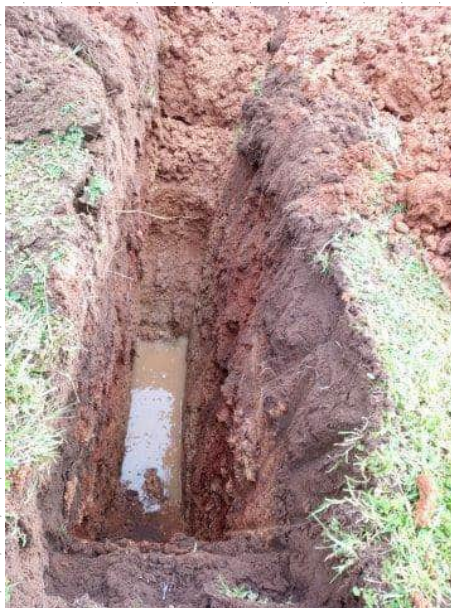
### Photographs

Excavation				Sampling		Field Material Description													
METHOD / SUPPORT	EXCAVATION RESISTANCE	WATER	DEPTH (metres)	DEPTH RL	SAMPLE OR FIELD TEST	RECOVERED	GRAPHIC LOG	GROUP SYMBOL	MATERIAL DESCRIPTION	MOISTURE CONDITION	CONSISTENCY DENSITY	STRUCTURE AND ADDITIONAL OBSERVATIONS	DCP TEST (AS1289.6.3.2) Blows per 100 mm						
													0	3	6	9	12	15	
TB	EP	<div>10/08/22 15:00</div>	0.0					SM	TOPSOIL: Silty SAND fine to coarse grained, brown, trace rootlets	M

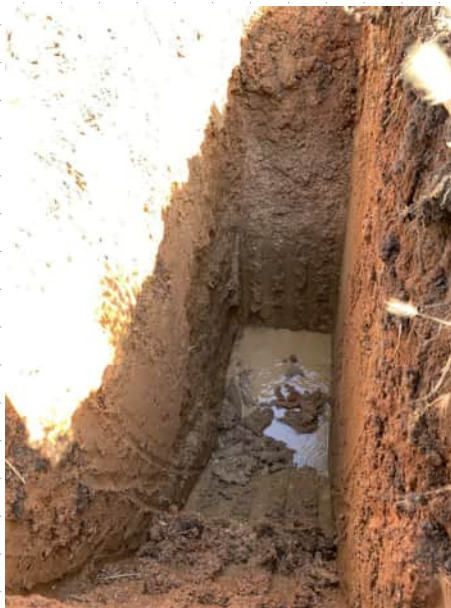
### Photographs

TEST PIT DISCONTINUED @ 3.00 m PRACTICAL REFUSAL GROUNDWATER ENCOUNTERED @ 0.80 m DEPTH BACKFILLED	W	D

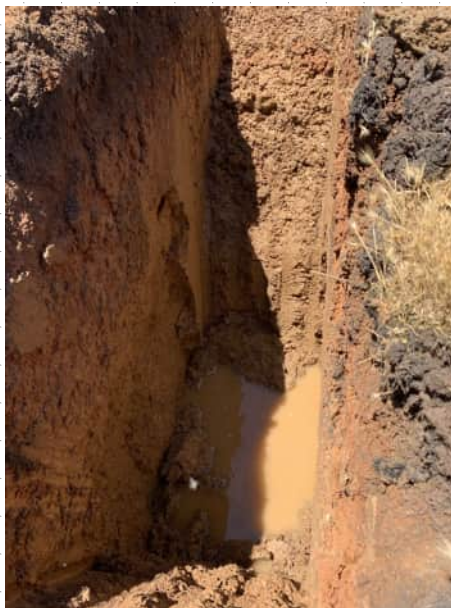
### Photographs

2.0						TEST PIT DISCONTINUED @ 2.00 m PRACTICAL REFUSAL GROUNDWATER ENCOUNTERED @ 0.70 m DEPTH BACKFILLED														
			2.5																				
			3.0

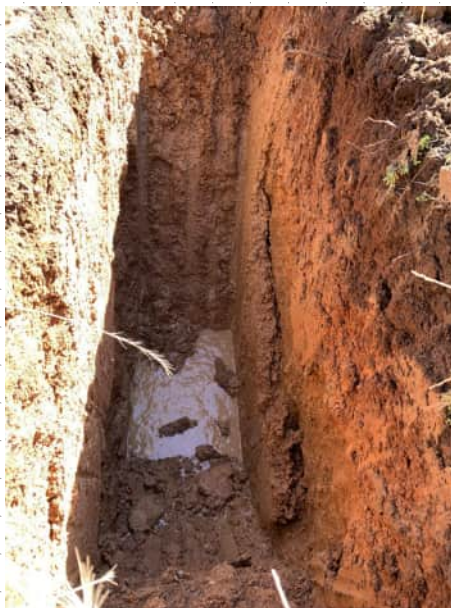
### Photographs

Excavation				Sampling		Field Material Description													
METHOD / SUPPORT	EXCAVATION RESISTANCE	WATER	DEPTH (metres)	DEPTH RL	SAMPLE OR FIELD TEST	RECOVERED	GRAPHIC LOG	GROUP SYMBOL	MATERIAL DESCRIPTION	MOISTURE CONDITION	CONSISTENCY DENSITY	STRUCTURE AND ADDITIONAL OBSERVATIONS	DCP TEST (AS1289.6.3.2) Blows per 100 mm						
													0	3	6	9	12	15	
TB	EP	<div>28/11/22 09:00</div>	0.0					SM	TOPSOIL: Silty SAND fine to coarse grained, brown, trace rootlets	M		0.30-2.00 m: Undifferentiated Quaternary Sediments(Qa), developed in estuarine deposits (EMS)

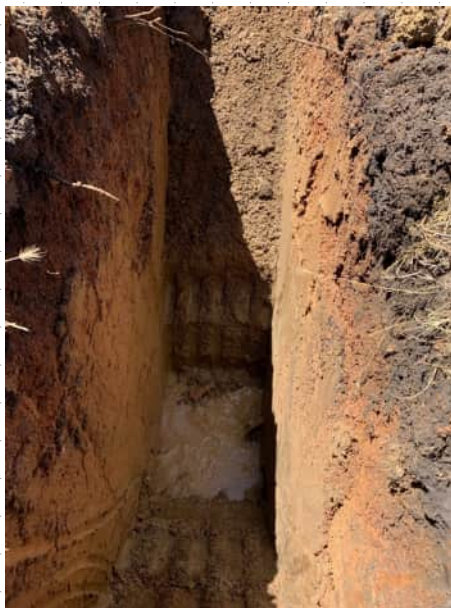
### Photographs

2.5						TEST PIT DISCONTINUED @ 2.30 m PRACTICAL REFUSAL GROUNDWATER ENCOUNTERED @ 0.70 m DEPTH BACKFILLED				
			3.0

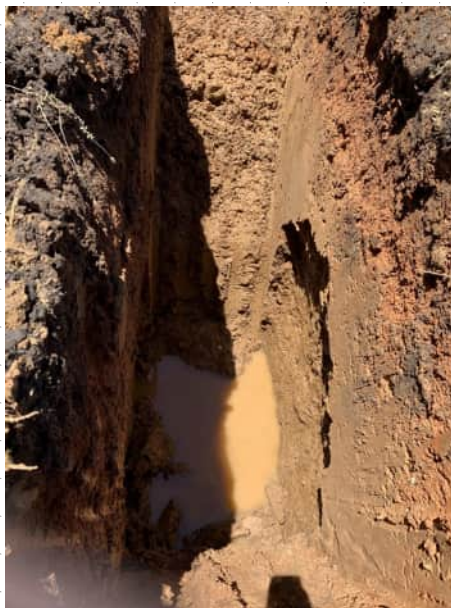
### Photographs

1.0															
				1.5															
				2.0															
				2.5															
				3.0					TEST PIT DISCONTINUED @ 2.80 m PRACTICAL REFUSAL GROUNDWATER ENCOUNTERED @ 0.60 m DEPTH BACKFILLED	w > PL	H

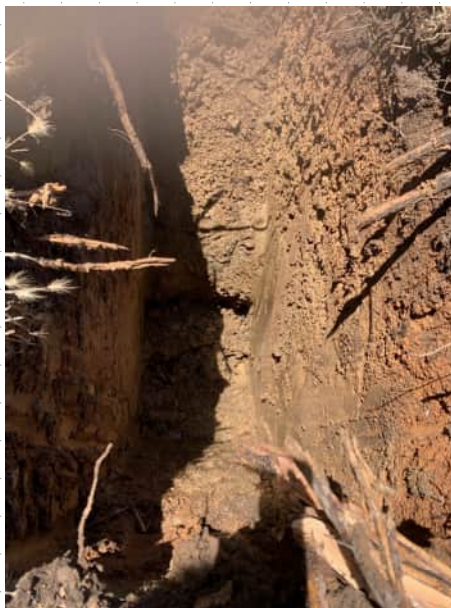
### Photographs

2.0						TEST PIT DISCONTINUED @ 2.00 m PRACTICAL REFUSAL GROUNDWATER ENCOUNTERED @ 1.20 m DEPTH BACKFILLED									
			2.5															
			3.0

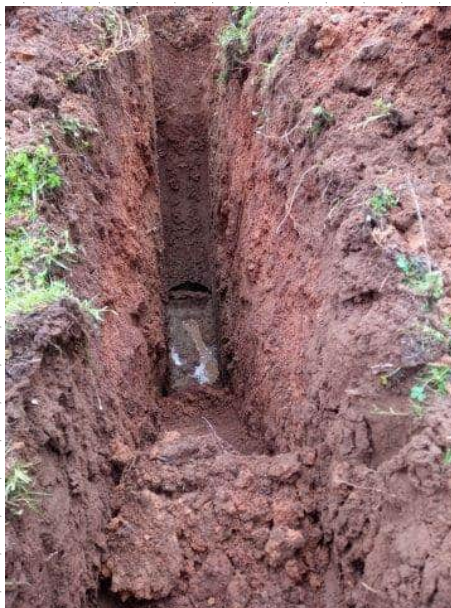
### Photographs

SM	TOPSOIL: Silty SAND fine to coarse grained, brown, trace rootlets  Sandy CLAY medium plasticity, red and orange brown, fine to coarse grained sand, trace fine to coarse grained, rounded gravel	M	St	0.10-1.70 m: Undifferentiated Quaternary Sediments (Qa), developed in estuarine deposits (EMS)

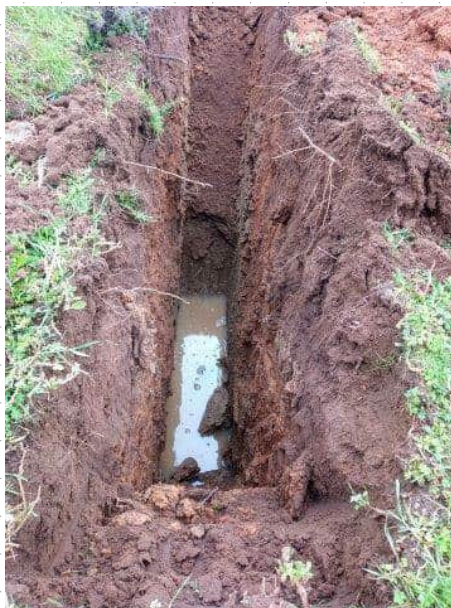
### Photographs

2.0							w > PL	H									
			2.0						TEST PIT DISCONTINUED @ 2.00 m PRACTICAL REFUSAL GROUNDWATER ENCOUNTERED @ 1.60 m DEPTH BACKFILLED

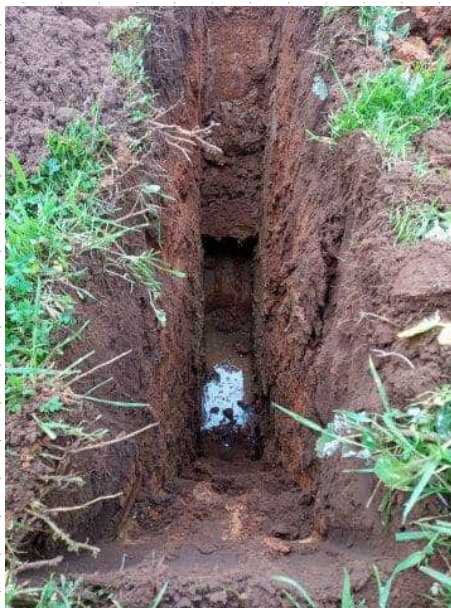
### Photographs

CL	Sandy CLAY low plasticity, grey brown, fine to coarse grained sand, with lenses of clayey sand	w > PL	VSt - H									
									TEST PIT DISCONTINUED @ 2.10 m PRACTICAL REFUSAL GROUNDWATER ENCOUNTERED @ 1.80 m DEPTH BACKFILLED

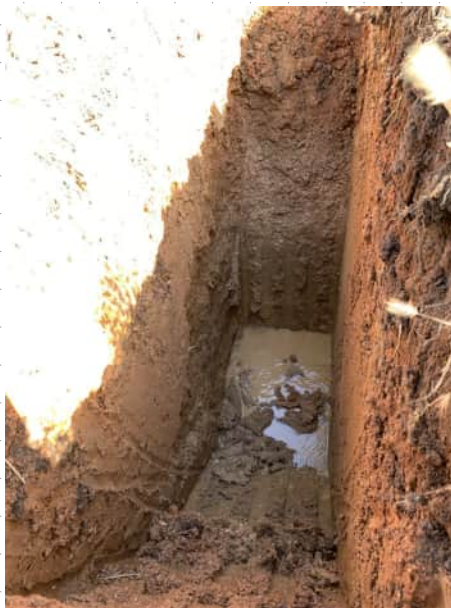
### Photographs

SM	TOPSOIL: Silty SAND fine to coarse grained, brown, trace rootlets	M		0.20-1.90 m: Glanville Formation

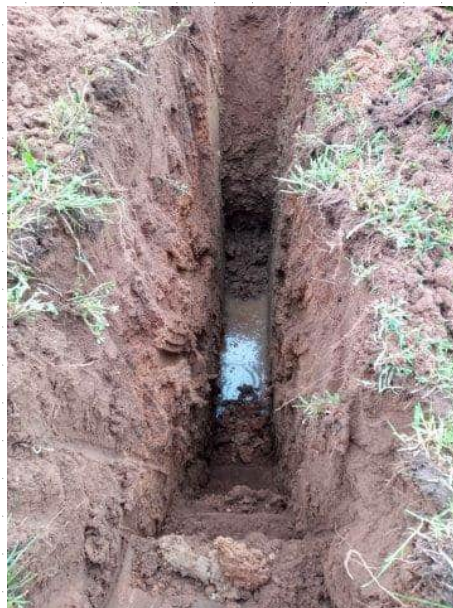
### Photographs

2.0					TEST PIT DISCONTINUED @ 2.00 m PRACTICAL REFUSAL GROUNDWATER ENCOUNTERED @ 1.70 m DEPTH BACKFILLED				
			2.5									
			3.0

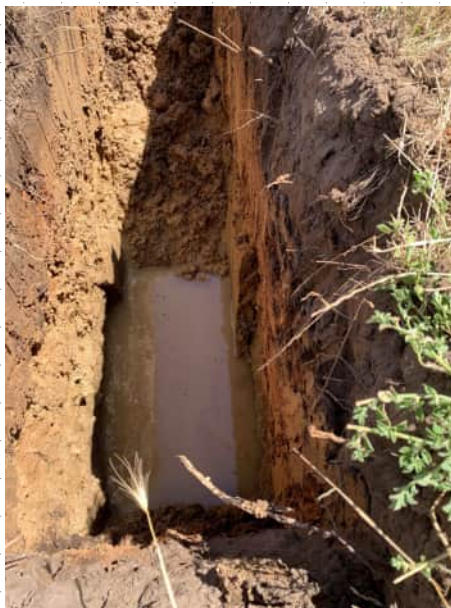
### Photographs

2.0					TEST PIT DISCONTINUED @ 2.00 m PRACTICAL REFUSAL GROUNDWATER ENCOUNTERED @ 1.50 m DEPTH BACKFILLED				
			2.5									
			3.0
