# Annexure C

Murray Bridge Technical College

C1-Project Green- Visual tree Assessment

# VISUAL TREE ASSESSMENT

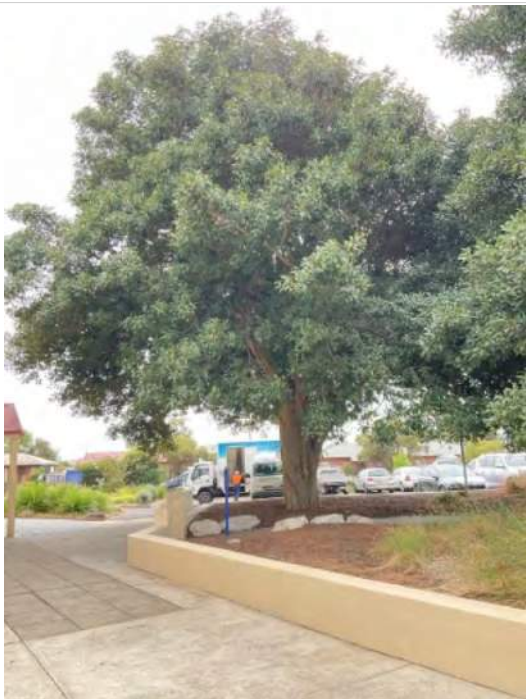
ID: PGSA00009617 | Tue, 11 Mar 2025

Photo shows failed limbs in crown above path to office.

| Failure Hazard | 2 Medium - 10 - 25% Defects |
| Defect Size | 2 Medium - 15 - 45cm |
| Target Hazard | 2 Medium - Intermittent Use |
| Hazard Score | 6 |
| Hazard Rating | Medium |

Recommend Pruning Ficus To Remove Failed Limbs Above Path And Building Entrance. Clear Security Light To Parking Bays.

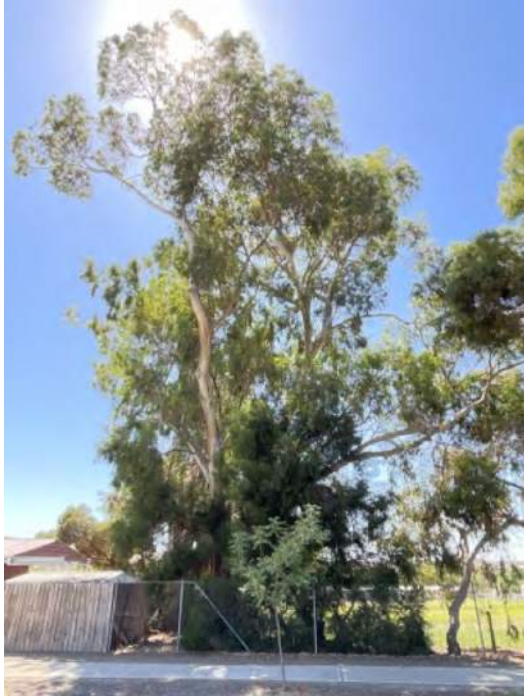
ID: PGSA00009619 | Wed, 12 Mar 2025

| Failure Hazard | 1 Low - <10% Defects |
| Defect Size | 1 Low - <15cm |
| Target Hazard | 2 Medium - Intermittent Use |
| Hazard Score | 4 |
| Hazard Rating | Low |

No Current Pruning Recommended For Large Mature Sa Blue Gum On Front Boundary Fence Line. Tree Exhibits Good Crown Health. Crown Reduced Well Over Road And Property

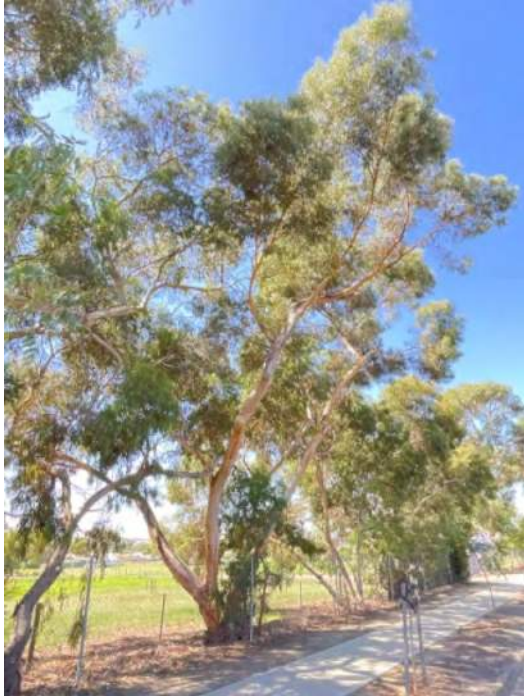
ID: PGSA00009622 | Wed, 12 Mar 2025

| Failure Hazard | 1 Low - <10% Defects |
| Defect Size | 1 Low - <15cm |
| Target Hazard | 2 Medium - Intermittent Use |
| Hazard Score | 4 |
| Hazard Rating | Low |

No Current Pruning Recommended For Tree. Crown Reduced Over Road And Path. Good Wound Occlusion. Good Crown Health. Multi Stemmed From Ground. Central Stem Removed. Minor Borer Damage Wound.

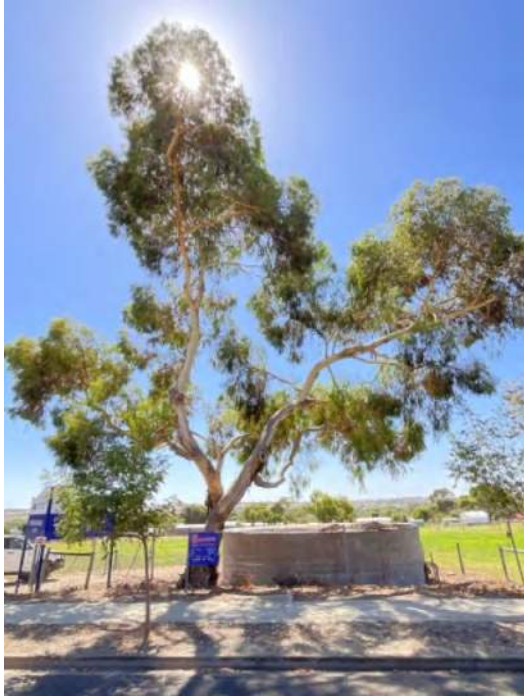
ID: PGSA00009626 | Wed, 12 Mar 2025

| Failure Hazard | 2 Medium - 10 - 25% Defects |
| Defect Size | 2 Medium - 15 - 45cm |
| Target Hazard | 2 Medium - Intermittent Use |
| Hazard Score | 6 |
| Hazard Rating | Medium |

Recommend Pruning To Reduce Lateral Over Water Tank By 15%.  
Tree Exhibits Good Crown Health. Shows Wounds From Past Pruning Reductions And Good Occlusion.

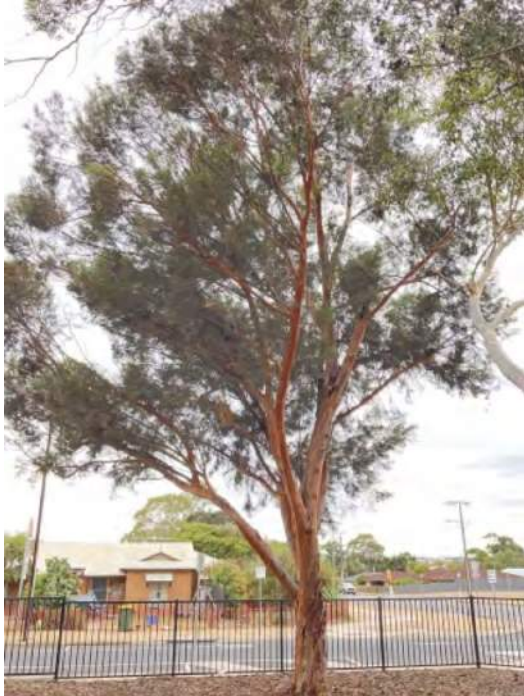
ID: PGSA00009628 | Tue, 11 Mar 2025

| Failure Hazard | 2 Medium - 10 - 25% Defects |
| Defect Size | 1 Low - <15cm |
| Target Hazard | 2 Medium - Intermittent Use |
| Hazard Score | 5 |
| Hazard Rating | Medium |

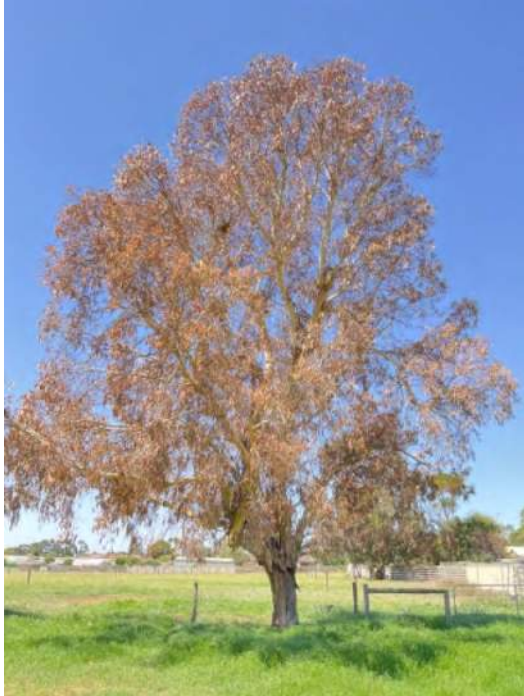
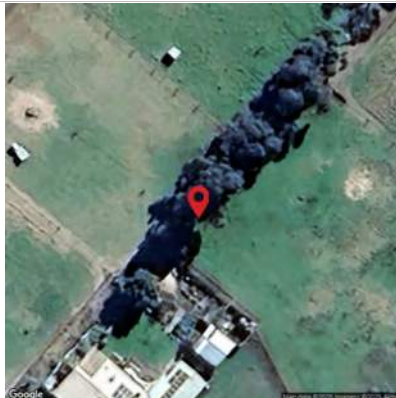
ID: PGSA00009633 | Wed, 12 Mar 2025

| Failure Hazard | 3 High - 30 - 50% Defects |
| Defect Size | 2 Medium - 15 - 45cm |
| Hazard Rating | Medium |

Recommend Removal Of Dead Sa Blue Gum. Tree Ring Barked By Animals. No Potential To Improve. Remove Tree Leaving Stump At 1m For Animal Rubbing Post.

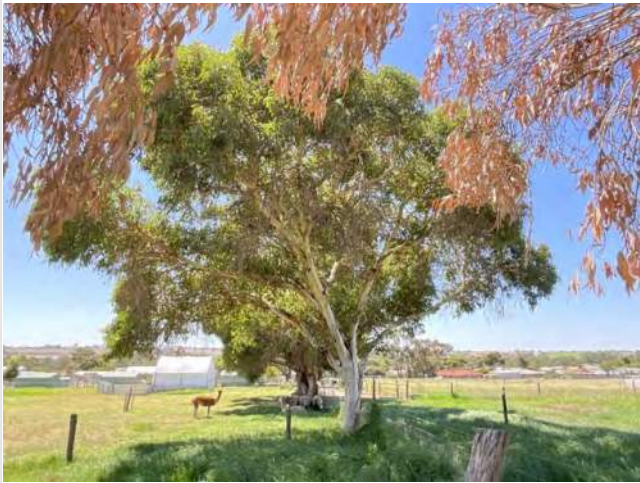
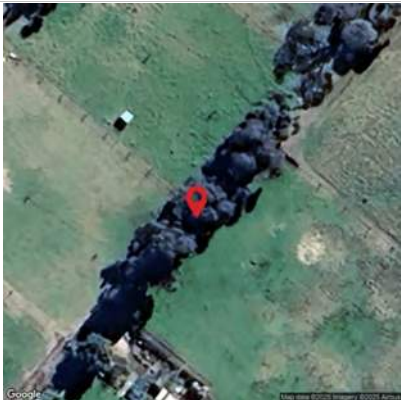
ID: PGSA00009635 | Wed, 12 Mar 2025

No Pruning Required. Exhibits Good Crown Health. No Ring Barking Noted.

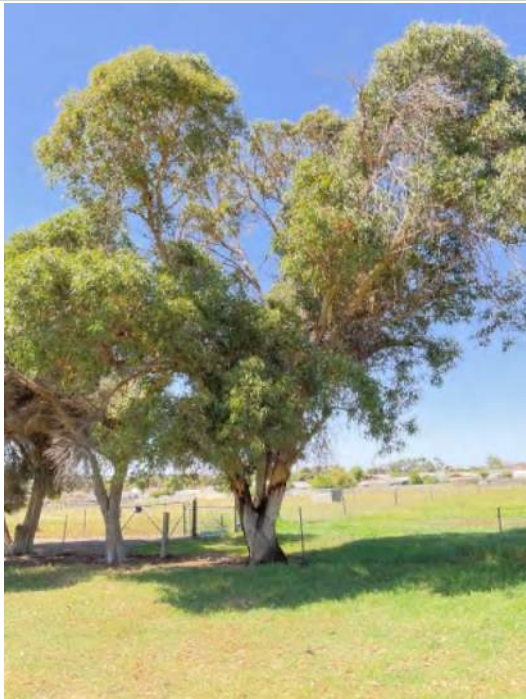
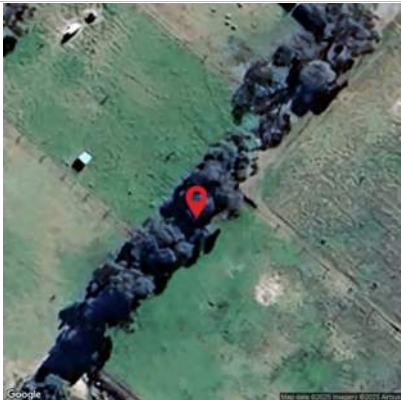
ID: PGSA00009636 | Wed, 12 Mar 2025

Photo shows failed limb resting in melaleuca to remove along with dead limbs.

| Failure Hazard | 2 Medium - 10 - 25% Defects |
| Hazard Rating | Medium |

| Recommend Pruning Dead Limbs From Crown Over Animal Pen. Remove Failed Limb In Melaleuca. Tree Exhibits Good Crown Health. Ring Barking To Approximately 50% Of Trunk Cambium. | |

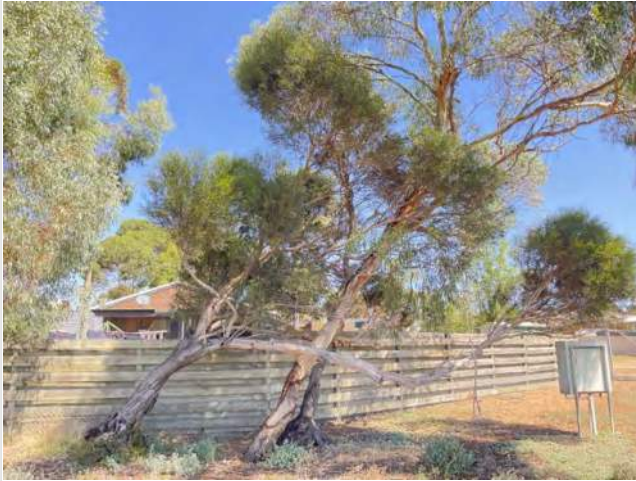
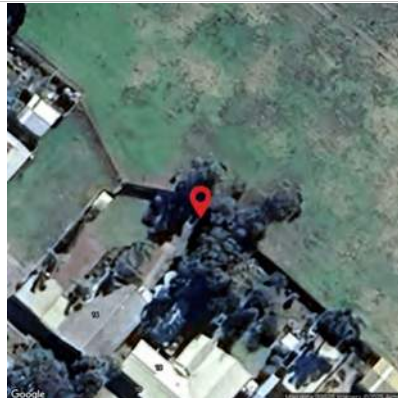
ID: PGSA00009649 | Wed, 12 Mar 2025

| Failure Hazard | 1 Low - <10% Defects |
| Defect Size | 1 Low - <15cm |
| Target Hazard | 2 Medium - Intermittent Use |
| Hazard Score | 4 |
| Hazard Rating | Low |

No Pruning Required To Tree. Cavity At Base Of Trunk From Stem Failure. Epicormic Growth Developing. Tree Grows On Moderate Lean.

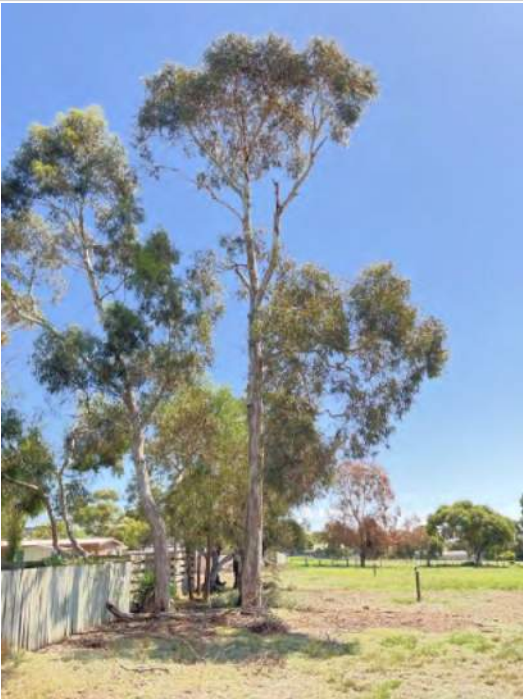
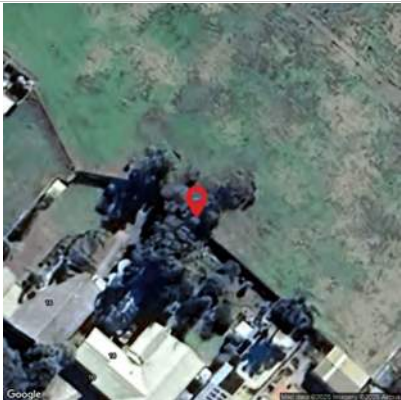
ID: PGSA00009651 | Wed, 12 Mar 2025

| Failure Hazard | 2 Medium - 10 - 25% Defects |
| Defect Size | 1 Low - <15cm |
| Target Hazard | 2 Medium - Intermittent Use |
| Hazard Score | 5 |
| Hazard Rating | Medium |

No Current Pruning Recommended. Tree Exhibits Good Crown Health. Recent Limb Fail From Upper Crown.

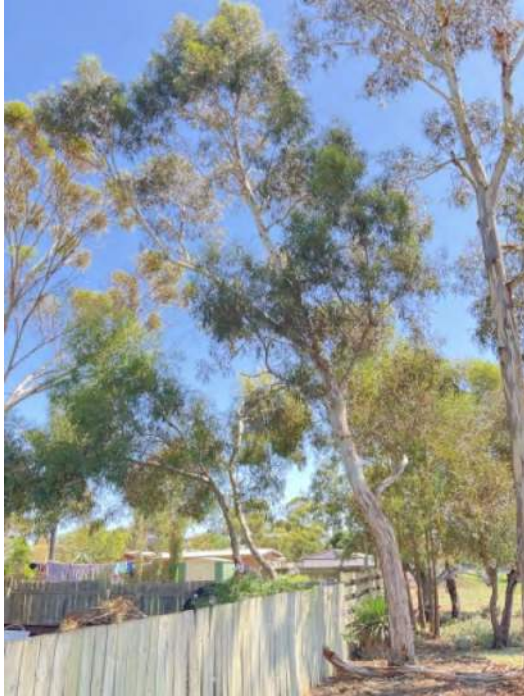
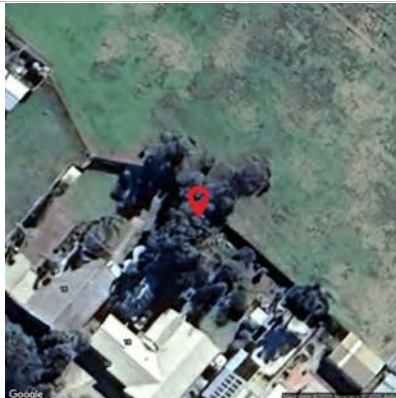
ID: PGSA00009652 | Wed, 12 Mar 2025

| Failure Hazard | 2 Medium - 10 - 25% Defects |
| Defect Size | 2 Medium - 15 - 45cm |
| Target Hazard | 2 Medium - Intermittent Use |
| Hazard Score | 6 |
| Hazard Rating | Medium |

Mature Sa Blue Gum On Property Boundary. Exhibits Good Crown Health. Crown Encroachment Over Neighbouring Property.  
Recommend Pruning To Reduce The Western Leader By Half Back To Lower Upright.

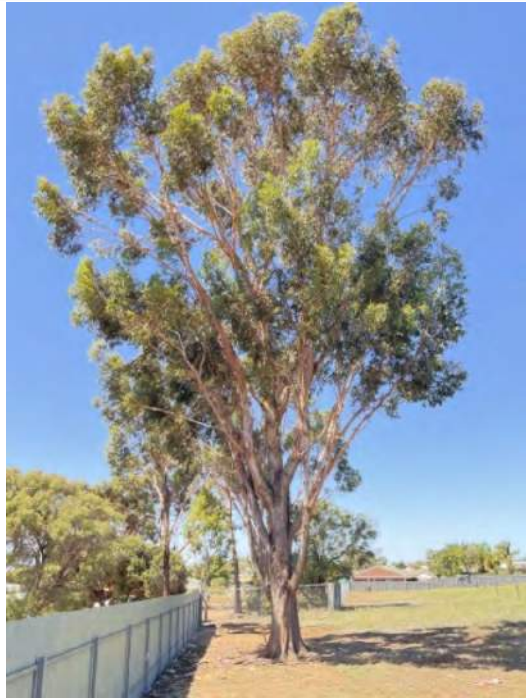
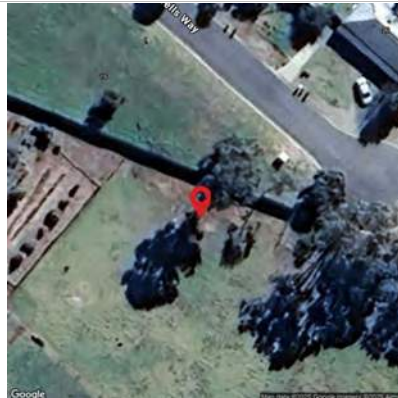
ID: PGSA00009653 | Wed, 12 Mar 2025

| Failure Hazard | 1 Low - <10% Defects |
| Defect Size | 1 Low - <15cm |
| Target Hazard | 2 Medium - Intermittent Use |
| Hazard Score | 4 |
| Hazard Rating | Low |

No Pruning Recommended For Mature Gum. Tree On Boundary Fence. Presents Good Structure Shape And Form. No Defects Noted Or Observed, Good Occlusion To Animal Chewing. Easy Access To Paddock. No Locks No Alarms.

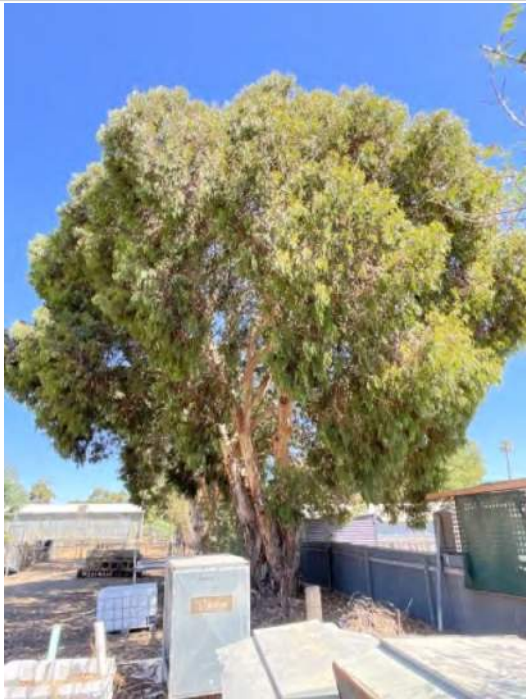
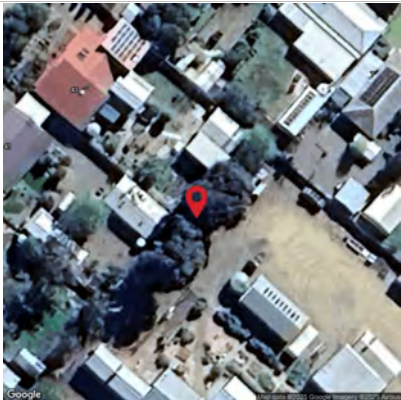
ID: PGSA00009656 | Wed, 12 Mar 2025

| Failure Hazard | 1 Low - <10% Defects |
| Defect Size | 1 Low - <15cm |
| Target Hazard | 2 Medium - Intermittent Use |
| Hazard Score | 4 |
| Hazard Rating | Low |

No Current Pruning Recommended For Sa Blue Gum. Exhibits Good Crown Health And Foliage Density. Compact Canopy Form Arising From Multiple Stems.

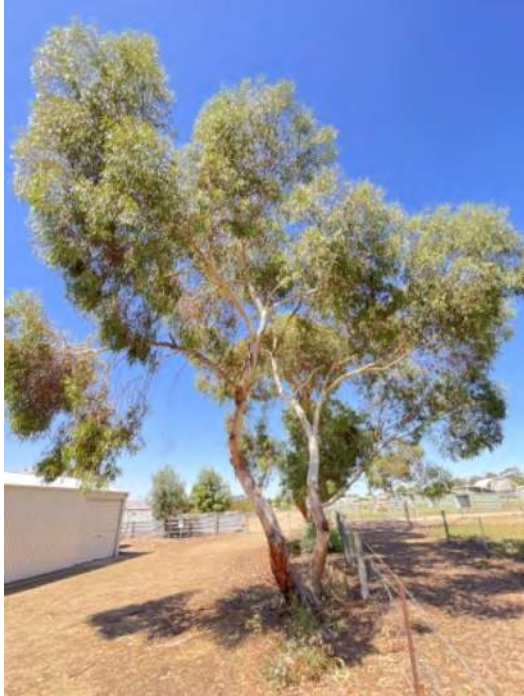
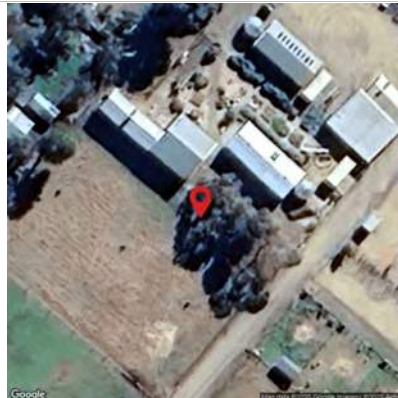
ID: PGSA00009660 | Wed, 12 Mar 2025

| Failure Hazard | 2 Medium - 10 - 25% Defects |
| Hazard Rating | Medium |

Recommend Pruning Tree To Remove Lateral Over Front Of Shed To Collar.  
Presents Good Crown Health. Co Dominant Stems From Ground.

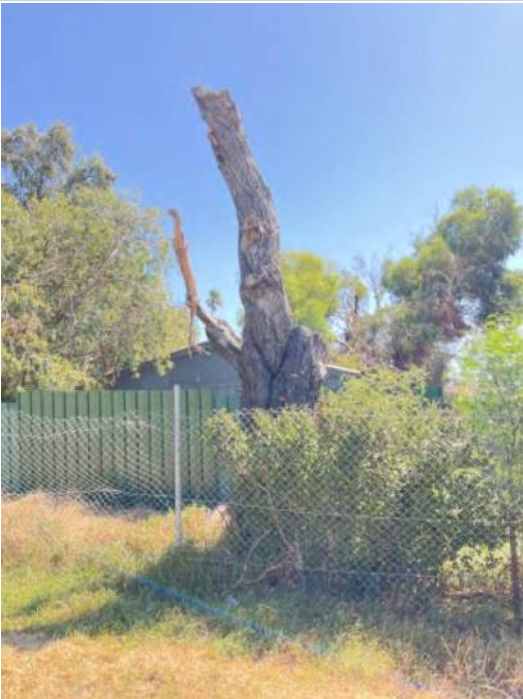
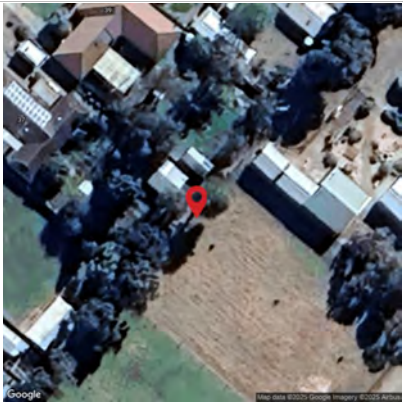
ID: PGSA00009664 | Wed, 12 Mar 2025

Photo shows major stem failure over property.

| Failure Hazard | 2 Medium - 10 - 25% Defects |
| Hazard Rating | Medium |

| Trunk Retained From Removal With No Regrowth Or Sign Of Live Cambium.<br>Recommend Remove To Ground. | |

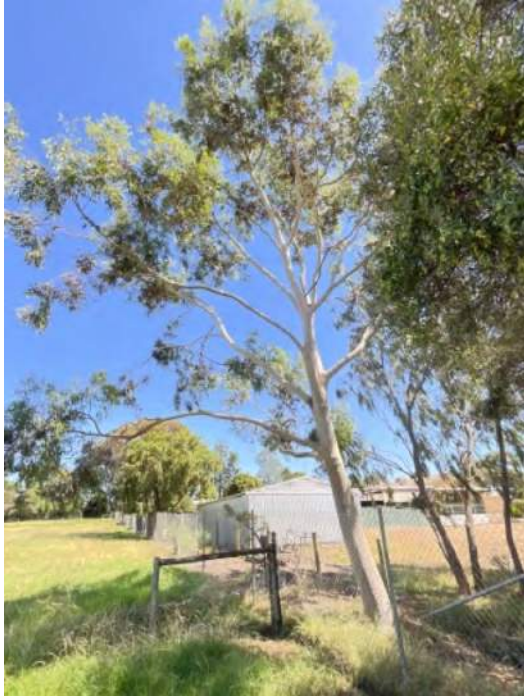
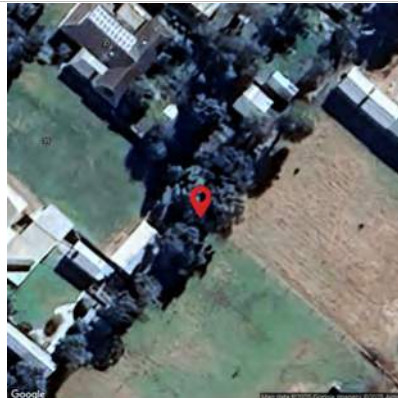
ID: PGSA00009665 | Wed, 12 Mar 2025

No Pruning Recommended For Lemon Scented Gum. Exhibits Good Crown Health. Minor Deadwood. Lower Limb Slightly Extended. Good Shade Tree For Animals.

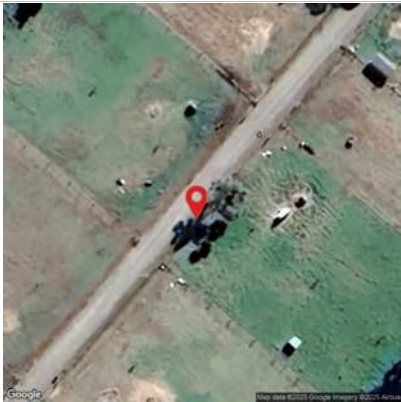
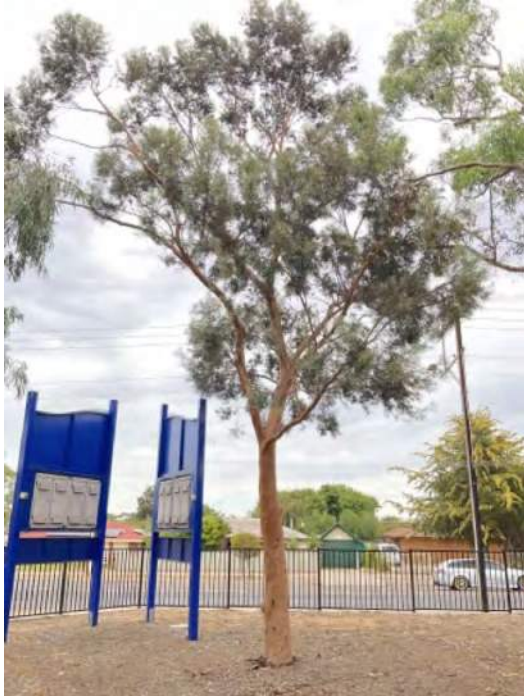
ID: PGSA00009672 | Wed, 12 Mar 2025

| Failure Hazard | 2 Medium - 10 - 25% Defects |
| Hazard Rating | Medium |

Recommend Pruning Tree To Reduce End Weight From Heavier Laterals To Increase Limb Stability. Good Shade Tree For Animals.

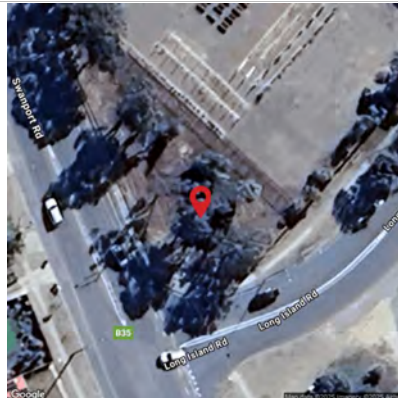
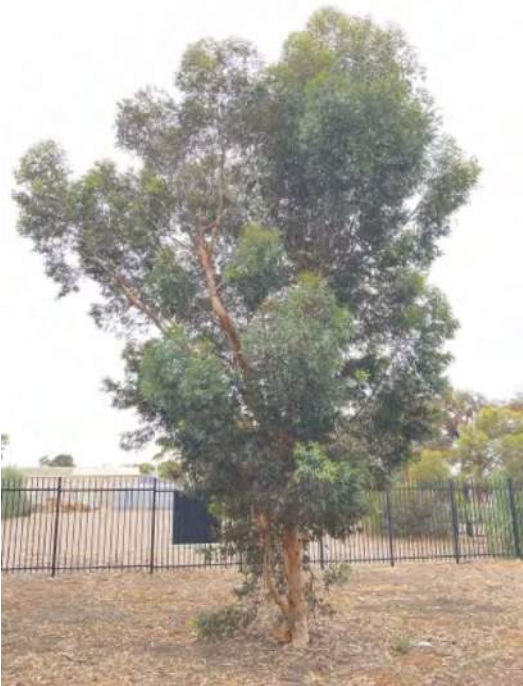
ID: PGSA00009675 | Tue, 11 Mar 2025

| Failure Hazard | 2 Medium - 10 - 25% Defects |
| Defect Size | 3 High - 45 - 75cm |
| Hazard Rating | Medium |

Recommend Removal Of The Remaining Co Dominant Stem. Stem Is Starting To Fail From Base And Leaning Into Neighbouring Trees. Splitting At Bifurcation. Lower Epicormic Growth Could Be Retained Due To Low Use Area.

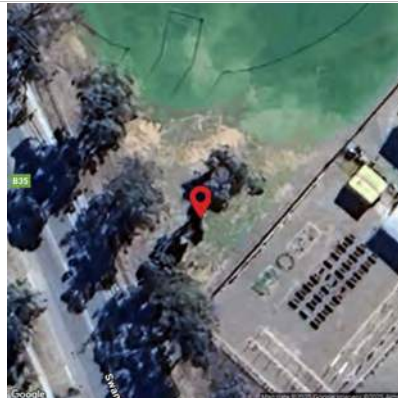
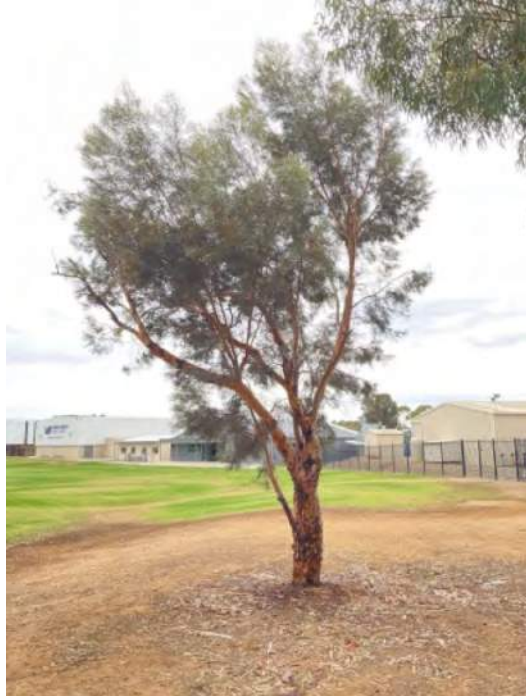
ID: PGSA00009686 | Tue, 11 Mar 2025

| Failure Hazard | 2 Medium - 10 - 25% Defects |
| Hazard Rating | Medium |

Crown Reduced To Uprights. Lower Epicormic Growth Developing. Recommend Pruning To Remove The Basal Epicormic Growth.

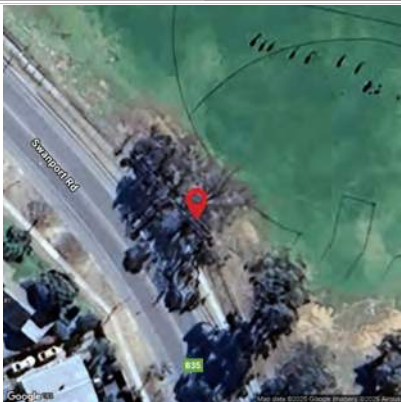
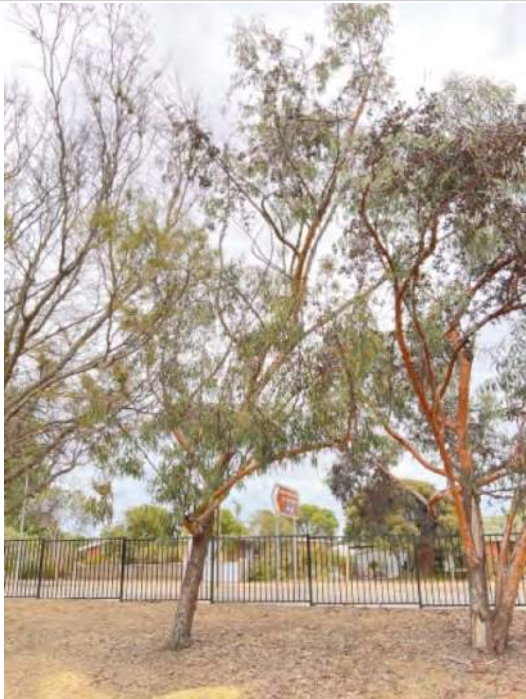
ID: PGSA00009693 | Tue, 11 Mar 2025

Hazard Assessment

| Failure Hazard | 2 Medium - 10 - 25% Defects |
| Hazard Score | 5 |
| Hazard Rating | Medium |

No Current Pruning Recommended. Die Back Through Crown Possibly Due To Poisoning Along Boundary Fence Line. Small Sections Of Foliage Emerging Through Crown. Monitor Trees Health And Progress. If Tree Further Declines Then Removal Is Recommended.

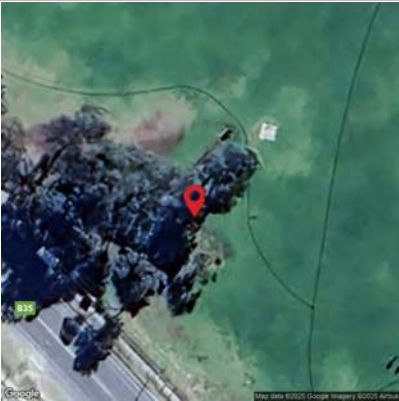
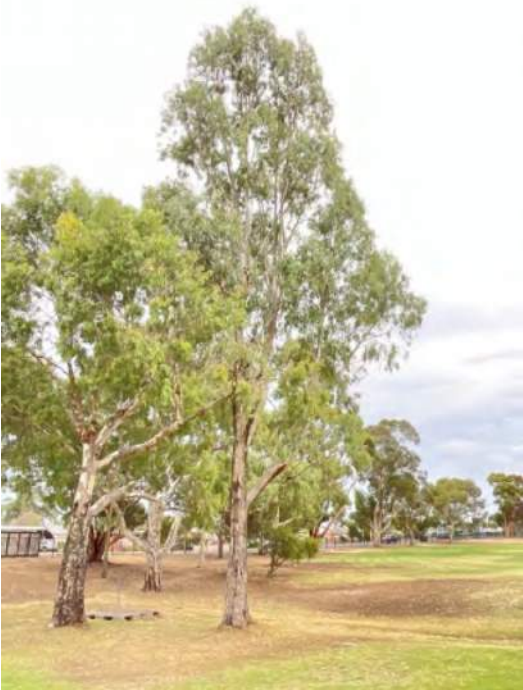
ID: PGSA00009702 | Tue, 11 Mar 2025

## Hazard Assessment

| Failure Hazard | 2 Medium - 10 - 25% Defects |
| Hazard Score | 5 |
| Hazard Rating | Medium |

Recommend Pruning To Reduce The Developing Epicormic Growth From Lopping Point On Main Stem By 10% To Increase Stability At Attachment.

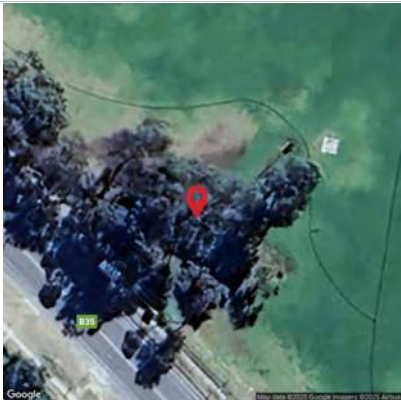
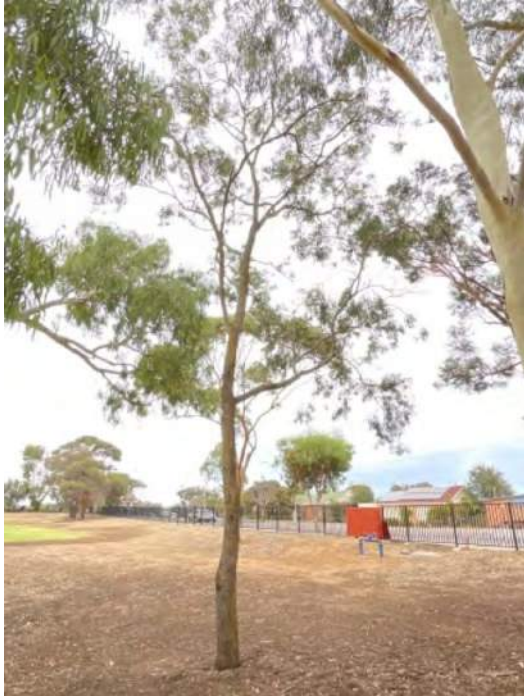
ID: PGSA00009704 | Tue, 11 Mar 2025

## Hazard Assessment

| Failure Hazard | 2 Medium - 10 - 25% Defects |
| Defect Size | 2 Medium - 15 - 45cm |
| Hazard Rating | Medium |

No Current Pruning Recommended. Presents Good Crown Health. Deadwood Removed. Good Wound Occlusion.

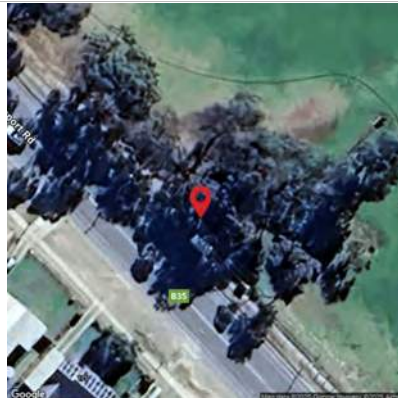
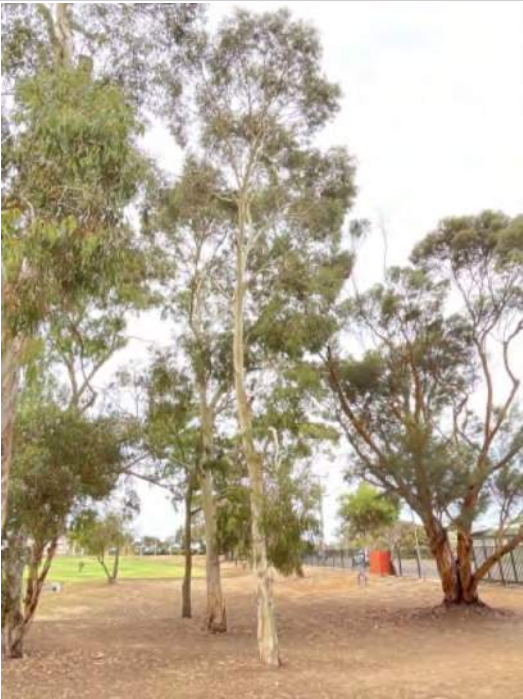
ID: PGSA00009709 | Tue, 11 Mar 2025

No Current Pruning Recommended. Crown Managed From Powerlines. Exhibits Good Crown Health.

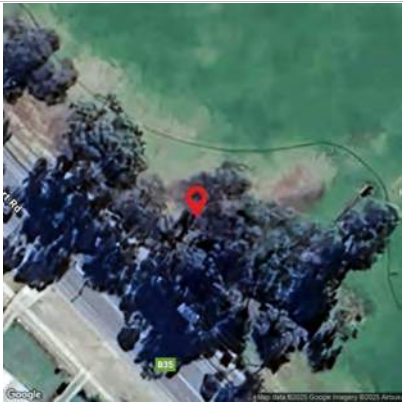
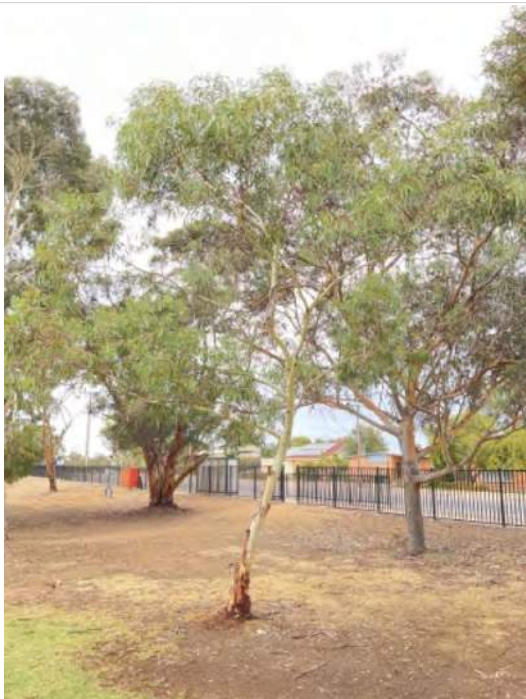
ID: PGSA00009711 | Tue, 11 Mar 2025

No Current Pruning Recommended. Several Stubs Present From Limb Fails. Epicormic Growth Developing. Bird Damage And Cavity Noted In Tree. Laterals Reduced From Oval And Running Track.

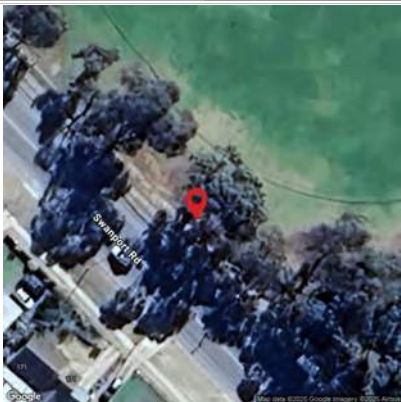
ID: PGSA00009715 | Tue, 11 Mar 2025

No Current Pruning Recommended. Tree Poorly Reduced Leaving Open Crown With Extended Stem Heads. A More Even Crown Reduction Could Have Been Applied To Tree. Remain With Good Crown Health. As Lower Growth Develops Over Time The Remaining Stem Heads Can Be Reduced In Line With Lower Crown.

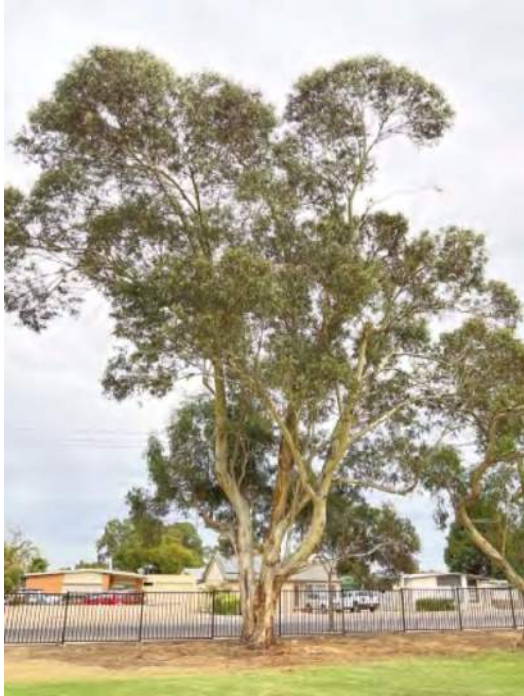
ID: PGSA00009716 | Tue, 11 Mar 2025

Photo shows failed limb in upper crown recommended to remove.

Recommend Pruning Tree To Remove Failed Limb From Upper Northern Crown.

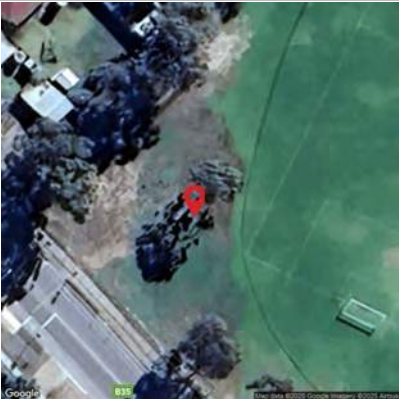
ID: PGSA00009719 | Tue, 11 Mar 2025

No Current Pruning Recommended For Tree. Presents Good Health. Minor Deadwood Removed.

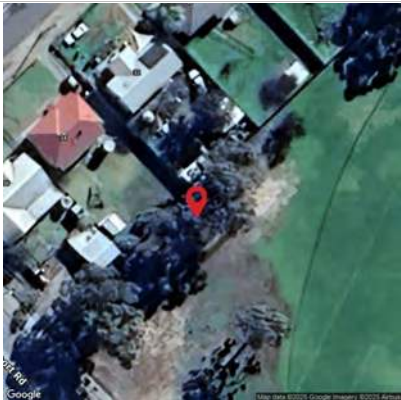
ID: PGSA00009725 | Tue, 11 Mar 2025

No Current Pruning Recommended. Recent Limb Fail Due To Inclusion With In Trunk Section. Failure Removed And Impacted Limbs Pruned. Epicormic Growth Developing.

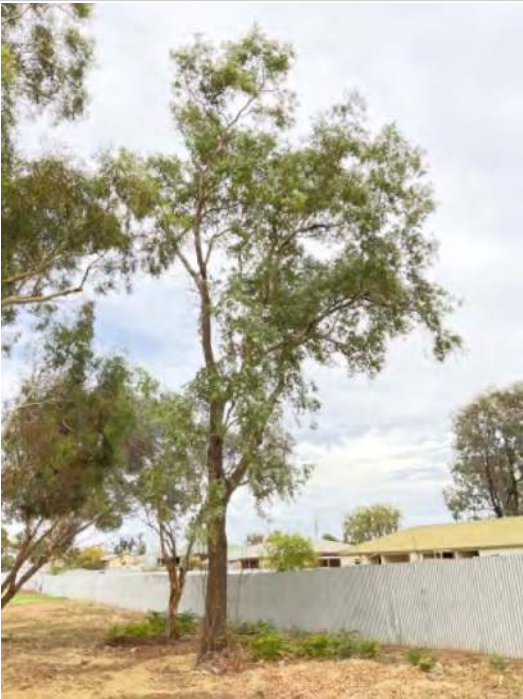
ID: PGSA00009732 | Tue, 11 Mar 2025

Deadwood recommended to remove.

Recommend Pruning Dead Limb To Collar.

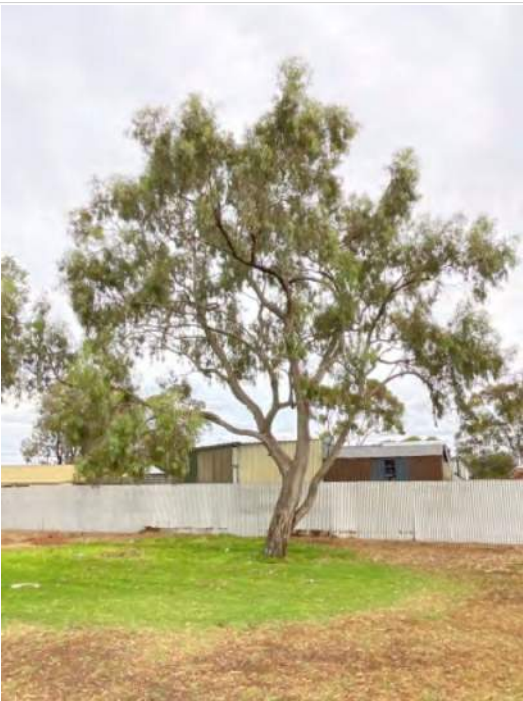
ID: PGSA00009738 | Tue, 11 Mar 2025

Photo shows lower lateral recommended to reduce by 10%.

| Failure Hazard | 2 Medium - 10 - 25% Defects |
| Hazard Rating | Medium |

Recommend Pruning To Reduce Extension On Lower Lateral By 10-15%.

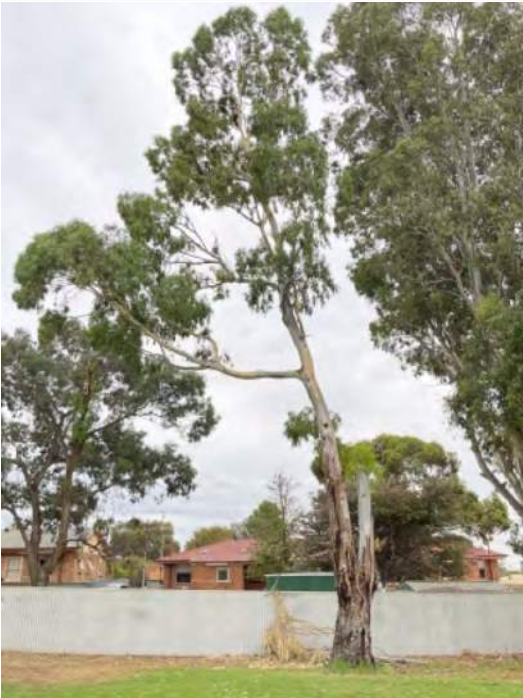
ID: PGSA00009741 | Tue, 11 Mar 2025

Photo shows failed limb to mulch and western lateral to reduce.

| Failure Hazard | 2 Medium - 10 - 25% Defects |
| Hazard Rating | Medium |

Recommend Pruning Tree To Reduce The Western Lateral By 15%. Remove Failed Limb From Crown And Mulch Larger Failed Limb By Tree. Epicormic Growth Developing From Reduction Point Of The Reduced Co Dominant Stem.

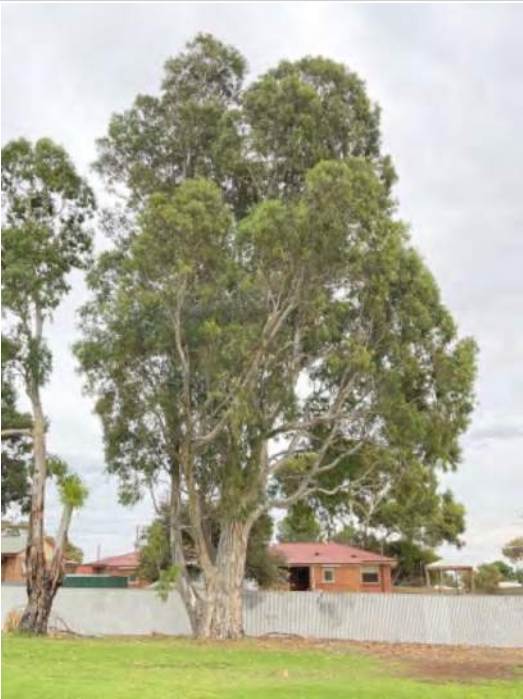
ID: PGSA00009742 | Tue, 11 Mar 2025

No Current Pruning Recommended For Mature River Red Gum. North Western Crown Reduce Over Small Shed In Neighbouring Property. Tree Is Clear From Dwelling With Heavy Encroachment Over Back Yard Due To Proximity By Boundary Fence.

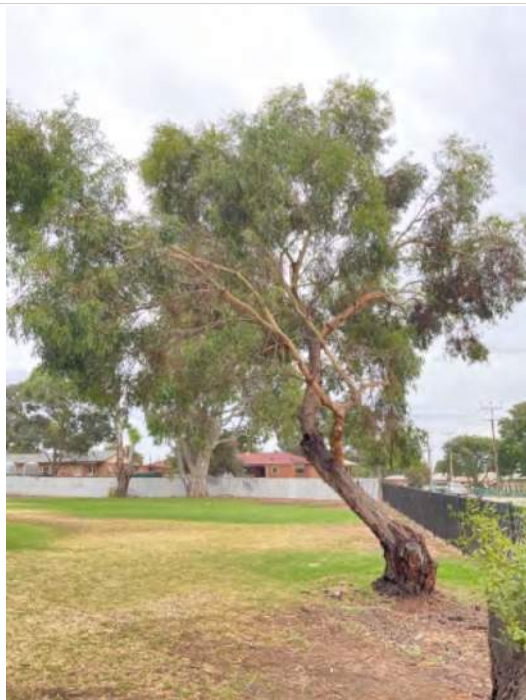
ID: PGSA00009743 | Tue, 11 Mar 2025

Photo shows heavier laterals recommended to reduce.

| Failure Hazard | 2 Medium - 10 - 25% Defects |
| Hazard Rating | Medium |

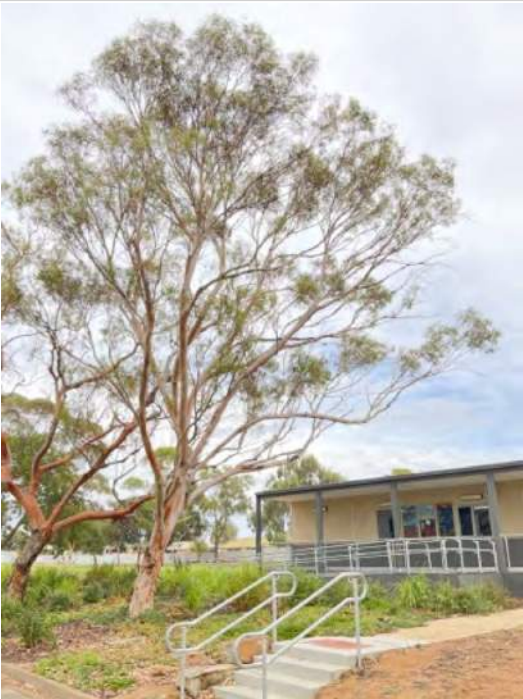
ID: PGSA00009752 | Tue, 11 Mar 2025

No Current Pruning Recommended. Tree Presents Good Crown Health. Holds Minor Deadwood Through Crown. Laterals Reduced Well From New Building.

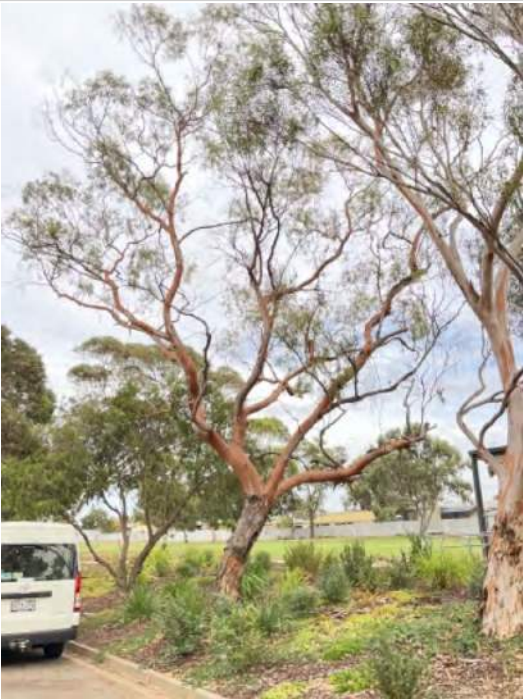
ID: PGSA00009753 | Tue, 11 Mar 2025

| Failure Hazard | 2 Medium - 10 - 25% Defects |
| Hazard Rating | Medium |

Recommend Pruning Tree To Remove All Deadwood.

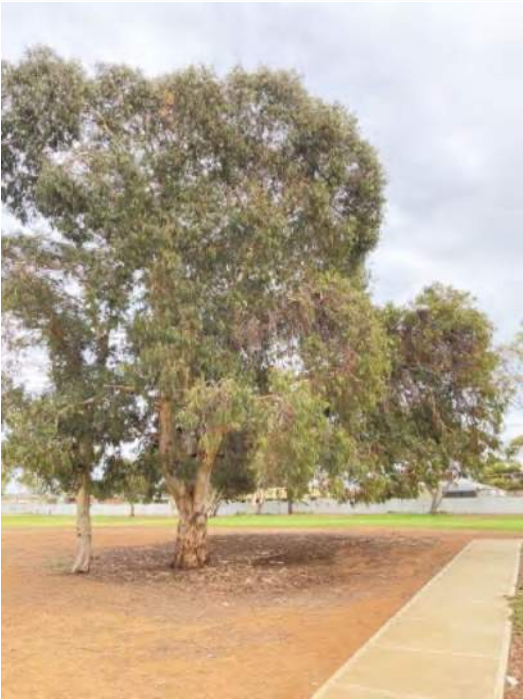
ID: PGSA00009757 | Tue, 11 Mar 2025

| Defect Size | 2 Medium - 15 - 45cm |
| Hazard Rating | Medium |

Recommend Pruning Tree To Lift The Lower Crown Over Path.  
Tree Exhibits Good Crown Health. Bird Damage Noted To Several Unions Through Tree.

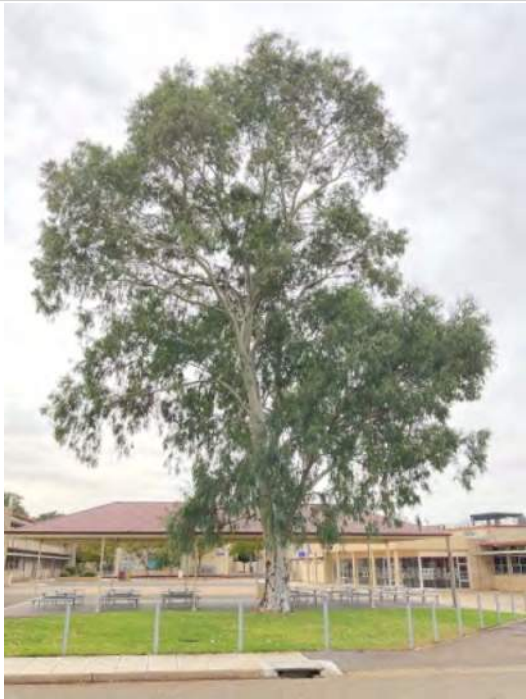
ID: PGSA00009761 | Tue, 11 Mar 2025

| Failure Hazard | 2 Medium - 10 - 25% Defects |
| Hazard Rating | Medium |

Recommend Pruning To Reduce The Southern Crown On Lower Leader Over Shelter Shed. Reduce The Western And Northern Extending Limbs By 15% To Lower Growth Points.  
Recent Limb Fail Of The Southern Upper Crown. Failures Removed. Epicormic Growth Developing.

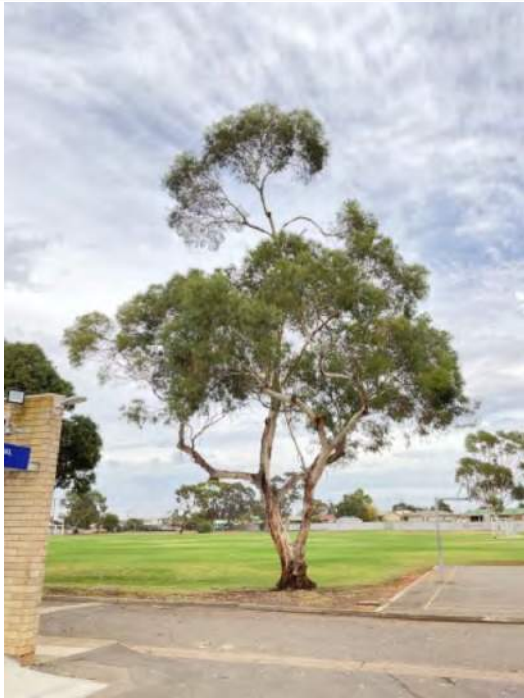
ID: PGSA00009762 | Tue, 11 Mar 2025

Sa Blue Gum Edge Of Oval Showing Good Crown Health. Shows Heavy Reductions To Laterals. No Pruning Recommended.

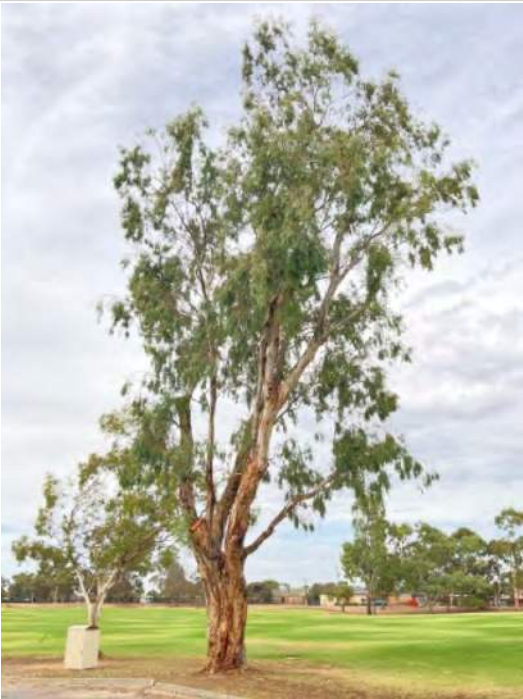
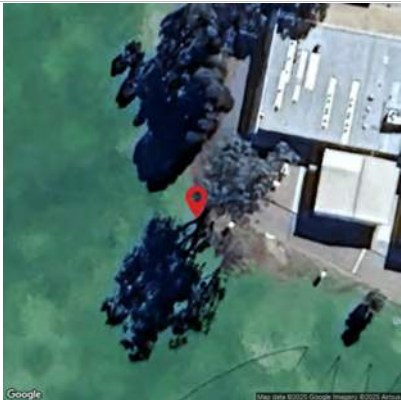
ID: PGSA00009765 | Tue, 11 Mar 2025

No Current Pruning Recommended For Mature Gum Edge Of Oval Grounds. Tree Exhibits Good Crown Health. Major Stem Reductions Applied To Eastern Stems. Epicormic Growth Developing.

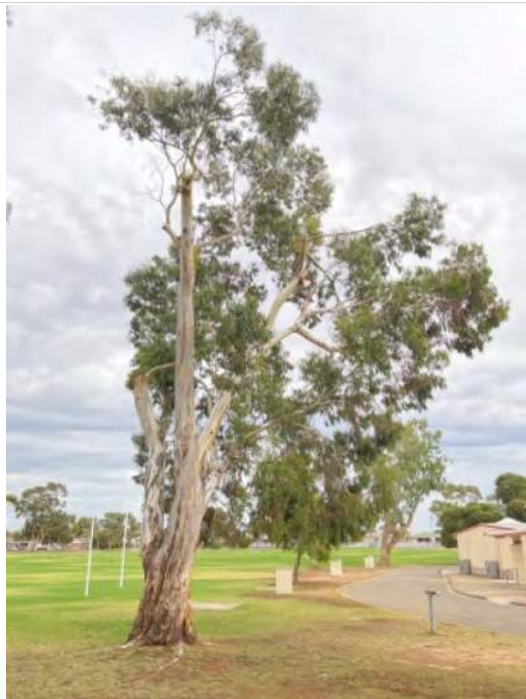
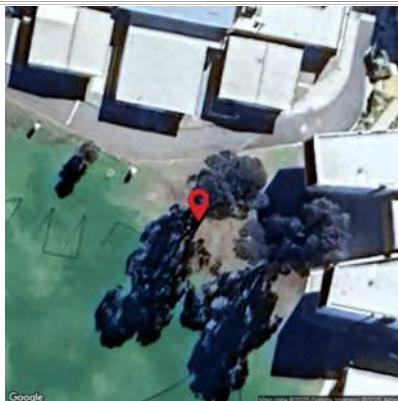
ID: PGSA00009769 | Tue, 11 Mar 2025

No Current Pruning Recommended For Mature Gum On Edge Of Oval. Tree Heavily Reduced Leaving Structure Bias To East. Epicormic Growth Developing From Lopped Points.

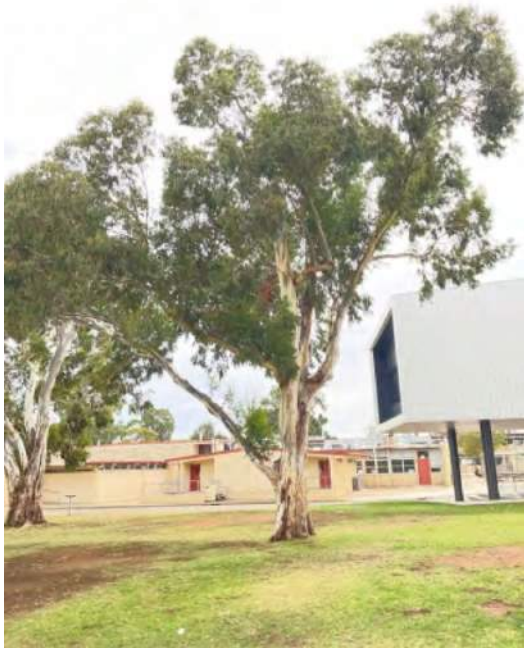
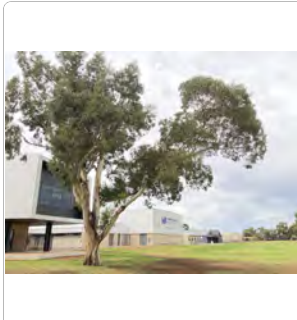
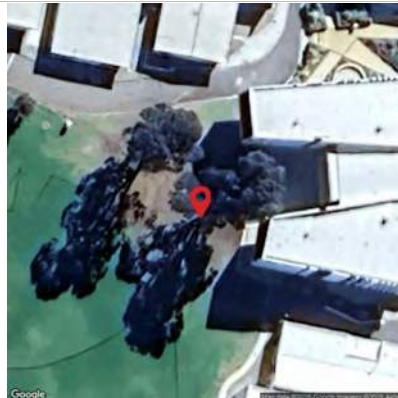
ID: PGSA00009770 | Tue, 11 Mar 2025

## Hazard Assessment

| Failure Hazard | 2 Medium - 10 - 25% Defects |
| Defect Size | 2 Medium - 15 - 45cm |
| Hazard Rating | Medium |

Recommend Pruning Tree To Reduce Crown On The Northern Scaffold Limb By 15%.  
Limb Not Reduced In Line With Crown Reduction And Holds Fair End Weight.  
Southern Laterals Reduced Adequately. Responding Well To Major Crown Reduction.

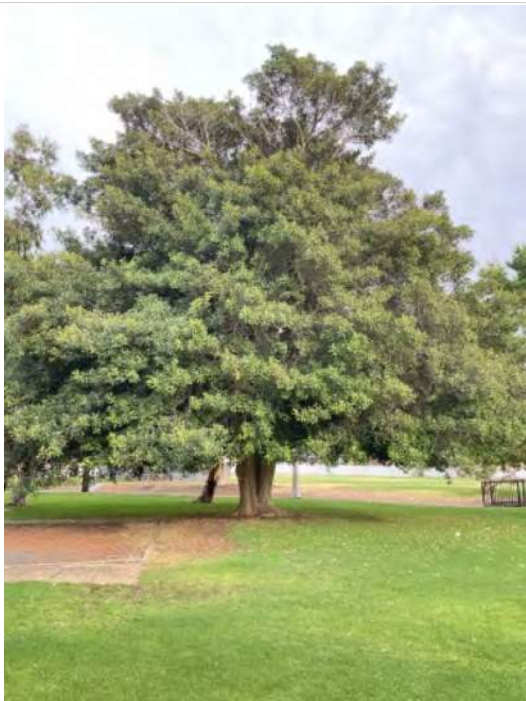
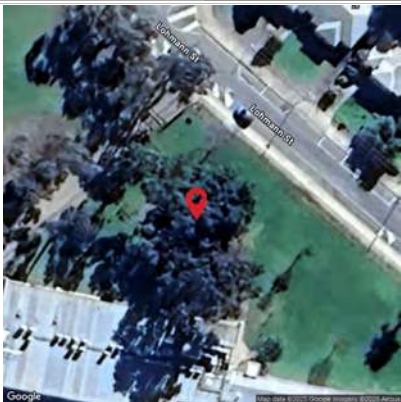
ID: PGSA00009792 | Tue, 11 Mar 2025

| Failure Hazard | 2 Medium - 10 - 25% Defects |
| Hazard Rating | Medium |

Recommend Pruning Failed Limbs From Central Crown.

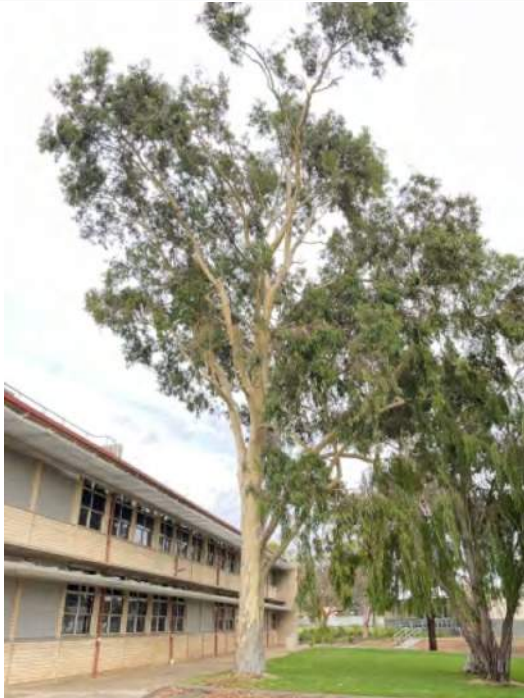
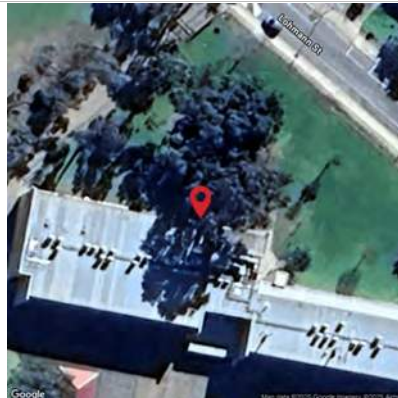
ID: PGSA00009797 | Tue, 11 Mar 2025

## Hazard Assessment

| Failure Hazard | 2 Medium - 10 - 25% Defects |
| Defect Size | 2 Medium - 15 - 45cm |
| Hazard Score | 6 |
| Hazard Rating | Medium |

Large Mature Spotted Gum By Front Building. Tree Exhibits Good Crown Health. Damage And Failed Limbs Through Upper Crown From Storm Damage. Failures Removed . Epicormic Growth Developing. Recommend Pruning To Reduce End Weight From Laterals To North Over And Resting In Sugar Gum.

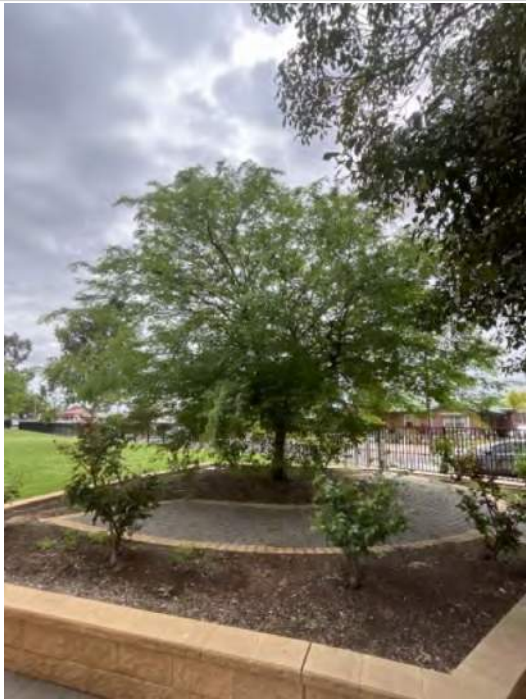
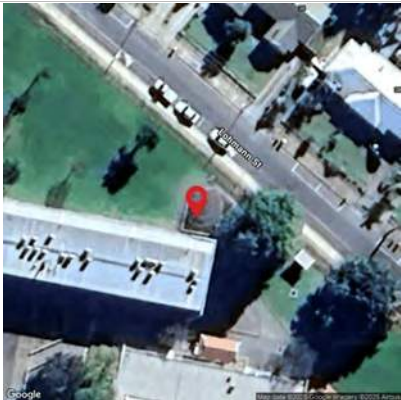
ID: PGSA00009805 | Tue, 11 Mar 2025

| Failure Hazard | 2 Medium - 10 - 25% Defects |
| Hazard Rating | Medium |

Recommend Pruning To Lift Lower Crown In Balance Over Garden.
