# Annexure C

Murray Bridge Technical College

C1-Project Green- Visual tree Assessment

# VISUAL TREE ASSESSMENT

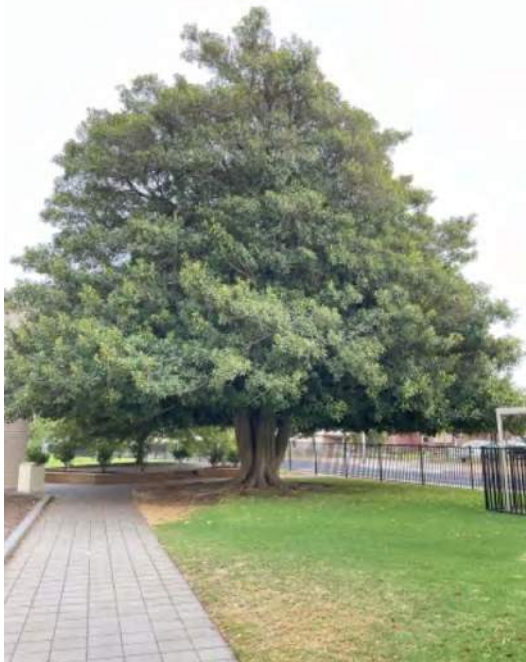
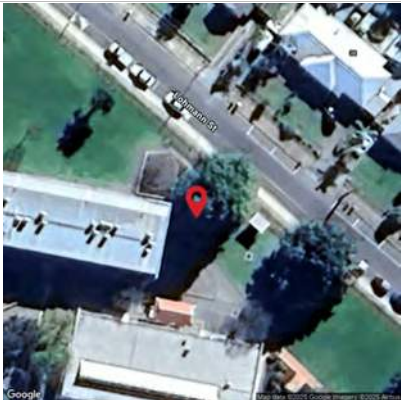
ID: PGSA00009806 | Tue, 11 Mar 2025

No Pruning Required To Ficus Tree. Exhibits Good Crown Health Shape And Form. Crown Raised Well Over Grounds And Footpath. No Defects Observed.

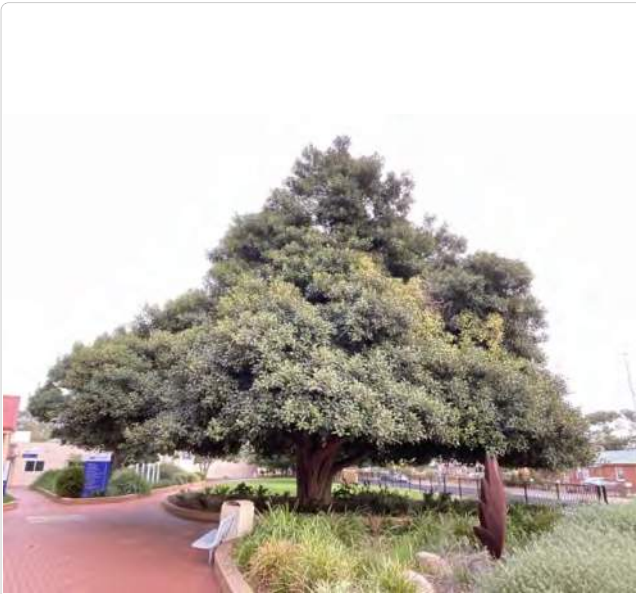
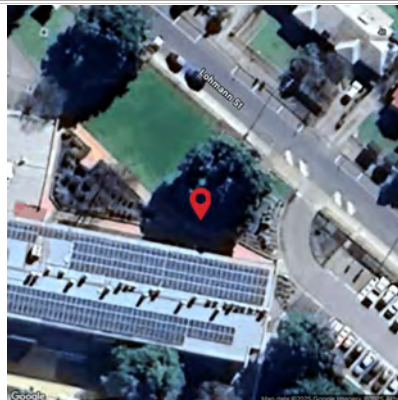
ID: PGSA00009809 | Tue, 11 Mar 2025

Photo showing larger failed limb and crown weight to reduce from eastern stem.

| Failure Hazard | 3 High - 30 - 50% Defects |
| Defect Size | 2 Medium - 15 - 45cm |
| Hazard Score | 7 |
| Hazard Rating | Medium |

Mature Fig Tree Front Of Administration Building. Exhibits Good Crown Health. Raised Well Over Entrance And Path Ways. Several Limb Fails In Mid To Upper Crown. Recommend Pruning To Remove All Failed Limbs In Crown. Reduce Crown Weight From The Eastern Stem Over Gate Entrance To Administration By 15% And Remove The Larger Failed Section.

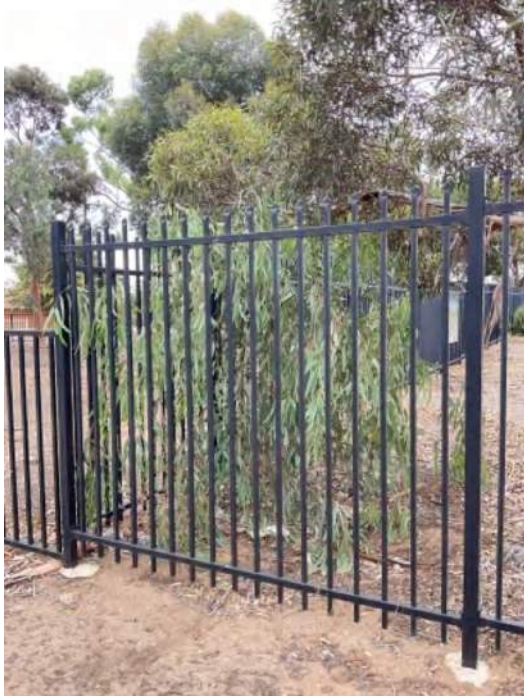
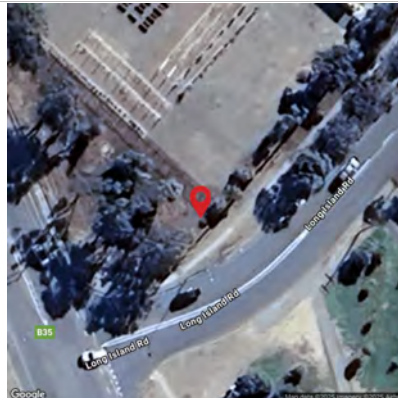
ID: PGSA00014168 | Tue, 11 Mar 2025

| Hazard Rating | Low |

Recommend Removal Of Tree On Fence Line Of Trade Agriculture Area.

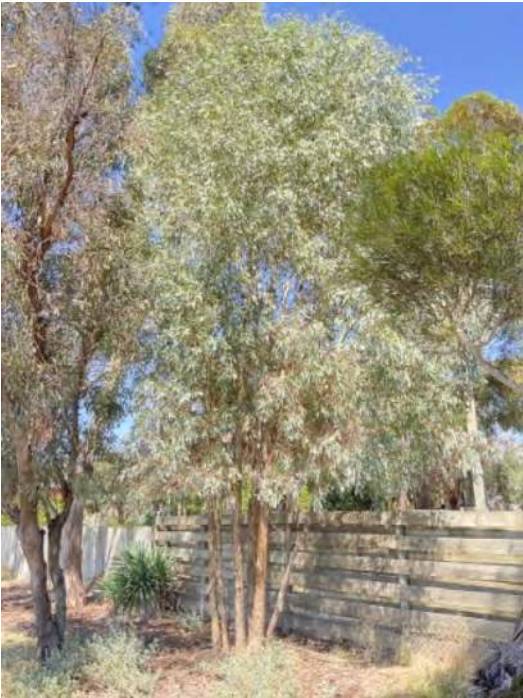
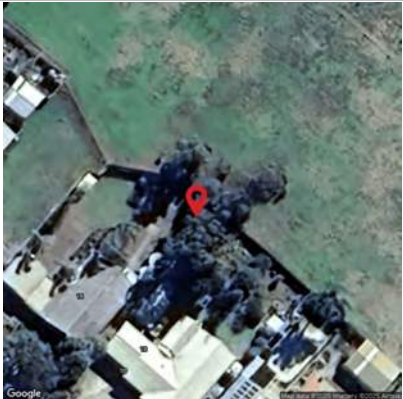
ID: PGSA00014174 | Wed, 12 Mar 2025

| Failure Hazard | 2 Medium - 10 - 25% Defects |
| Hazard Rating | Medium |

No Current Pruning Required. Epicormic Growth Developing From Stump Of Previously Removed Tree. Exhibits Good Crown Health. Currently Small Compact Canopy Form. Stem Appear Stable With Good Attachment.

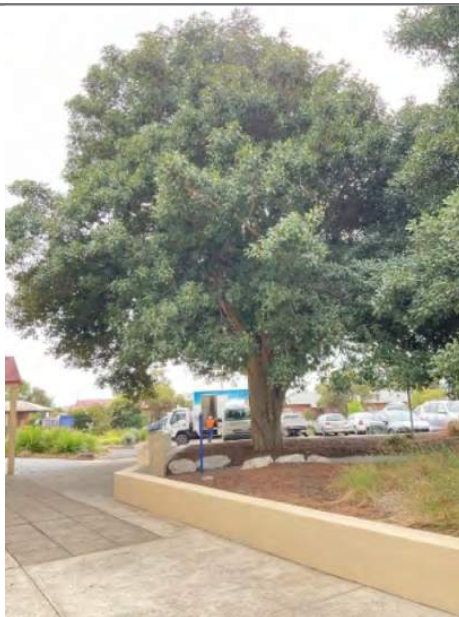
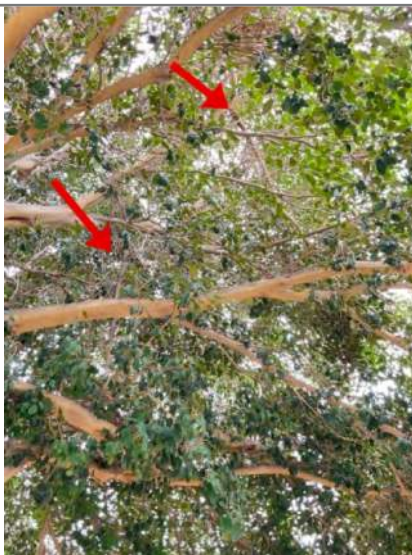
| PG Number | PGSA00009617 |

| Hazard Rating | Medium |

Recommend pruning ficus to remove failed limbs above path and building entrance. Clear security light to parking bays.

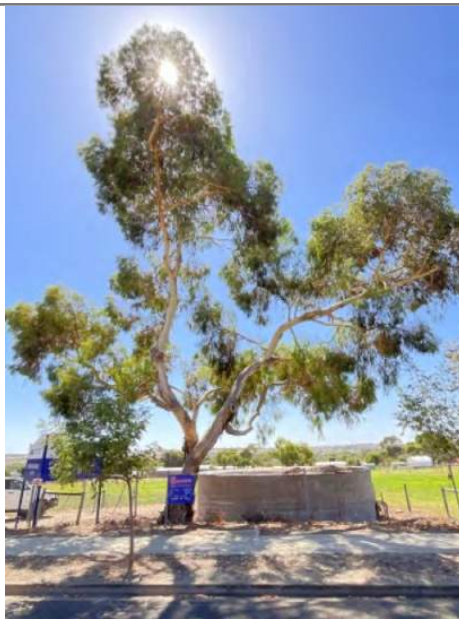
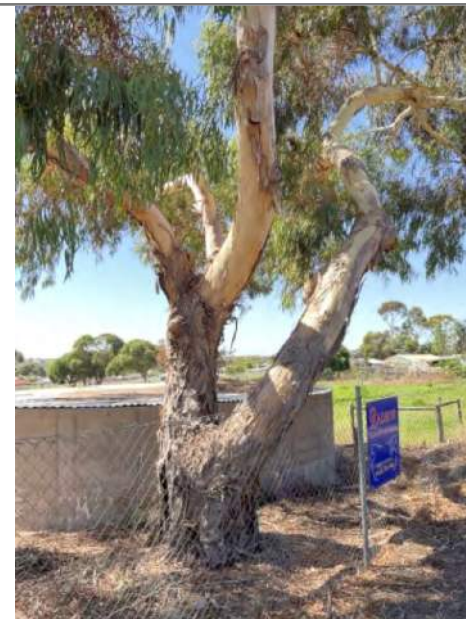
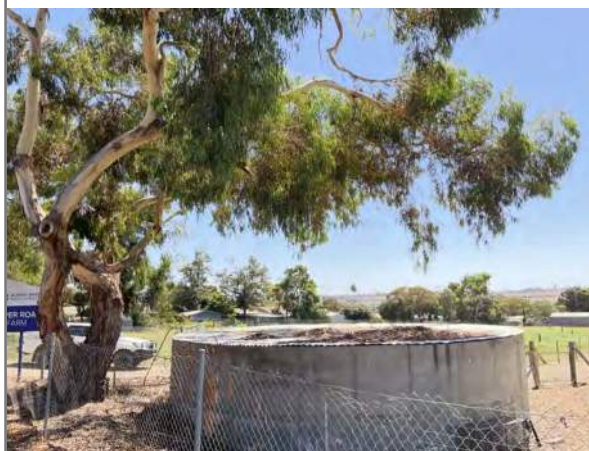
Recommend pruning to reduce lateral over water tank by 15%.  
Tree exhibits good crown health. Shows wounds from past pruning reductions and good occlusion.

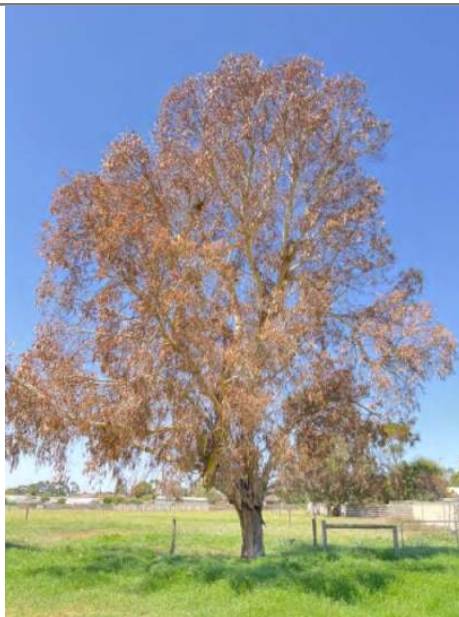
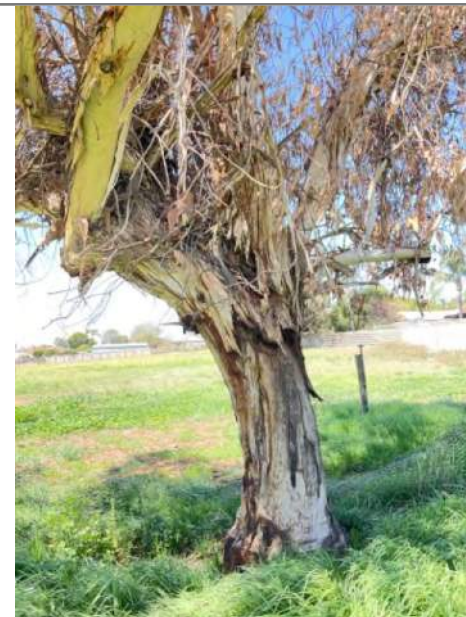
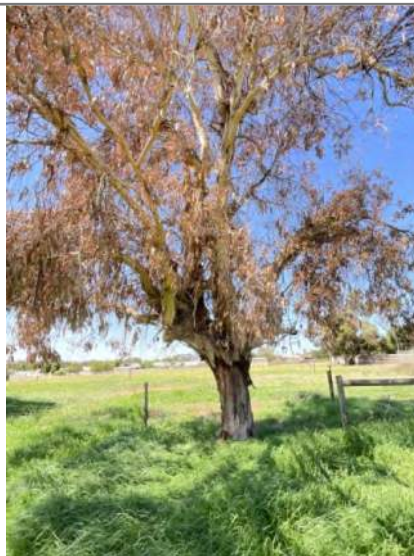
| PG Number | PGSA00009633 |

Recommend removal of dead Sa blue gum. Tree ring barked by animals. No potential to improve. Remove tree leaving stump at 1m for animal rubbing post.

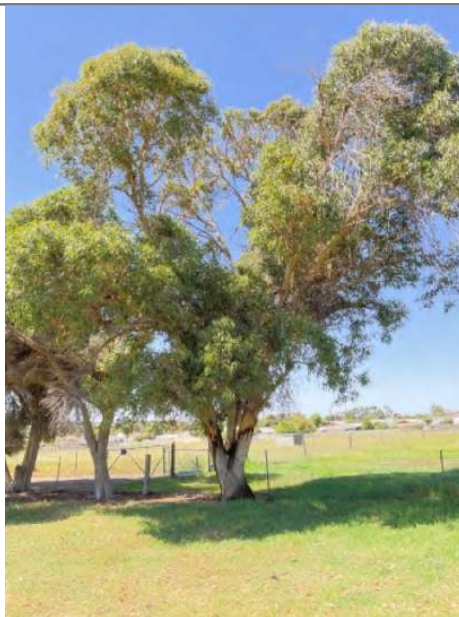
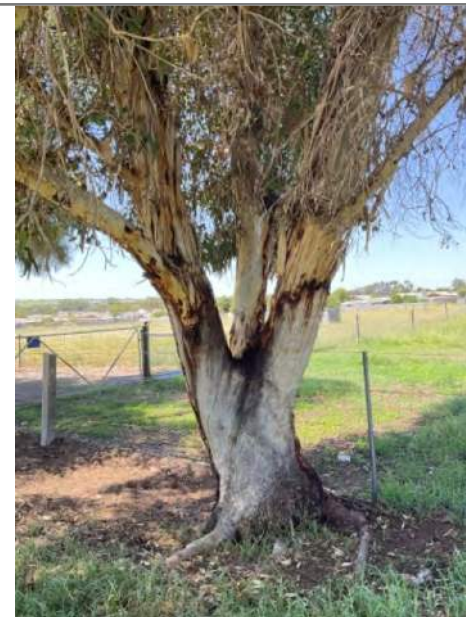
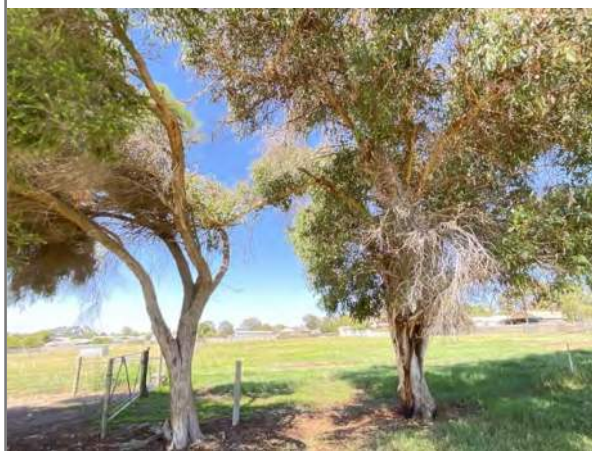
| PG Number | PGSA00009636 |

Recommend pruning dead limbs from crown over animal pen. Remove failed limb in melaleuca. Tree exhibits good crown health. Ring barking to approximately 50% of trunk cambium.

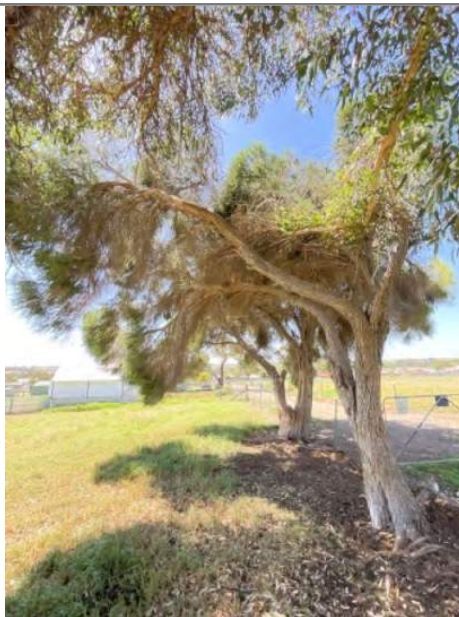
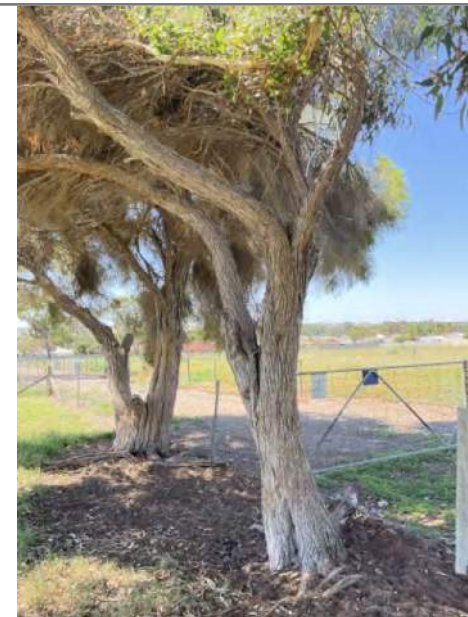
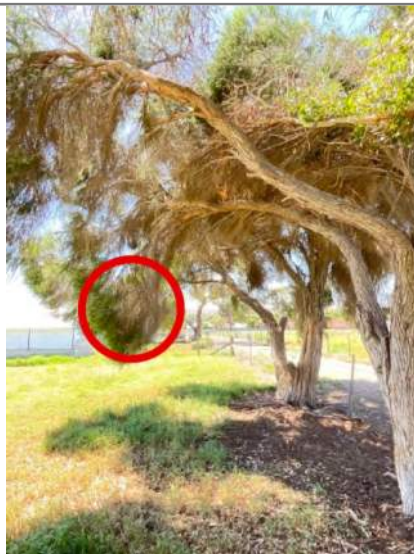
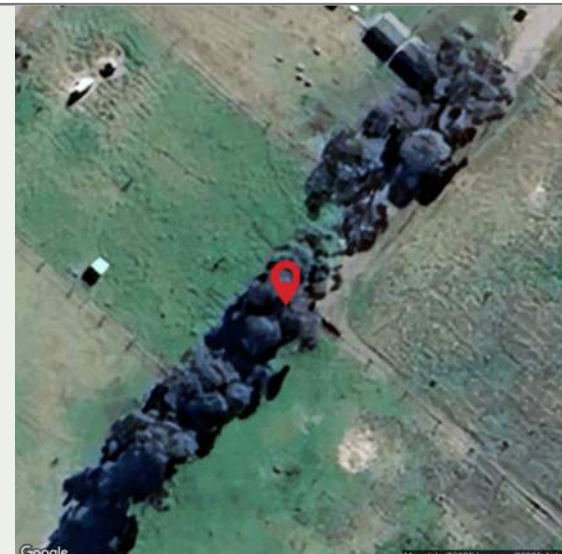
| PG Number | PGSA00009637 |

Lightly lift low crown.

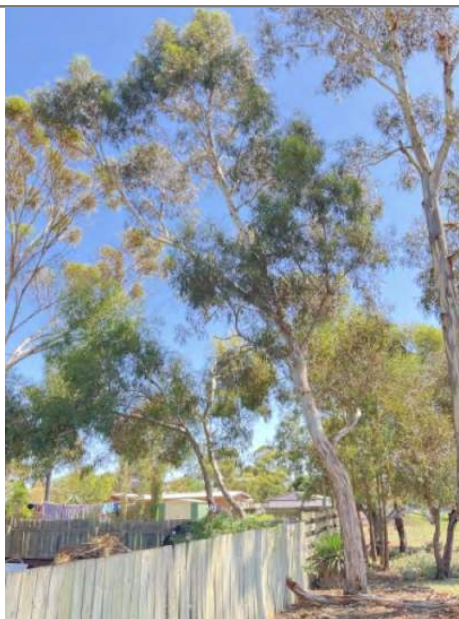
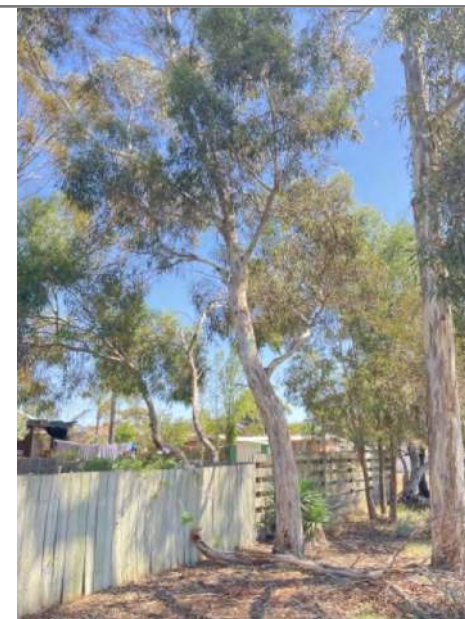
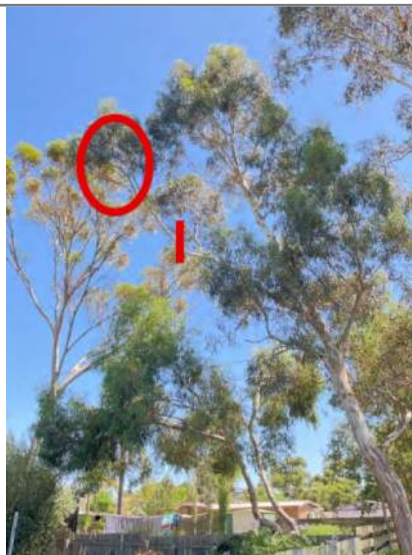
| PG Number | PGSA00009652 |

Mature Sa blue gum on property boundary. Exhibits good crown health. Crown encroachment over neighbouring property.  
Recommend pruning to reduce the western leader by half back to lower upright.

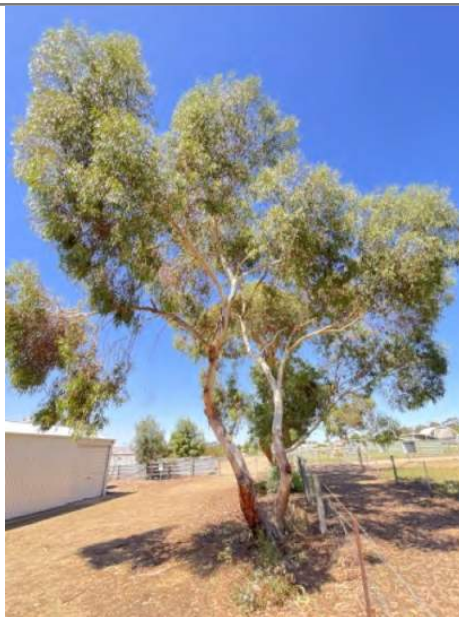
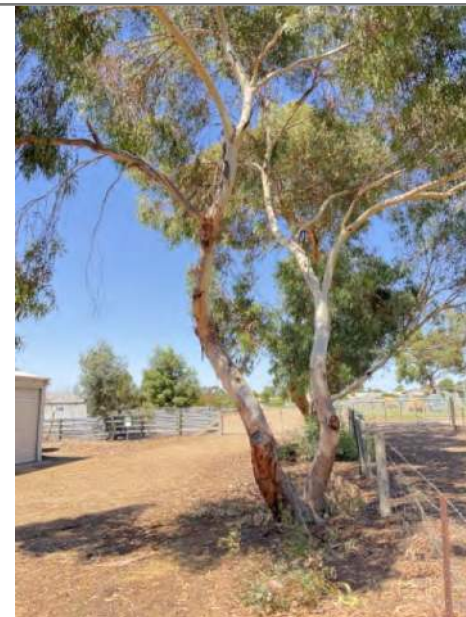
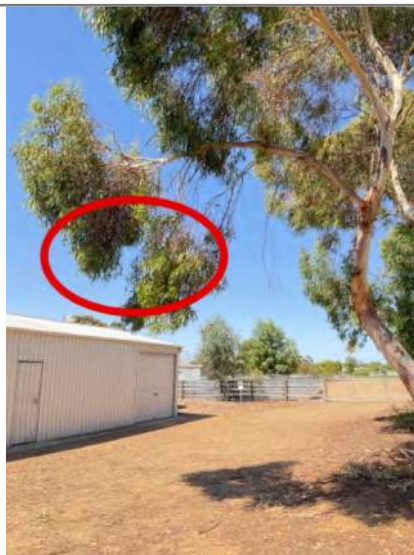
| PG Number | PGSA00009660 |

Recommend pruning tree to remove lateral over front of shed to collar.  
Presents good crown health. Co dominant stems from ground.

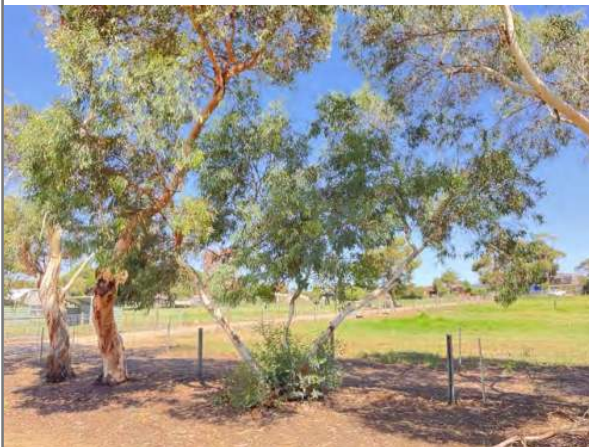
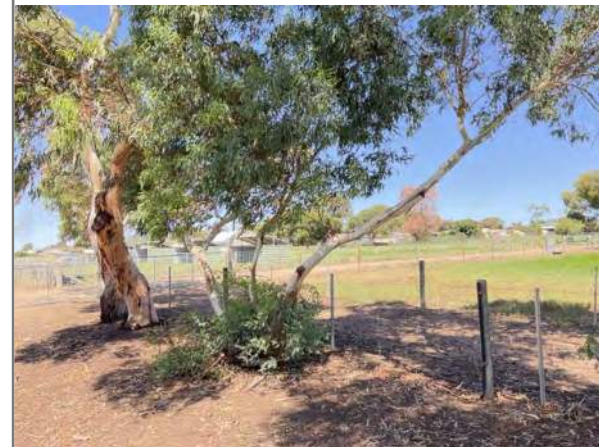
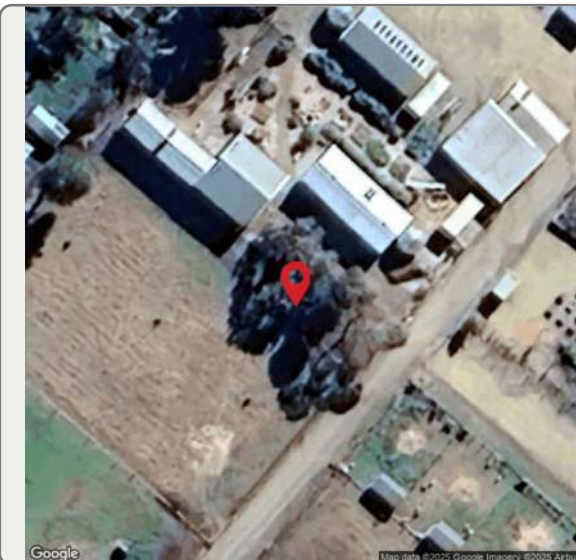
| PG Number | PGSA00009661 |

Prune to manage lower developing epicormic growth.

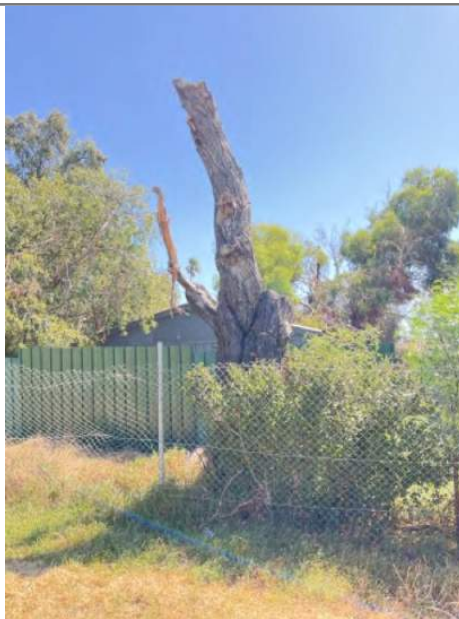
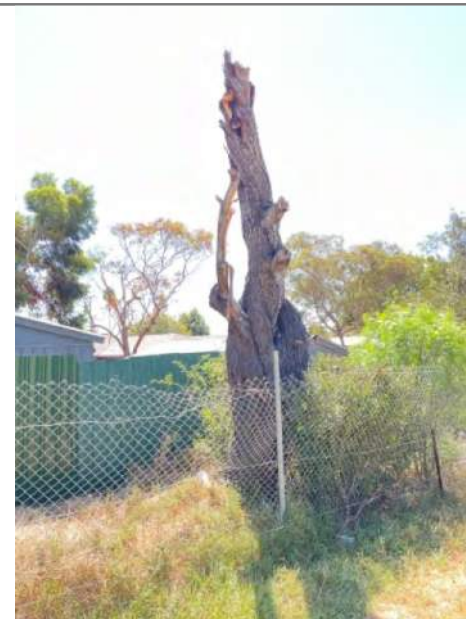
| PG Number | PGSA00009664 |

Trunk retained from removal with no Regrowth or sign of live cambium.  
Recommend remove to ground.

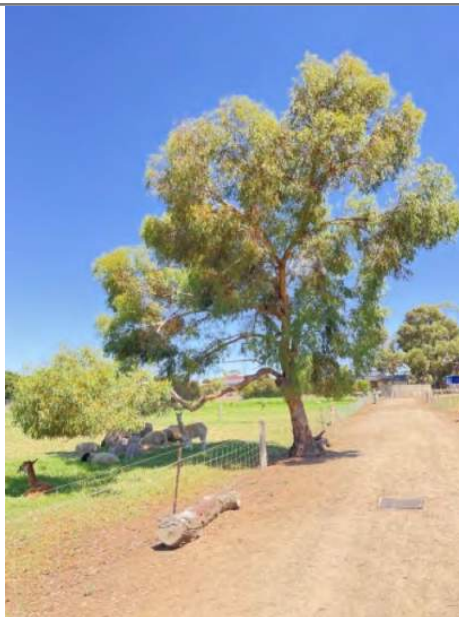
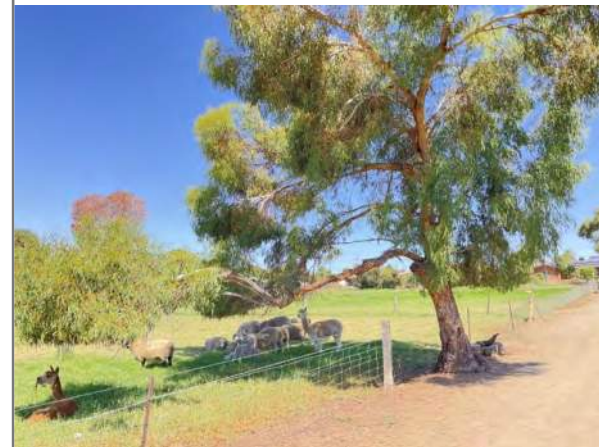
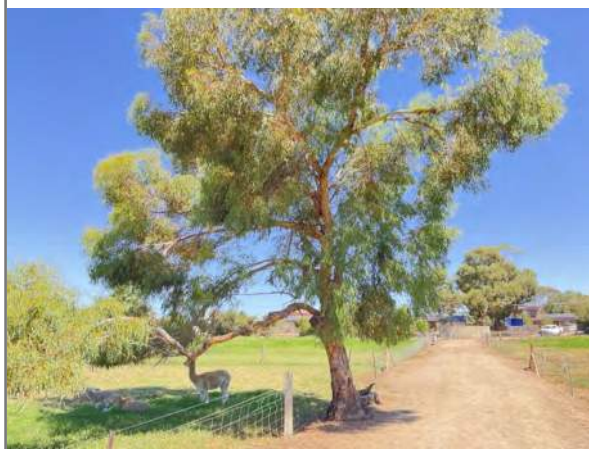
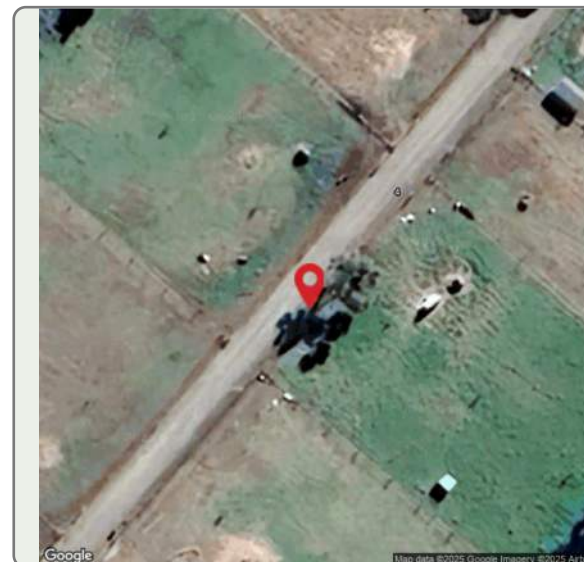
| PG Number | PGSA00009672 |

Recommend pruning tree to reduce end weight from heavier laterals to increase limb stability. Good shade tree for animals.

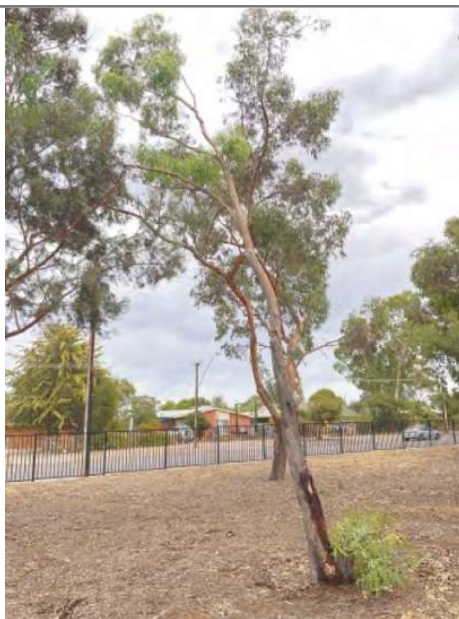
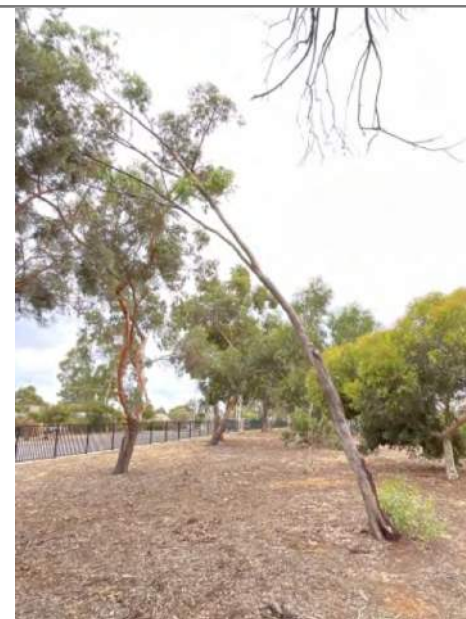
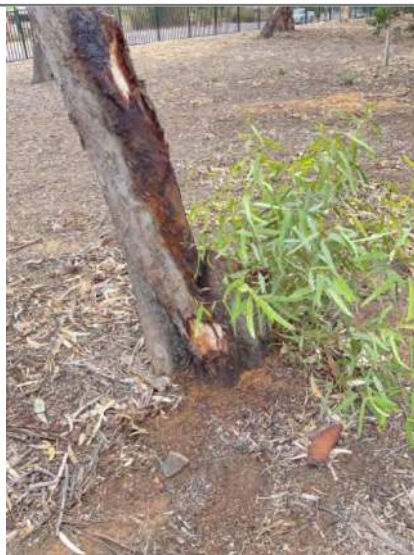
| PG Number | PGSA00009675 |

Recommend removal of the remaining co dominant stem. Stem is starting to fail from base and leaning into neighbouring trees. Splitting at bifurcation. Lower epicormic growth could be retained due to low use area.

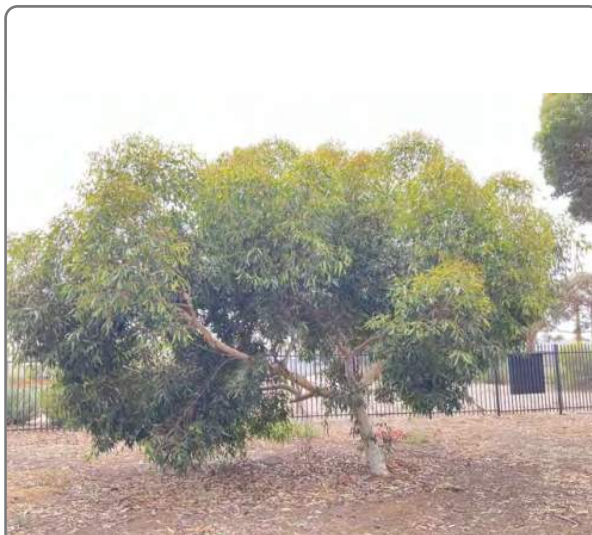
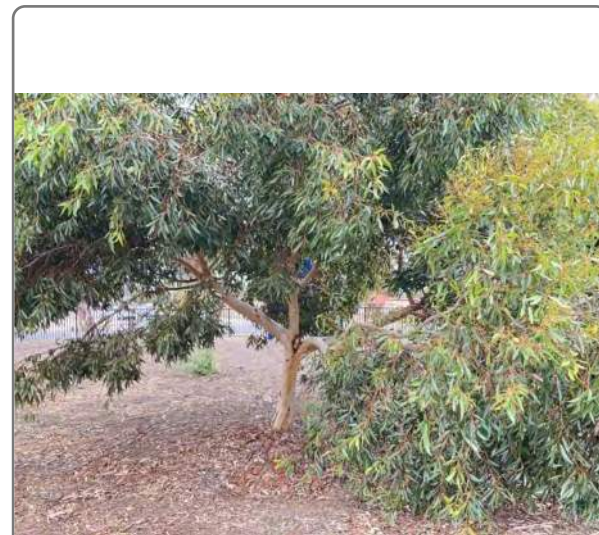
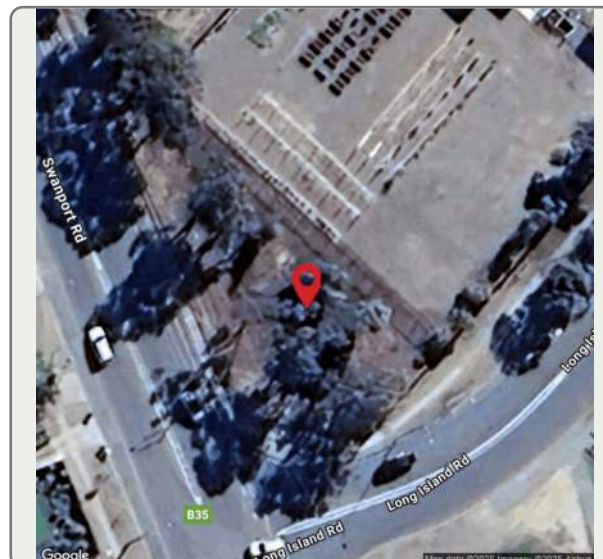
| PG Number | PGSA00009677 |

Recommend lifting low crown to uprights.

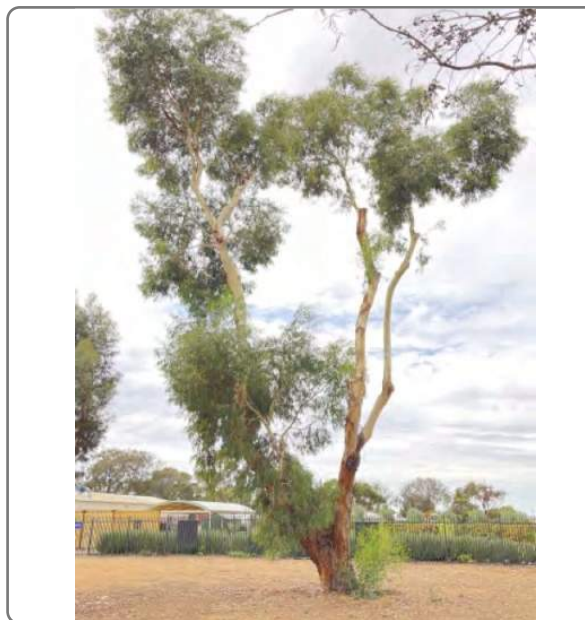
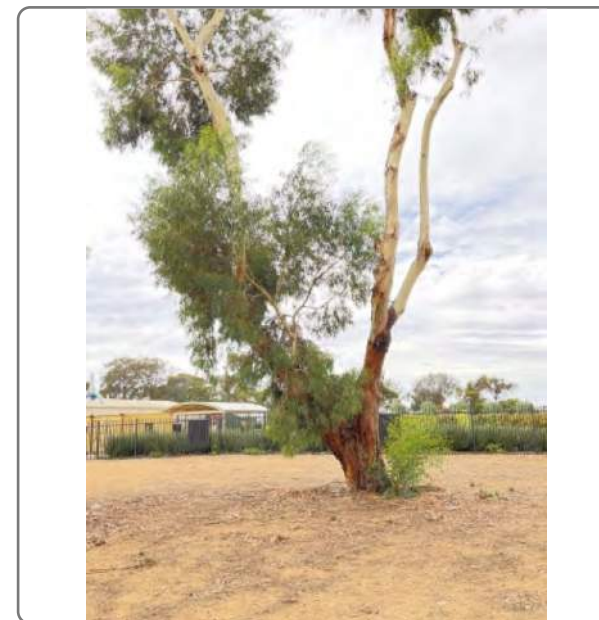
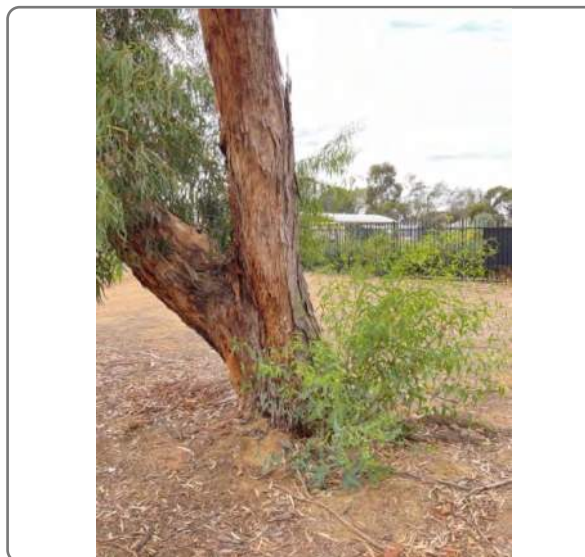
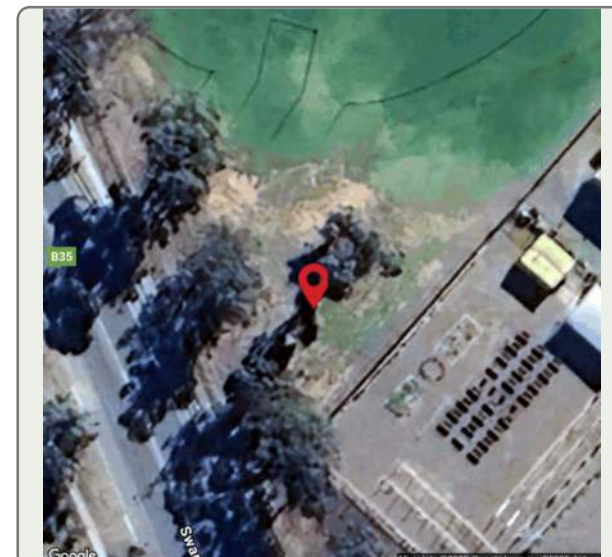
| PG Number | PGSA00009686 |

Crown reduced to uprights. Lower epicormic growth developing. Recommend pruning to remove the basal epicormic growth.

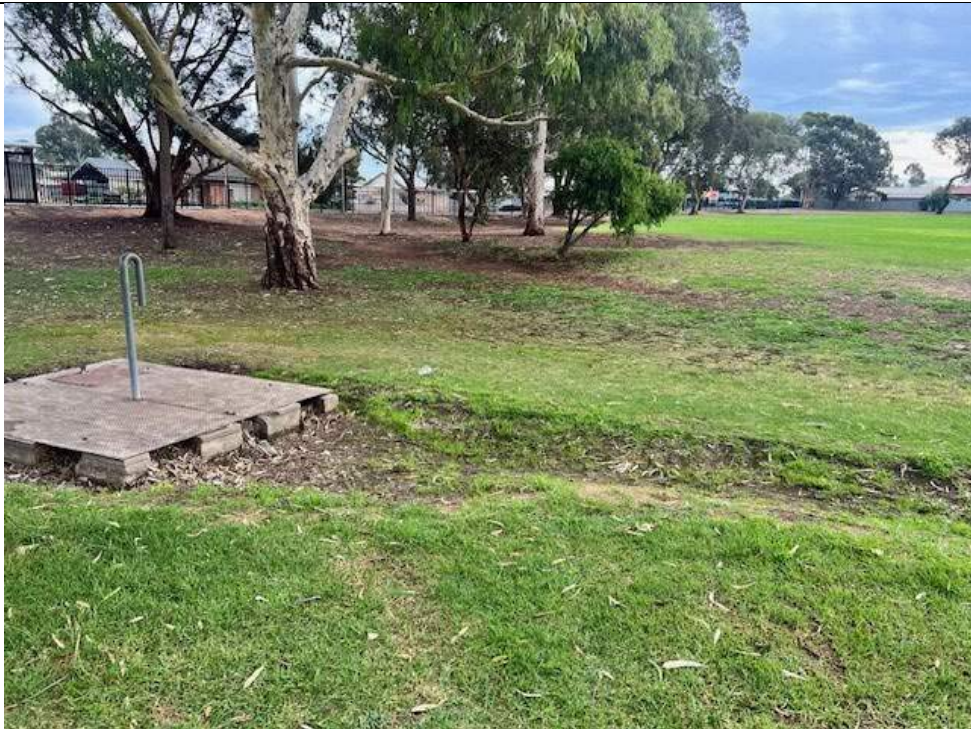
| <b>Description</b><br>View looking to school stormwater drain into drainage groundwater well. Stormwater drains to aquifer approximately 30 m below ground level. Located at southeastern site boundary. | | |

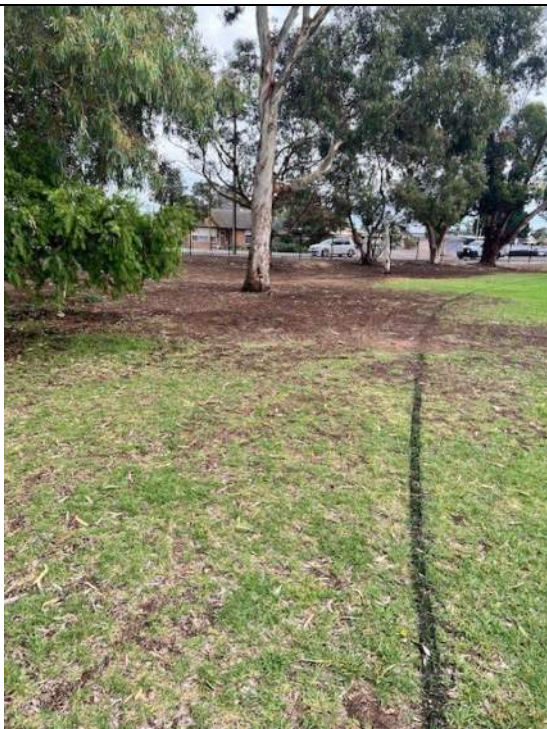
| <b>Description</b><br>View looking southwest of the site of the playing oval, oval surrounds, and large mature trees. | | |

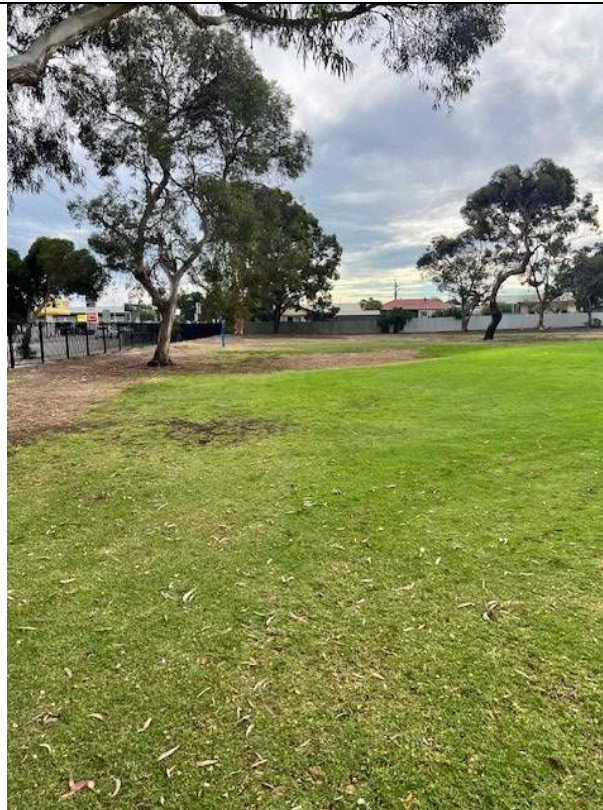
**Photo No.**  
4

View looking northwest of school oval and surrounds, showing northwestern extent of site.

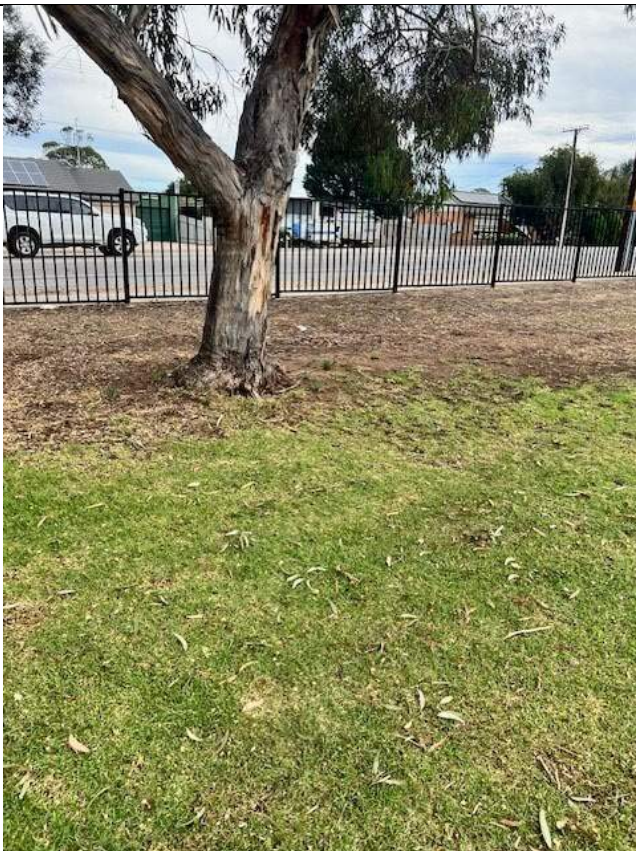
| <b>Description</b><br>View of southwestern site boundary showing example mature tree, school fence and site level relative to Swanport Road | | |

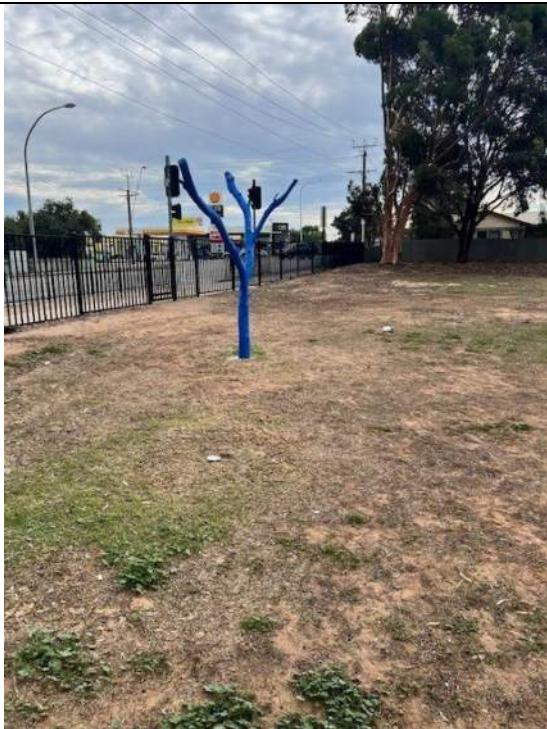
| <b>Description</b><br>View looking west showing 'Beyond Blue' monument tree and west site boundary. Site staff indicated this monument can be moved as required.<br><br>OTR service station present in background. | | |

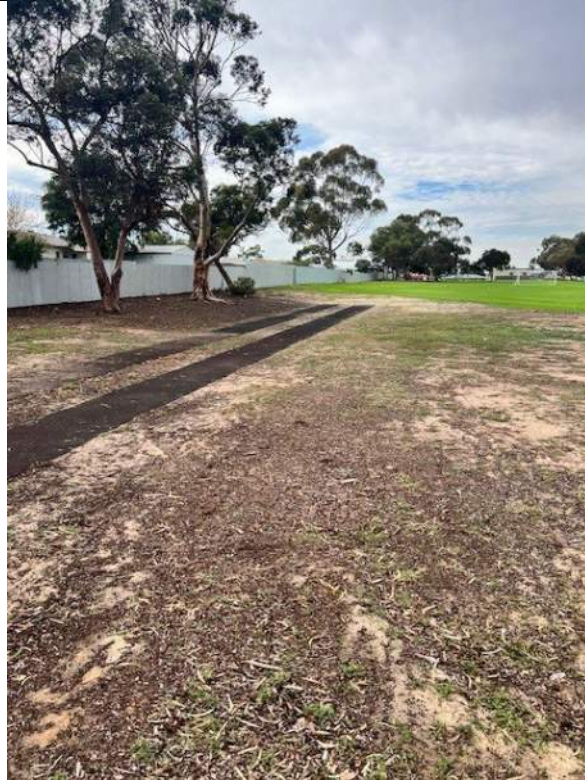
**Photo No.**  
7**Date**  
12/05/26**Description**

View looking north showing long-jump running track present on site and northern boundary.

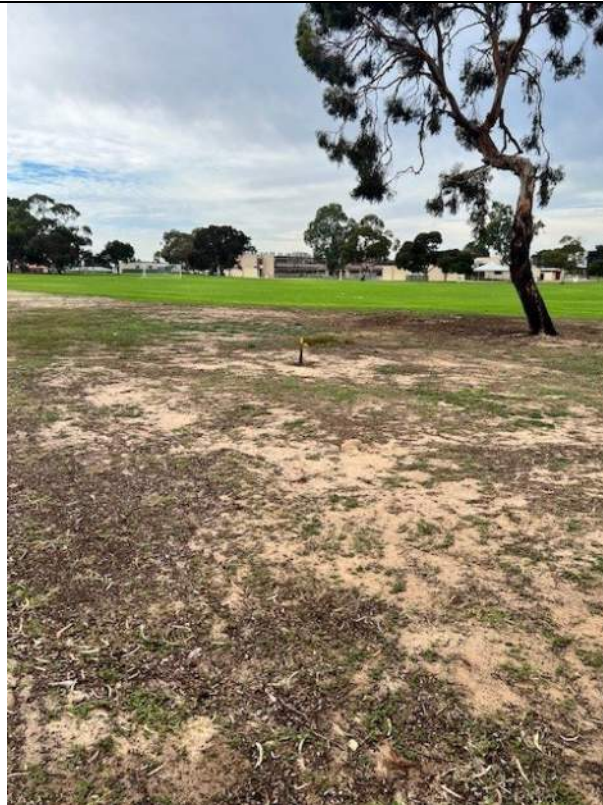
**Photo No.**  
8**Date**  
12/05/26**Description**

View looking southeast from northern site extent, showing site conditions. Water tap seen in middle of photo.

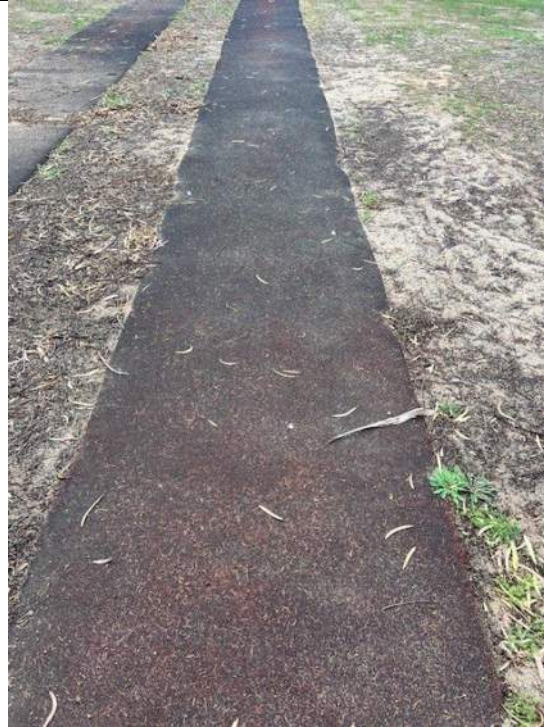
Close-up of long jump track showing asphaltic top layer on concrete slab.

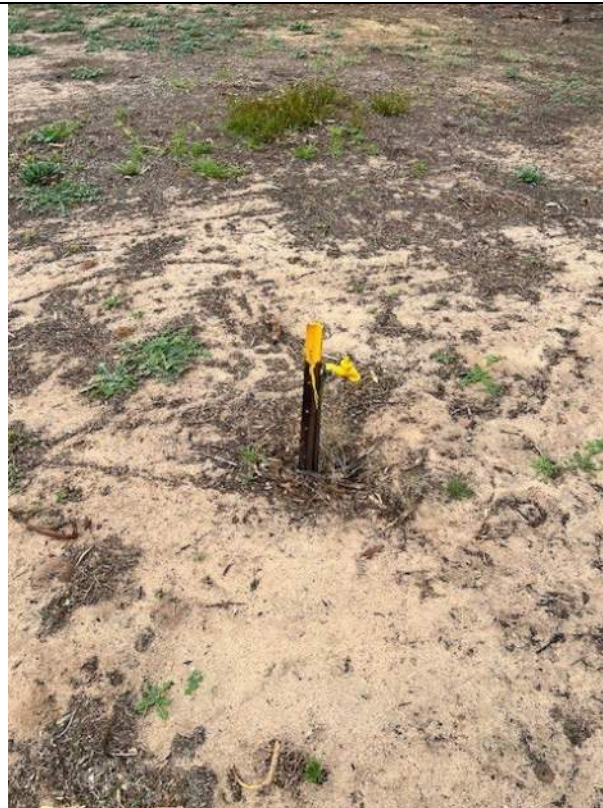
**Photo No.**  
10

Close up of water tap located in western corner of site, adjacent long-jump track.

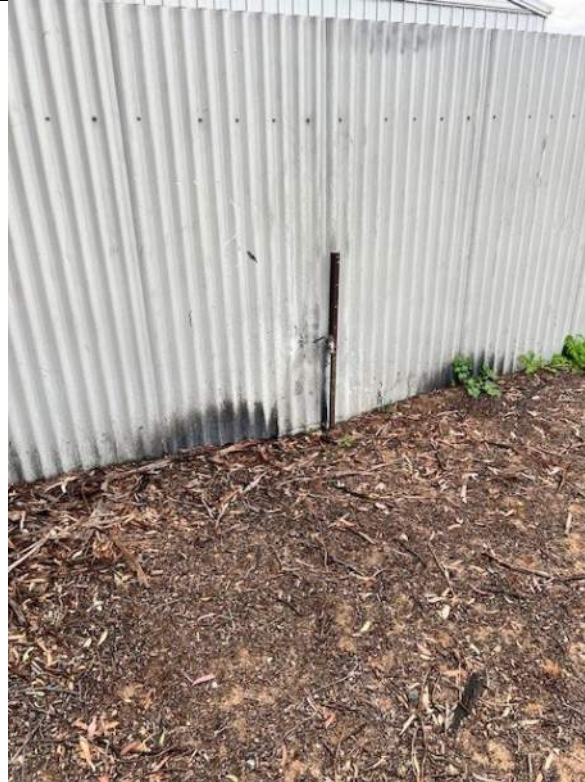
Water tap located on northern site boundary fence.

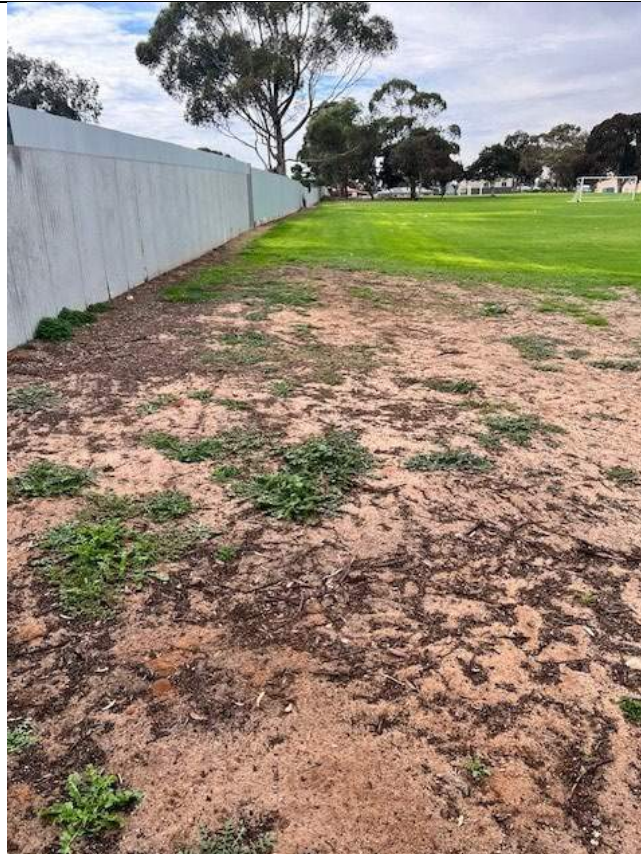
**Photo No.**  
12

View looking northeast at northern site extent showing general site conditions.
