# Arboricultural Impact Assessment and Development Impact Report

Site: Stirling Golf Club, 35 Golflinks Road, Stirling

Date: Tuesday, 6 December 2022

ATS6360-035GoIRdDIR R1

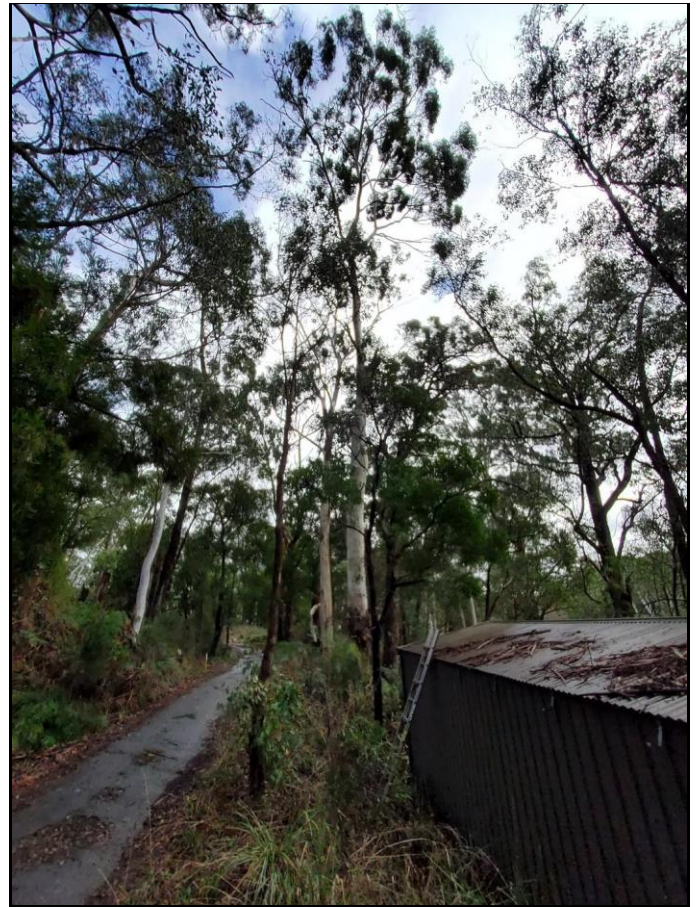
## Manna Gum

This tree is considered to be in fair overall condition as evidenced by the moderate volume of deadwood and history of branch failure throughout the crown. This tree has a moderate trunk lean however this is natural and not considered to be affecting the overall structural rating.

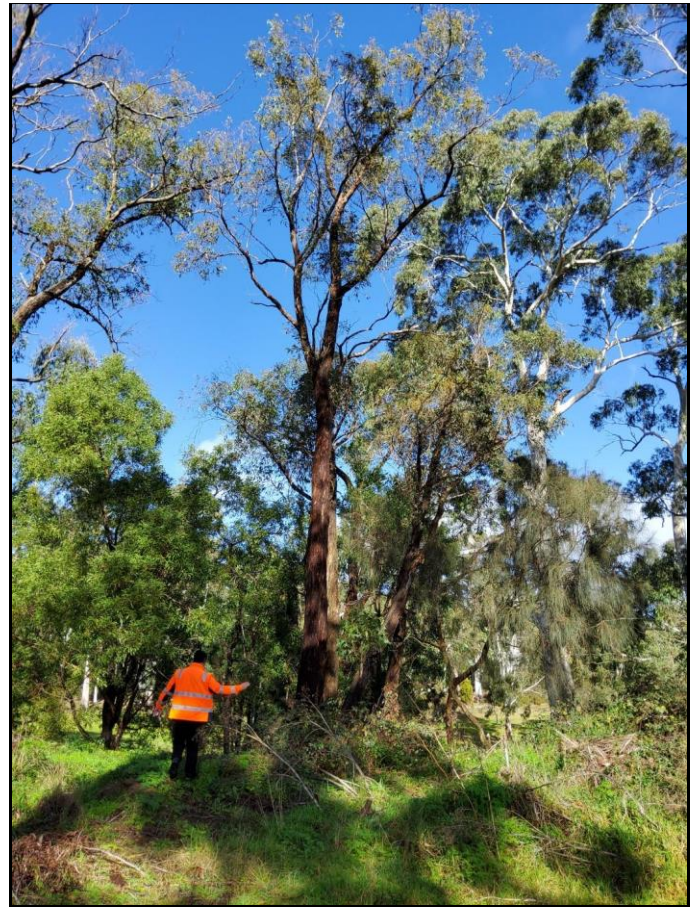
## Messmate Stringy-bark

This tree is considered to be in poor overall condition due to the level of dieback in the upper crown.

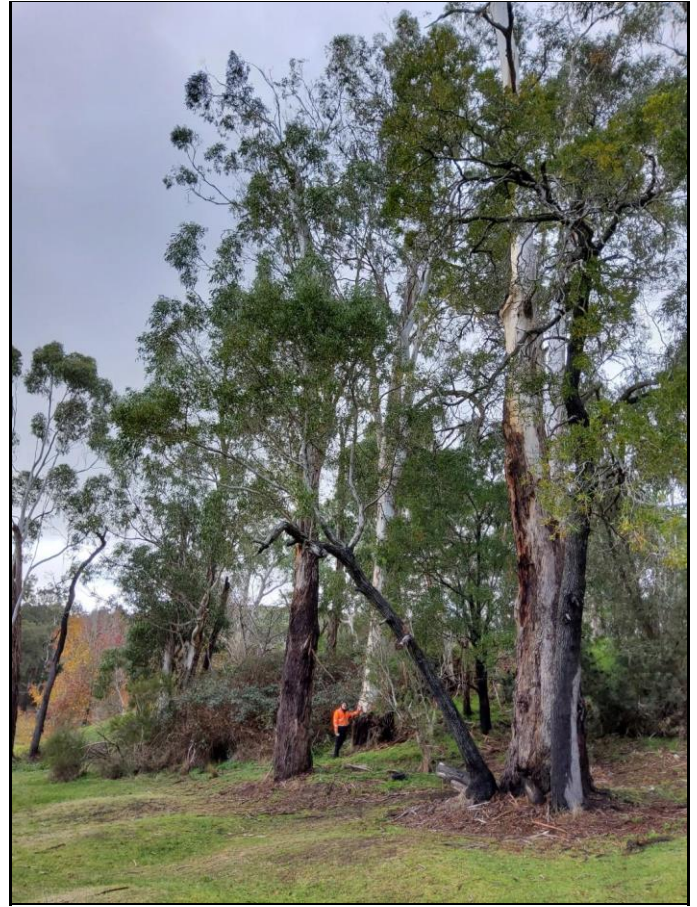
## Manna Gum

This tree is poor overall condition as evidenced by the high level of deadwood and dieback and the moderate levels of decay and epicormic growth.

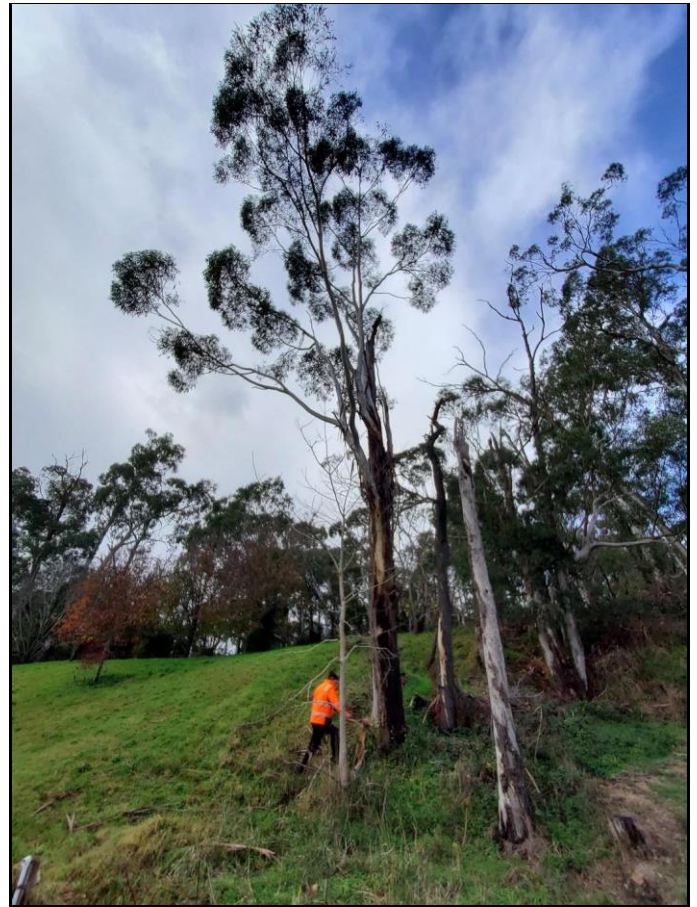
## Manna Gum

This tree is considered to be in poor overall condition due to the substantial history of branch failure and the moderate volume of deadwood.

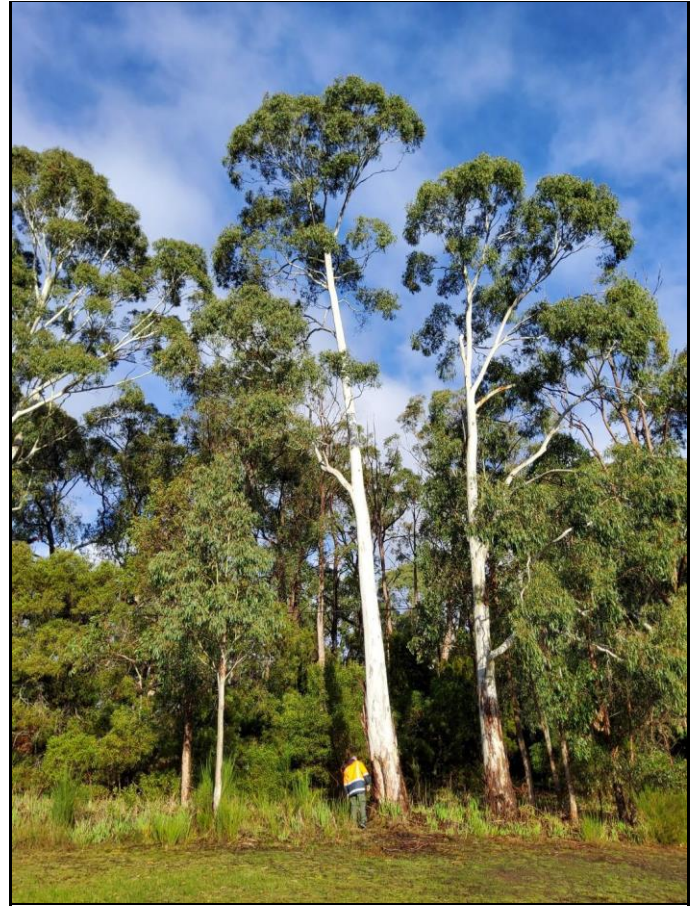
## Manna Gum

This tree is considered to be in poor overall condition due to its poor structure rating. This tree has a significant history of small diameter branch failure and a moderate level of decay in the trunk.

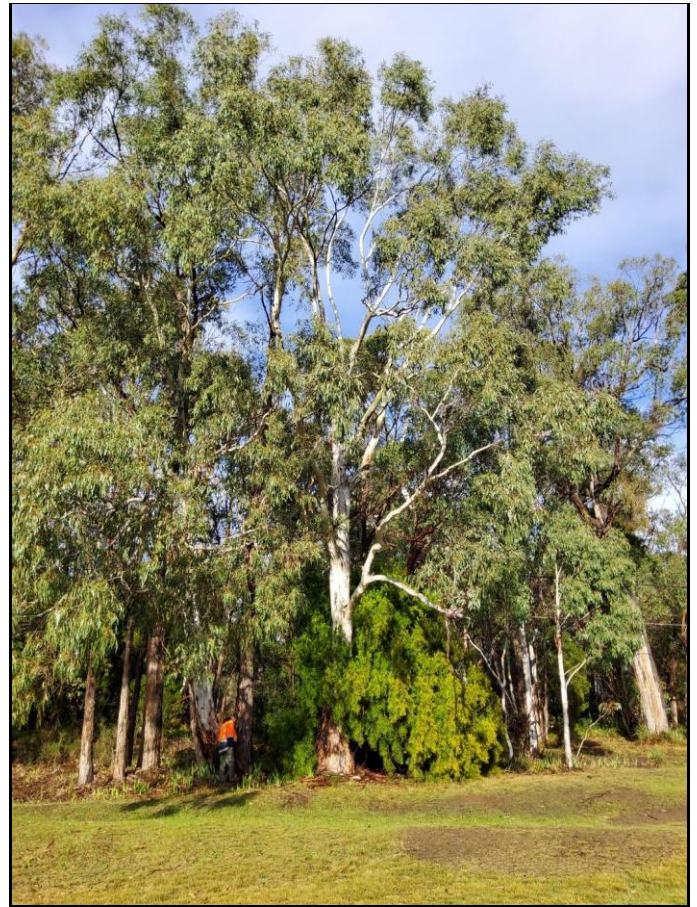
## Manna Gum

This tree is considered to be in fair overall condition due to its moderately reduced health rating.

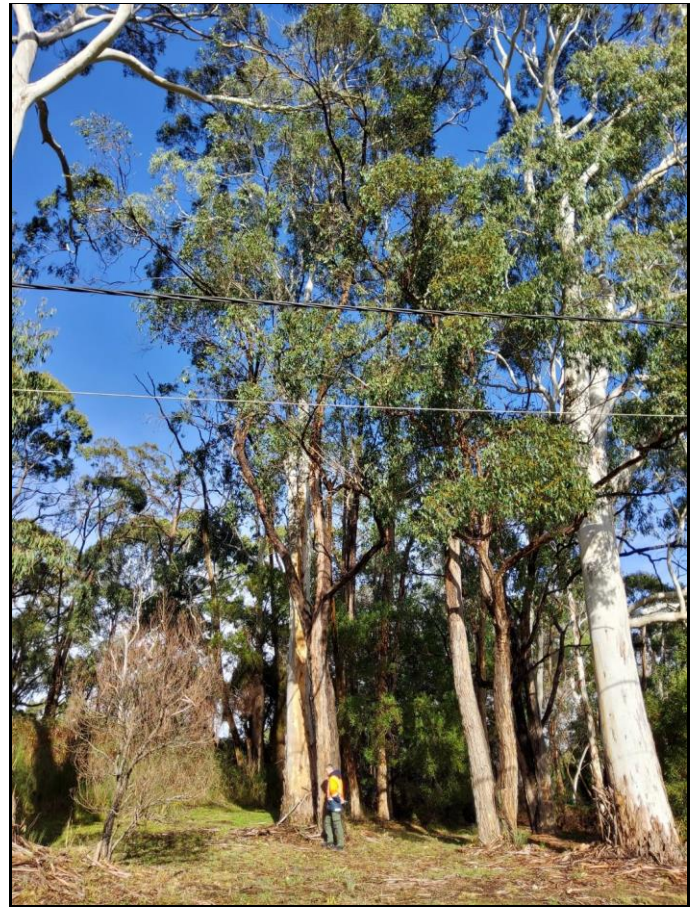
## Messmate Stringy-bark

This tree is considered to be in fair condition due to the moderate quantity of deadwood in the crown and slightly reduced overall structural rating. Additionally, this tree has a number of poorly tapered branches throughout the crown.

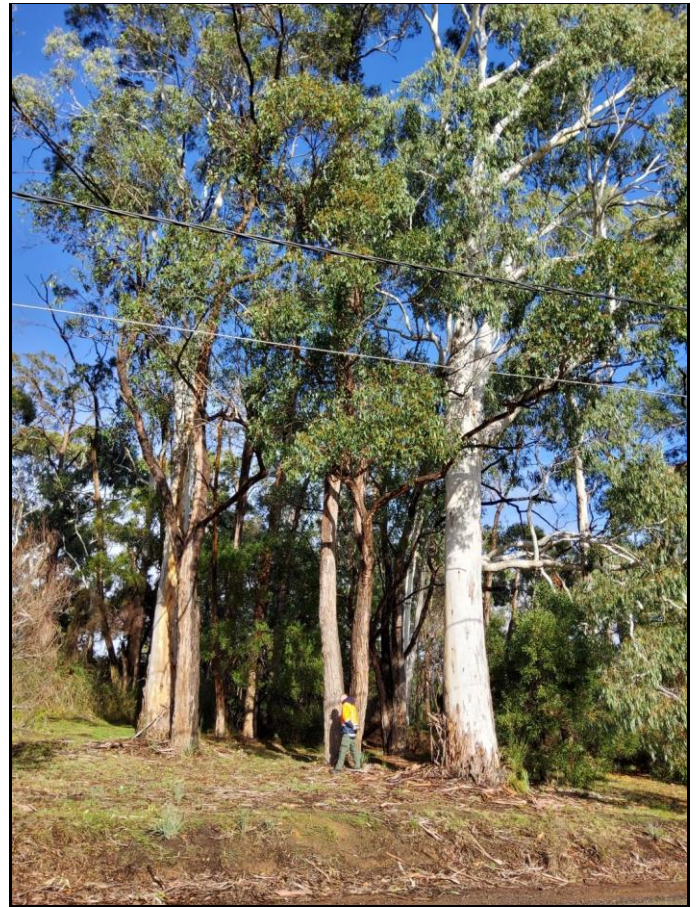
## Messmate Stringy-bark

The health and structure of this tree indicate it is in good overall condition and has adapted to its local environment. There is included bark in the primary structure however this is not impacting the overall structural rating at this point.

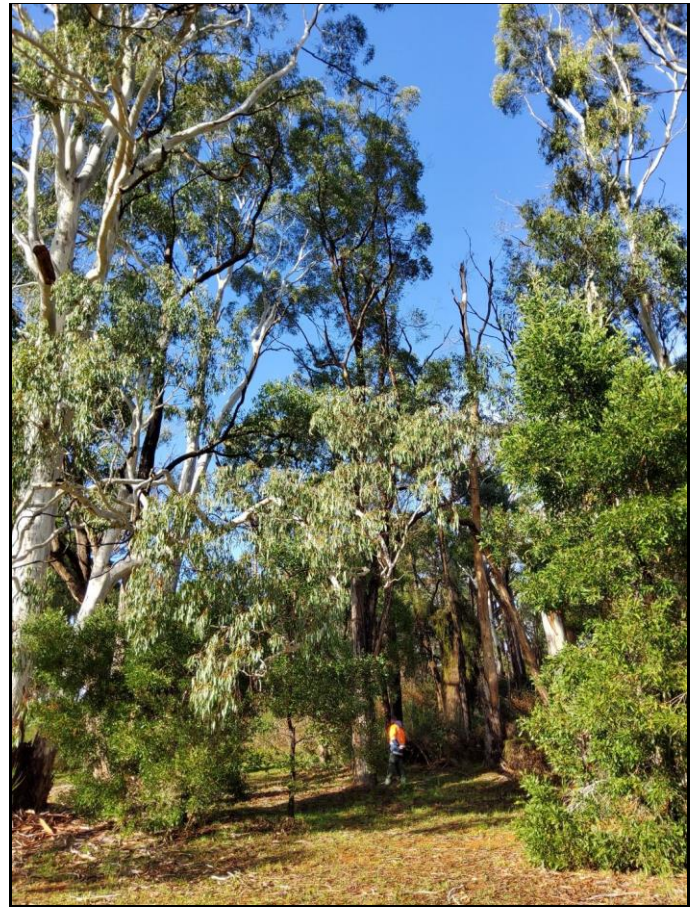
## Messmate Stringy-bark

This tree is considered to be in poor overall condition due to the structure of the primary trunk union which is supporting a dead leader.

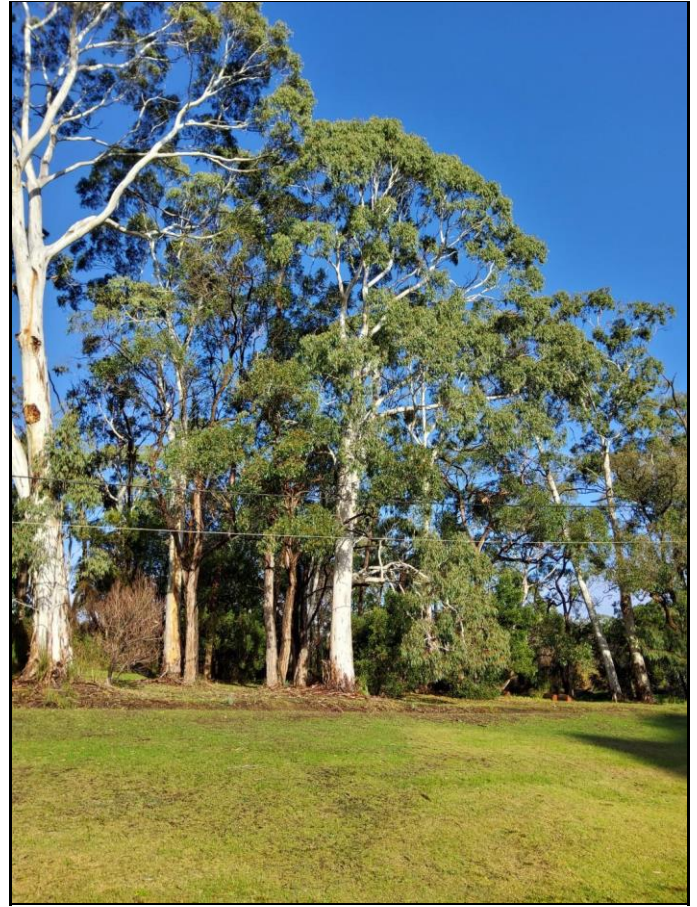
## Manna Gum

This tree is considered to be in fair overall condition due to it having a moderate history of branch failure impacting its structural rating and therefore its overall condition.

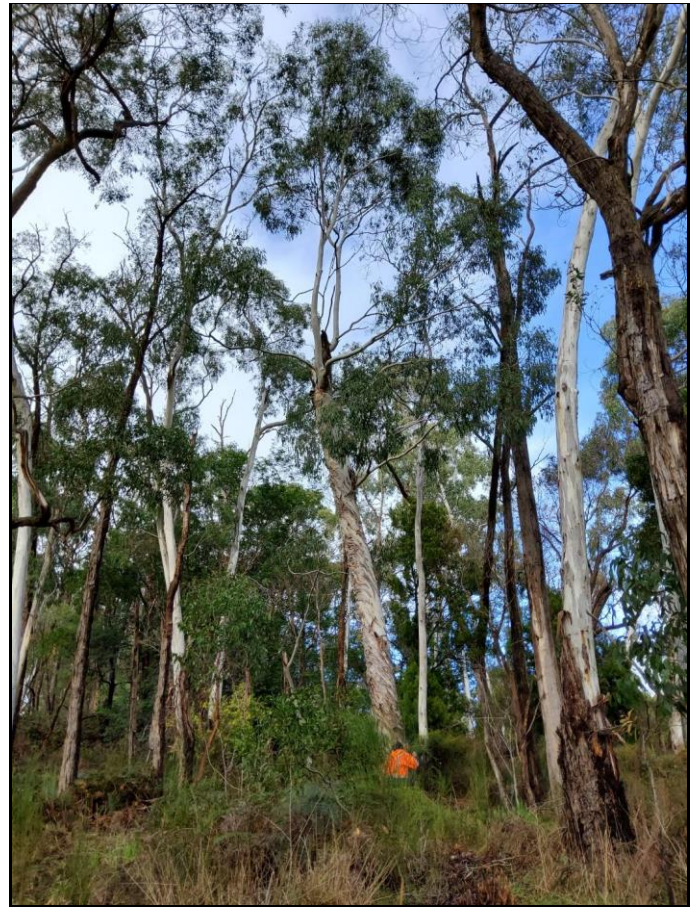
## Manna Gum

This tree is considered to be in poor overall condition due to a history of substantial failure, a moderate level of epicormic growth and an overall reduction in its health rating. The trunk of this tree has failed at approximately eight metres above ground level, with the crown now consisting of epicormic regrowth.

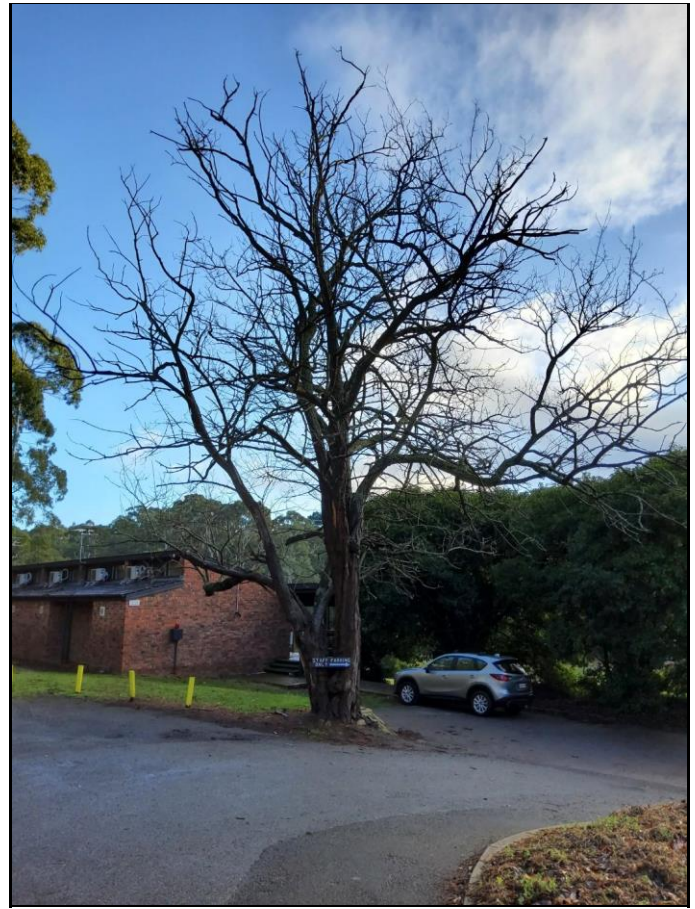
## Black Locust

This tree is considered to be in poor overall condition due to its poor health and reduced structure rating. This tree has a codominant form with included bark in the primary structure, there is also a moderate level of decay in the trunk and a substantial volume of deadwood in the crown.

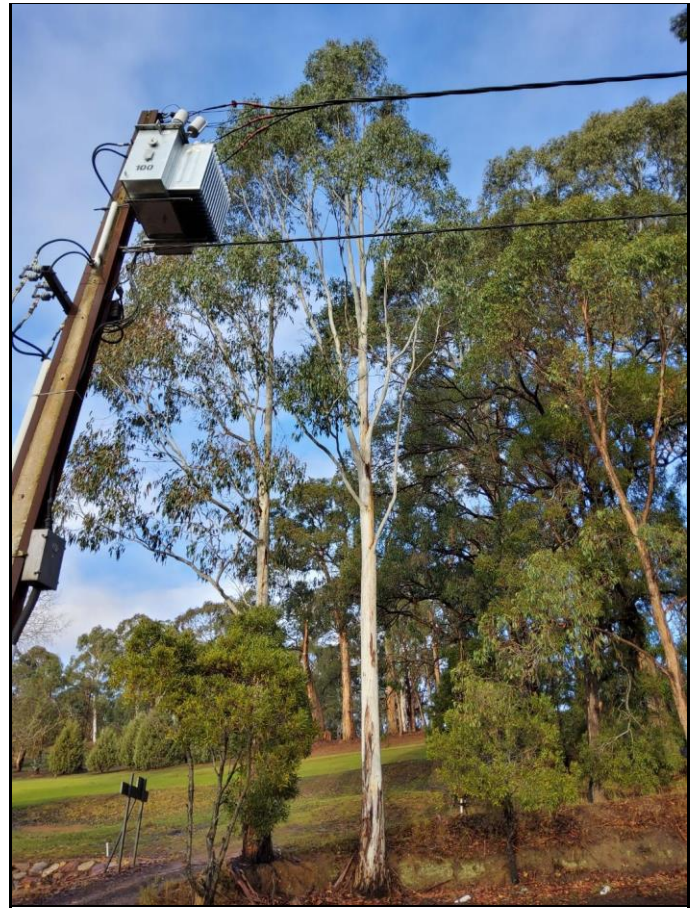
## Manna Gum

The health and structure of this tree indicate it is in good overall condition and has adapted to its local environment.

<b>Legislative Status</b>	<b>Controlled</b>
This tree appears to be naturally occurring indigenous vegetation in an area subject to regulation under the Native Vegetation Act 1991 and its management is therefore controlled under this Act. However, this tree does not achieve a regulated trunk circumference and therefore is not regulated by the Planning, Development and Infrastructure Act 2016.	
<b>Retention Rating</b>	<b>Moderate</b>
This tree has a Moderate Retention Rating and could be considered for retention in any future development.	
<b>Development Impact</b>	<b>Conflicted</b>
The identified encroachment is greater than 10% of the TPZ area and will also impact the SRZ and/or the trunk. On that basis the proposed development will negatively impact tree viability to the point where its removal is required.	
<b>Action</b>	<b>Removal Required</b>
Tree removal is required to facilitate the proposed development.
